## 2023 Master Plan

# Jose D. Leon Guerrero Commercial Port of Guam 2023 Master Plan

Prepared by:  
WSP  
Guam International Trade Center  
South Marine Corps Drive, Suite 808  
Tamuning, Guam 96913  
Telephone: 671-646-6872

# Port Authority of Guam Facility Condition Assessment Report Berths F2, F3, F4, F5, and F6

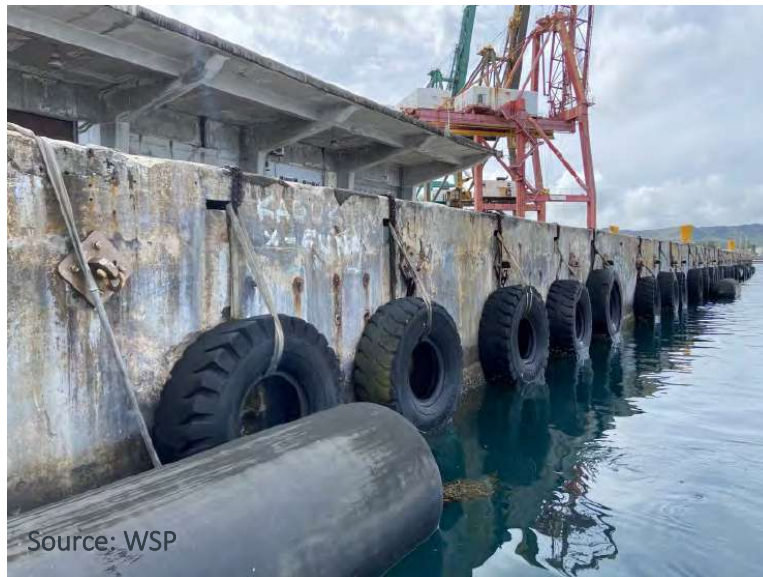
**Photo 3: Berth F3**

Overall, Berth F3 is in **poor** condition. See Photo 3. Previous inspection reports identify holes in the sheet pile wall, open-corrosion spalls along the concrete bullrail, and cracking of the concrete facing at multiple locations. The fender system is non-uniform and consists of a combination of tires, floating pneumatic fenders, and cylindrical fenders. Moderate to major corrosion is present at the mooring hardware. A detailed condition assessment report for Berth F3 is provided in Appendix B.

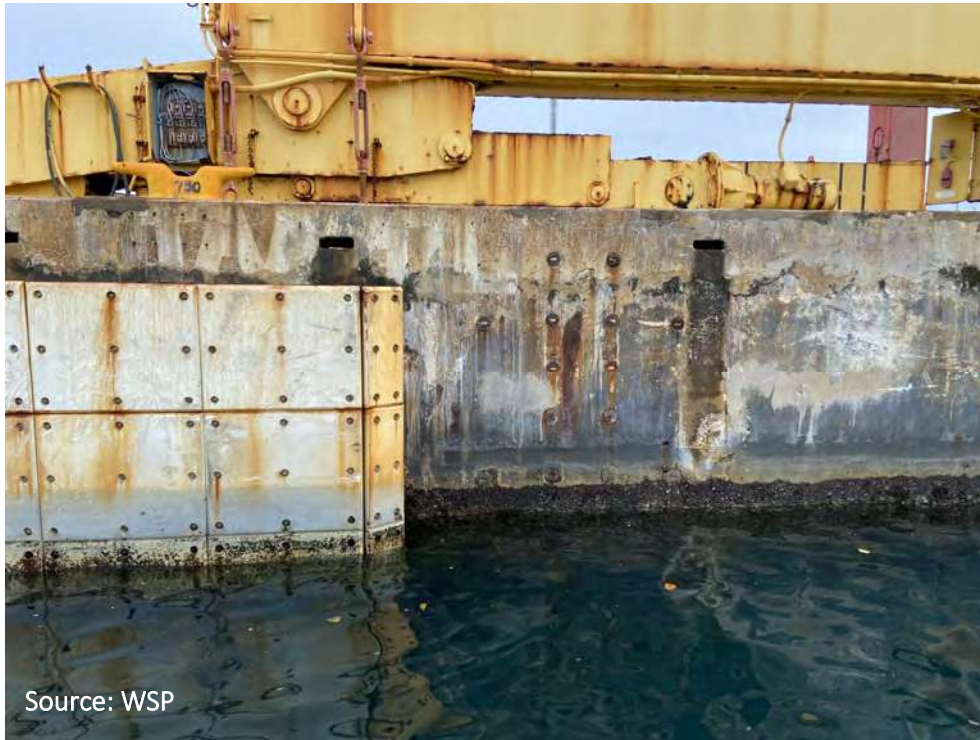
**Photo 4: Berth F4**

Overall, Berth F4 is in **fair** condition. See Photo 4. Previous inspection reports identify holes in the sheet pile wall at isolated locations, closed-corrosion spalls along the concrete bullrail, and cracking of the concrete facing at multiple locations. The fender system is in working condition, but in need of extensive repairs due to missing chains and torn rubber fenders. Minor to moderate corrosion is present at the mooring hardware. A detailed condition assessment report for Berth F4 is provided in Appendix B.

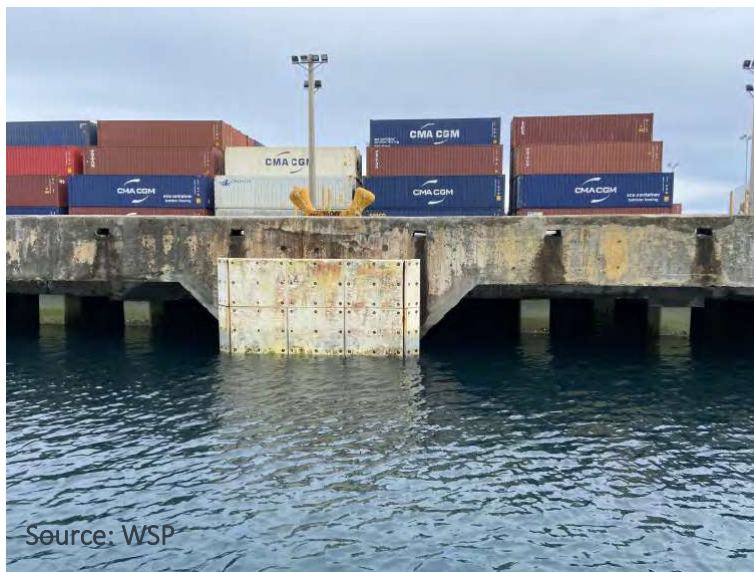
**Photo 5: Berth F5**

Overall, Berth F5 is in **satisfactory** condition. See Photo 5. Concrete piles and pile caps are in good condition. Moderate to major corrosion is present at the mooring hardware and fender panels. Moderate to major corrosion is present at the upland sheet pile wall. Several of the rubber fender elements are severely torn. A detailed condition assessment report for Berth F5 is provided in Appendix B.

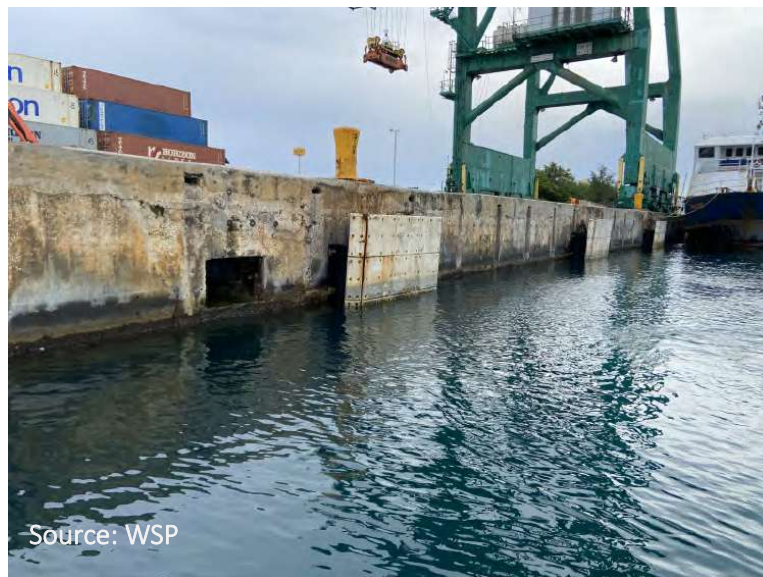
**Photo 6: Berth F6**

Overall, Berth F6 is in **satisfactory** condition. See Photo 6. Minor cracking of the concrete facing was observed at several locations. Rubber fender elements are torn and split at isolated locations. A detailed condition assessment report for Berth F6 is provided in Appendix B.

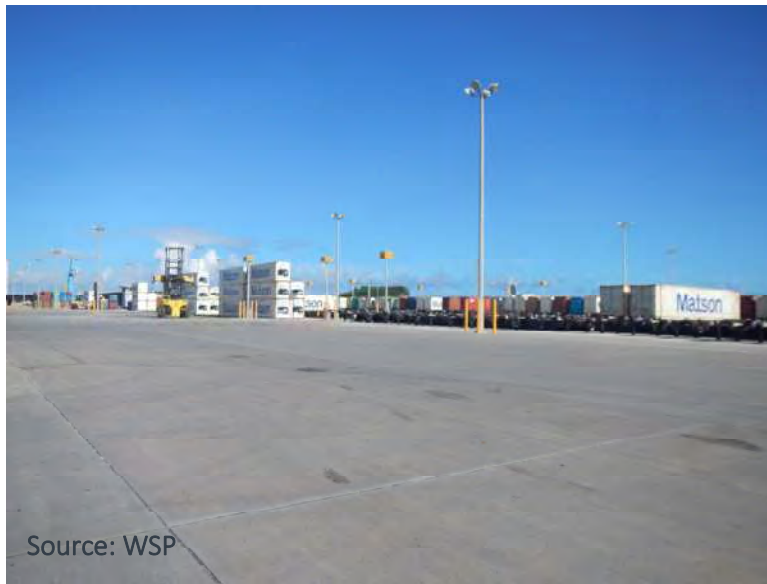
**Photo 8: Container Yard Pavement**

A condition assessment of the container yard was completed in August 2021. A majority of the yard is in serviceable condition with limited evidence of cracking, spalling, rutting, and ponding. Some areas of the yard contain asphalt pavement that have depressions due to container stacking or chassis landing legs. The trench drain grates consist of older grates that are showing signs of damage. Overall, the condition of the container yard is "Fair." See Photo 8.

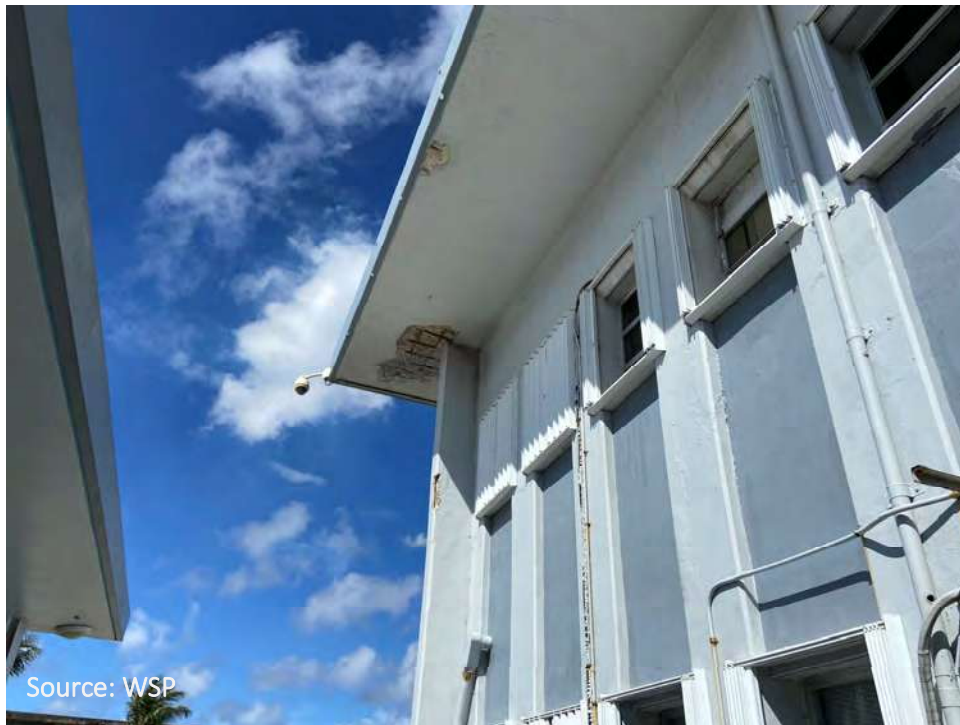
**Photo 10: Administration Building Concrete Spalling**

Construction of a new building adjacent to the existing building is a more practical solution. The new building could be a smaller footprint based on the current number of tenants, A programming study is recommended to determine the most effective size and layout of the building. Once completed, the existing Administration Building should be demolished to provide additional parking for the new building.

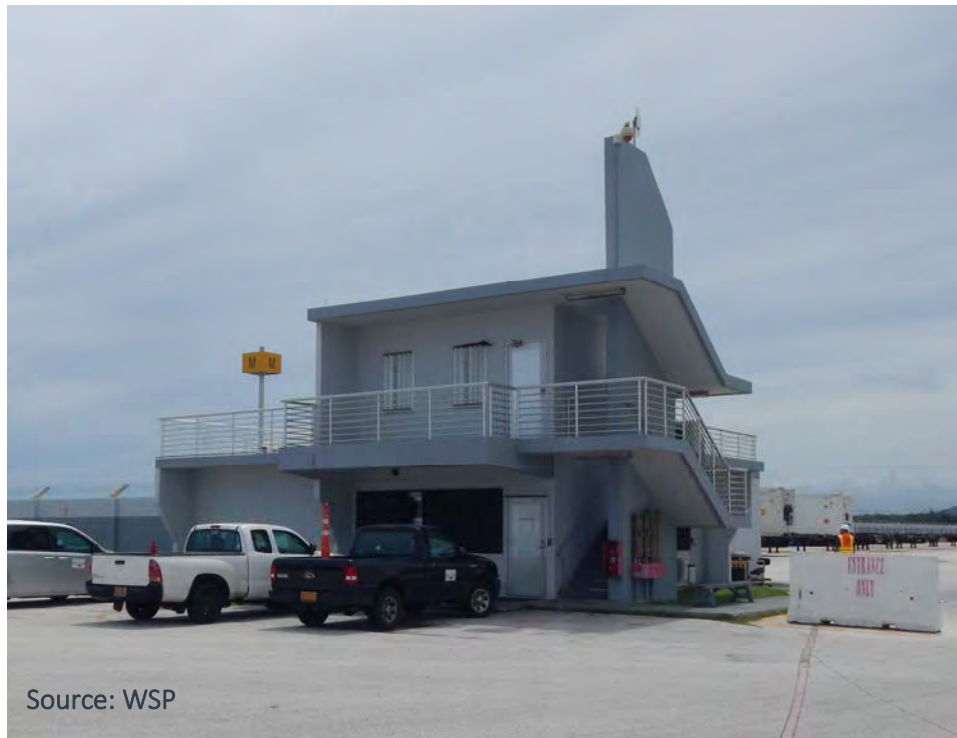
**Photo 19: Low Tower**

A condition assessment of the Low Tower was performed in August of 2021 and found it to be in **fair** condition. No visible deficiencies were observed.

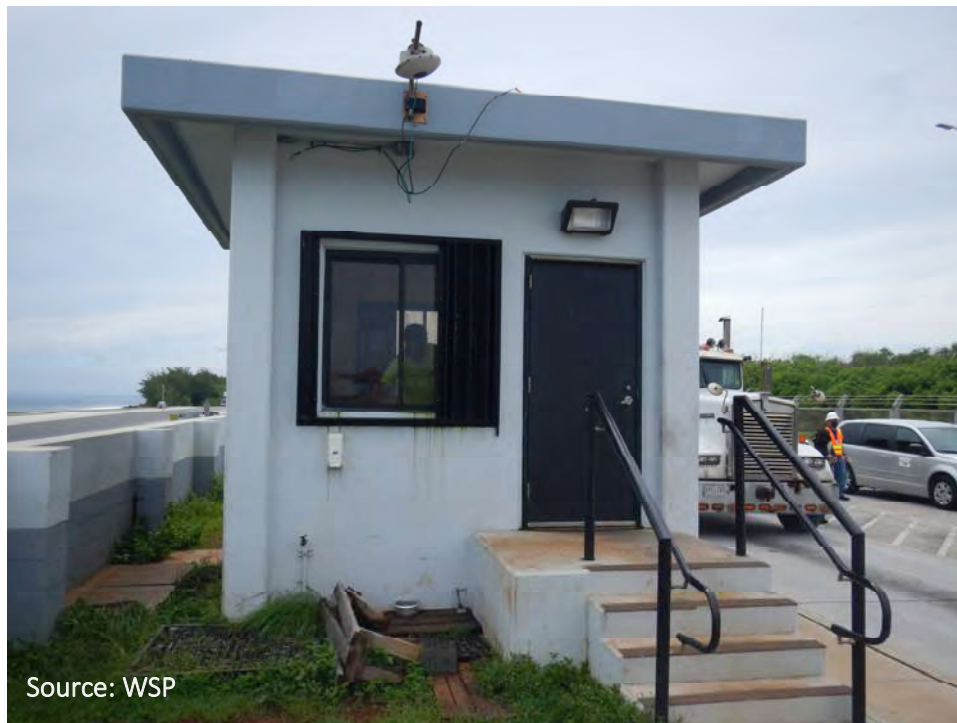
**Photo 22: Guard Booth**

A condition assessment of the Guard Booths was performed in August of 2021 and found them to be in **fair** condition. At both booths, damage to the windows was observed.

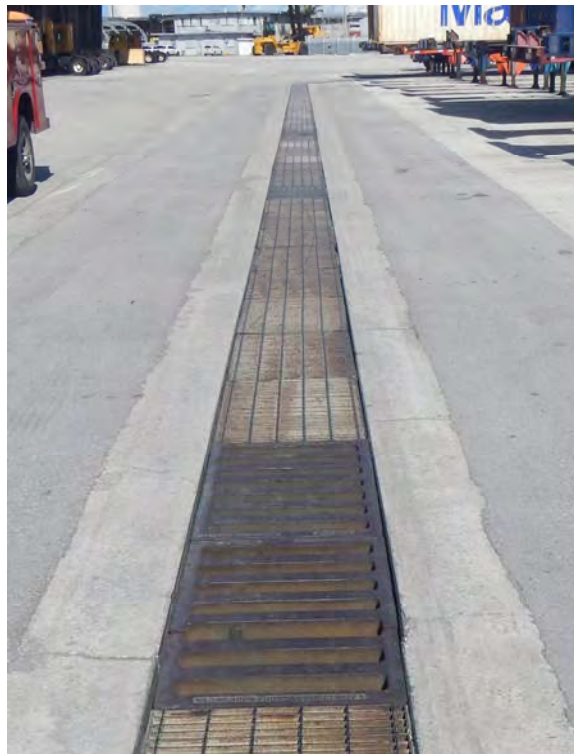
**Photo 24: Container Yard Trench Drains**

PAG is selectively replacing deficient grates with heavier duty grates.

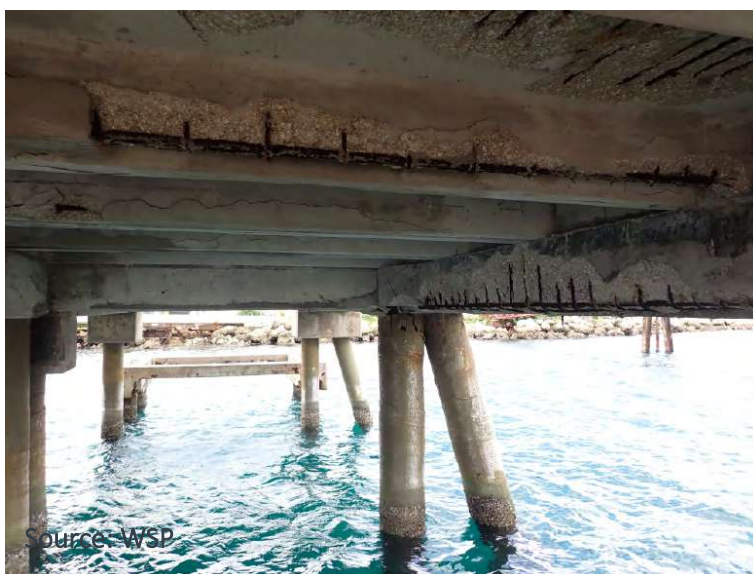
The pier is in **serious** condition. Several elements have severe damage consisting of spalled concrete, open corrosion spalls, bent piles, sheared piles, split piles, and non-functional fender systems. At multiple locations, failed pile repairs are present at the pile to pile cap interfaces. Open- and close-corrosion spalls were also observed at the main pier and trestle. Slope protection is in fair condition. The peninsula area west of the trestle was constructed on reclaimed land and is founded on sunken barges. Along the south shoreline west of the trestle, approximately 200 feet of rip rap is missing. At this location, portions of corroded steel barges are visible. Along the north side of the peninsula, a void is present beneath the concrete slab-on-grade which has settled. See Photo 25, Photo 26, and Photo 27. A detailed condition assessment report for Berth F1 is provided in Appendix C.

**Photo 25: Main Pier (Open Corrosion Spalling)**

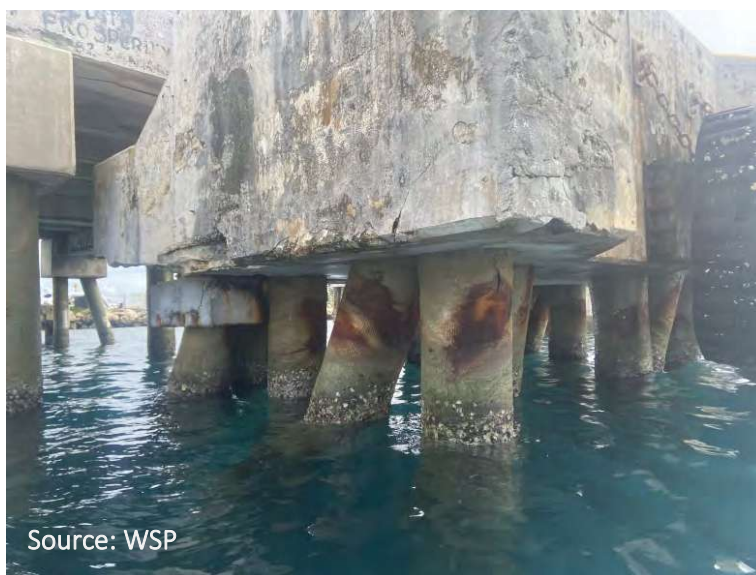
**Photo 26: Breasting Dolphin H (Failed Repair and Damaged Fender System)**

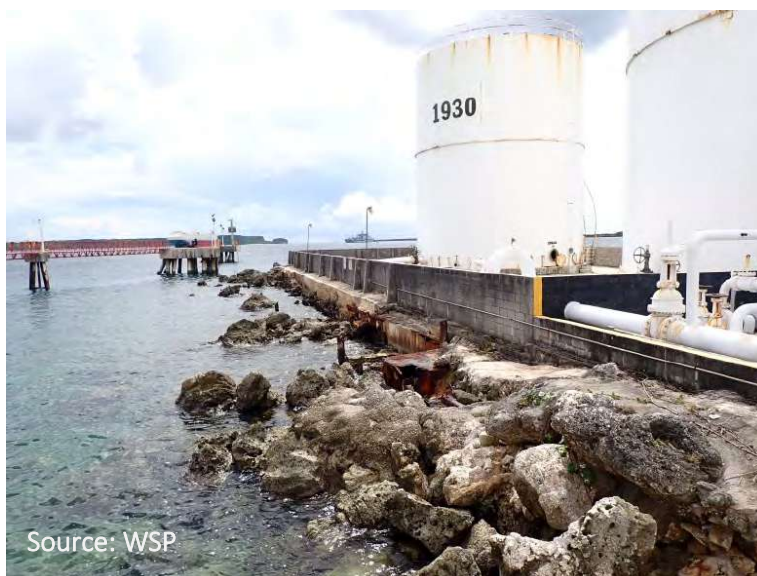
**Photo 27: Peninsula West of Trestle (Exposed Barge Foundation)**

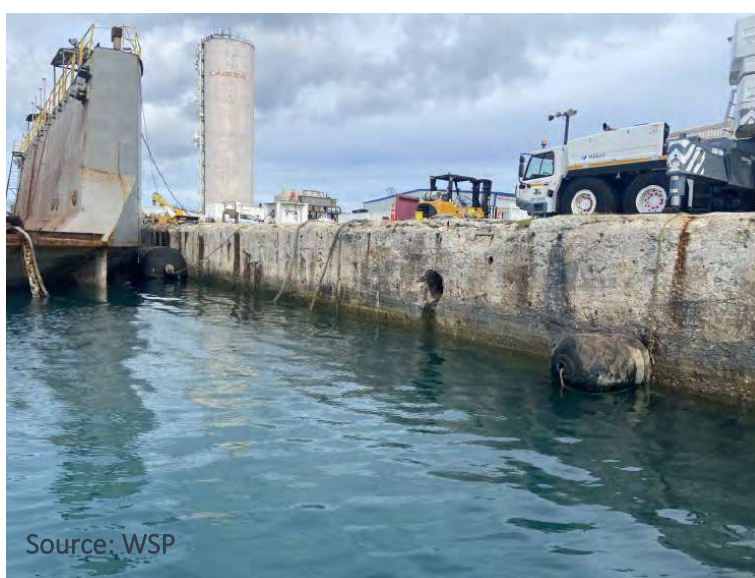
**Photo 28: Berth F2**

The berth is in **poor** condition. The concrete facing has delaminated and spalled from the steel sheet pile wall at several locations. At the inner tidal zone, severe corrosion is present at the sheet pile wall. Previous inspection reports identify holes in the sheet pile wall at multiple locations. Open-corrosion spalling of the longitudinal concrete pile cap is present at multiple locations along the length of the berth. In general, Berth F2 lacks a dedicated fender system. Moderate to major corrosion is present at the mooring hardware. See Photo 28. A detailed condition assessment report for Berth F2 is provided in Appendix B.

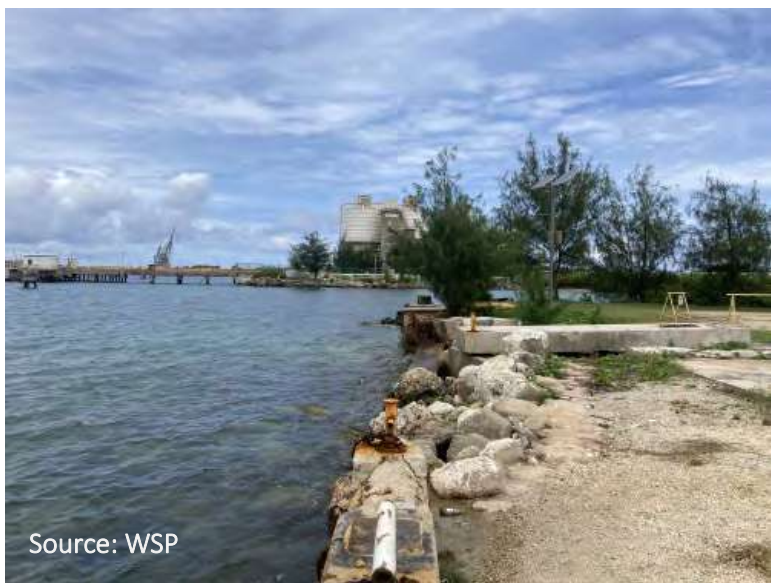
**Photo 29: Seaplane Ramp Bulkhead**

In general, the ramp is in **poor** condition. Major cracking and delamination of the concrete is present at multiple locations. Similarly, mechanical spalling and closed corrosion spalling were also observed at the top of the bulkhead and adjacent to mooring hardware. See Photo 29 and Photo 30.

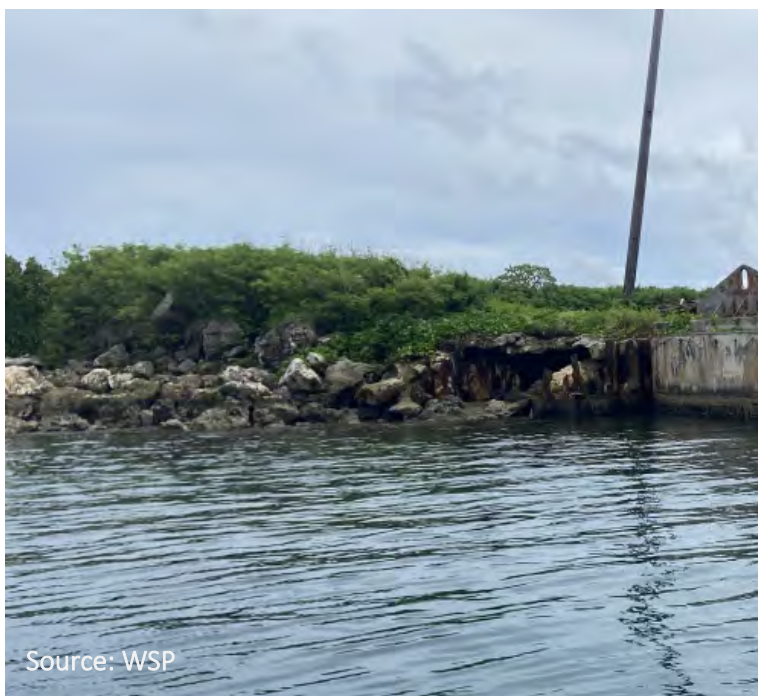
Similar to the marine structure, the building structures on the wharf are **poor** condition. Leaking and corroded potable water supply pipes were observed at multiple locations. It is recommended that the building structures are removed and replaced.

**Photo 33: Hotel Wharf (Exposed Anchor Wall)**

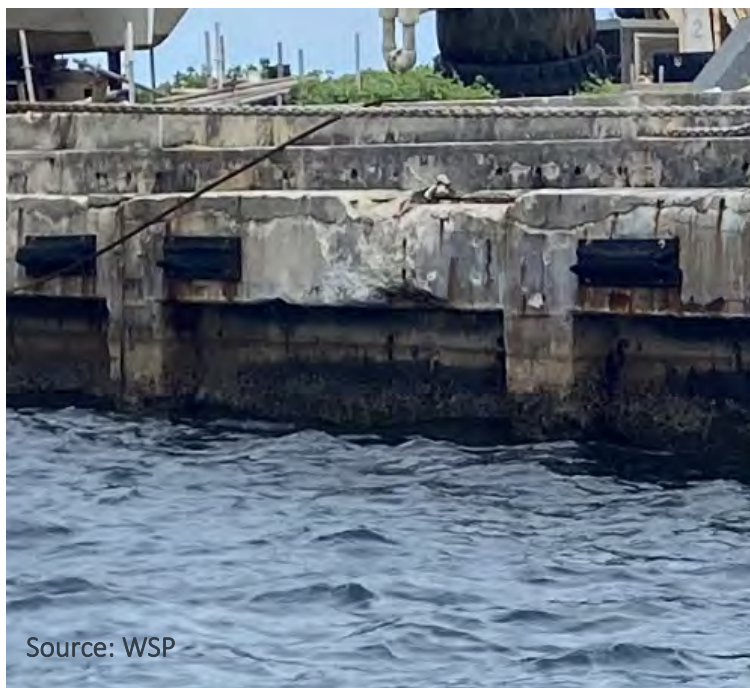
**Photo 34: Hotel Wharf (Open-Corrosion Spalling)**

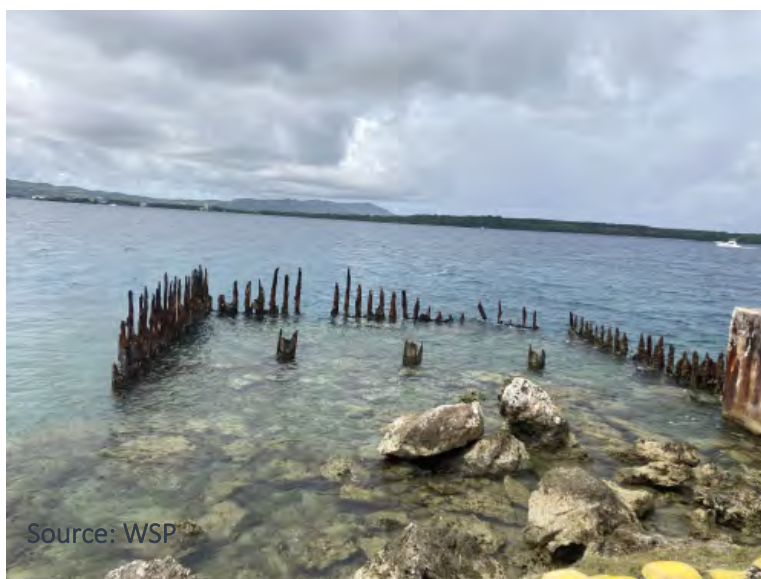
**Photo 41: Dog Leg Pier (West Jetty)**

Dog Leg Pier is located on the north shore of Apra Harbor and sits directly east of Family Beach. Dog Leg Pier is comprised of two jetties that extend approximately 320 feet to the south. Marine structures at Pier Dog are no longer present but remnants of box-shaped sheet pile walls are present on the south ends of the jetties. The sheet piles are severely corroded and pose a hazard to nearby water recreational activities. It is recommended that appropriate demolition and cleanup be performed to avoid risk and injury to the public. See Photo 41.

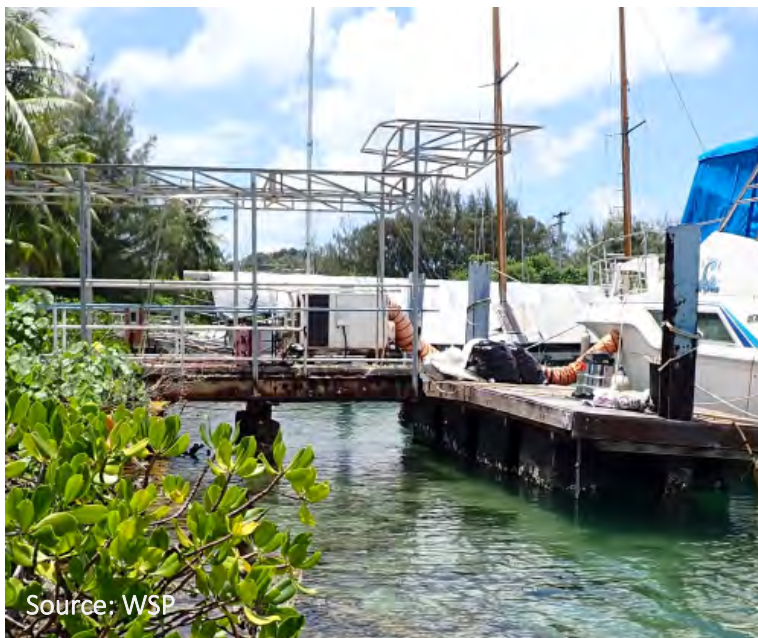
In general, long-term moorage structures are in **serious/critical** condition. Listing floats, excessive deflection of framing elements, and suspect framing were observed at multiple locations. Moderate to severe corrosion of steel framing members was also observed at several locations.

**Photo 42: Harbor of Refuge (Long-Term Moorage Structure)**

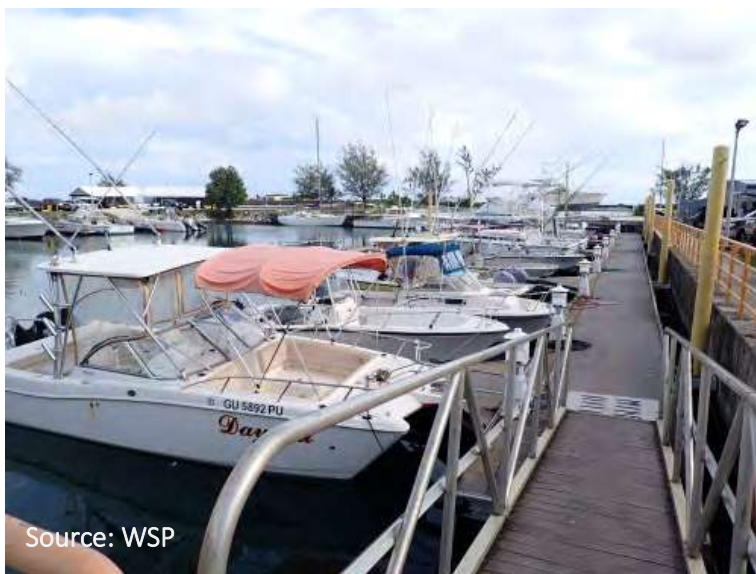
**Photo 45: GDP Marina**

In general, GDP Marina is in **poor** condition. Widespread corrosion of the sheet pile wall at the breakwater is present above the water line. From discussions with PAG staff, it is understood that Phase 3 repairs to replace the severely deteriorated sheet pile wall is being discussed. Erosion of the slope armoring on the north side of the breakwater is present. Failure or partial failure of this structure may impact the ability for vessels to enter/exit the marina. At several locations, floats are listing and present a safety hazard to pedestrians. See Photo 45, Photo 46, and Photo 47.

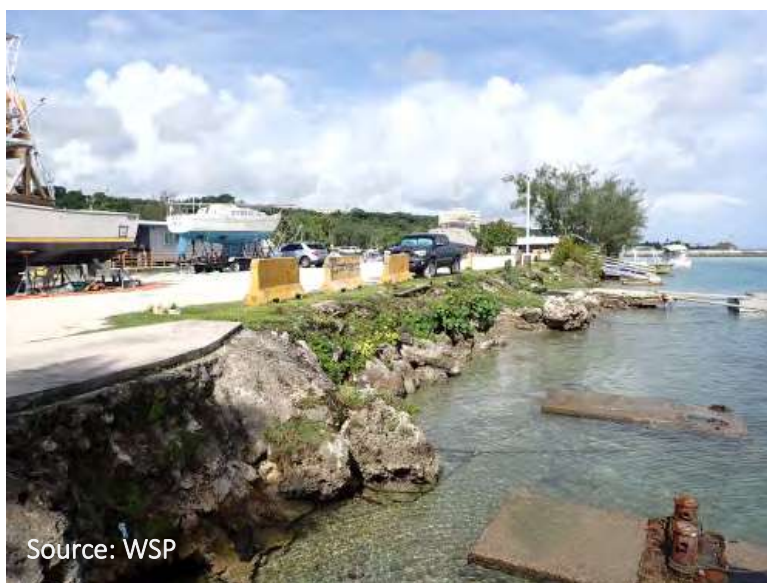
**Photo 47: GDP Marina (Erosion on North Side of Breakwater)**

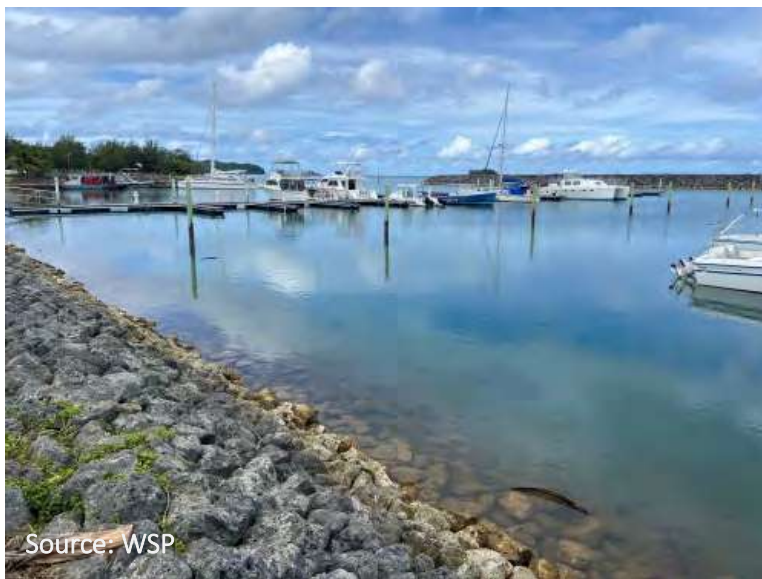
**Photo 48: Agat Small Boat Marina**

In general, Agat Marina is in **fair** condition. With exception of minor corrosion of the steel guide piles, damage at docks A, C, and D was not observed. Similarly, the breakwater and slope armoring to the east are in satisfactory to good condition with no noticeable defects. The northern pier at the boat ramp has major to severe damage. At several locations, vertical timber framing is missing and has been replaced with rubber tires suspended from the facing. The boat ramp is in satisfactory condition with only minor cracking observed. At the loading pier, severe damage consisting of cracking, and open- and closed-corrosion spalling are present at multiple locations. Due to the severe nature and extent of damage present, it is understood that this facility closed to pedestrian and vehicular use. A sanitary sewer pump-out is located adjacent to the boat ramp but is non-functional. See Photo 48, Photo 49, and Photo 50.

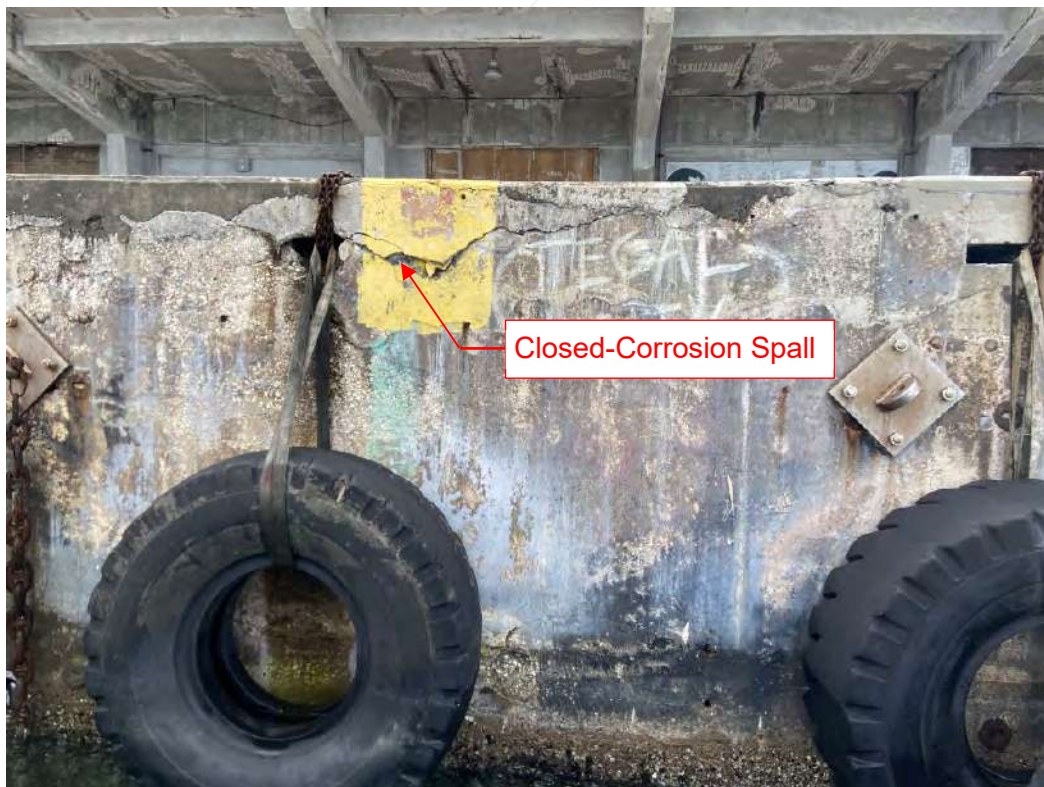
Photo 6 – Berth F3 Typical Closed-Corrosion Spalling

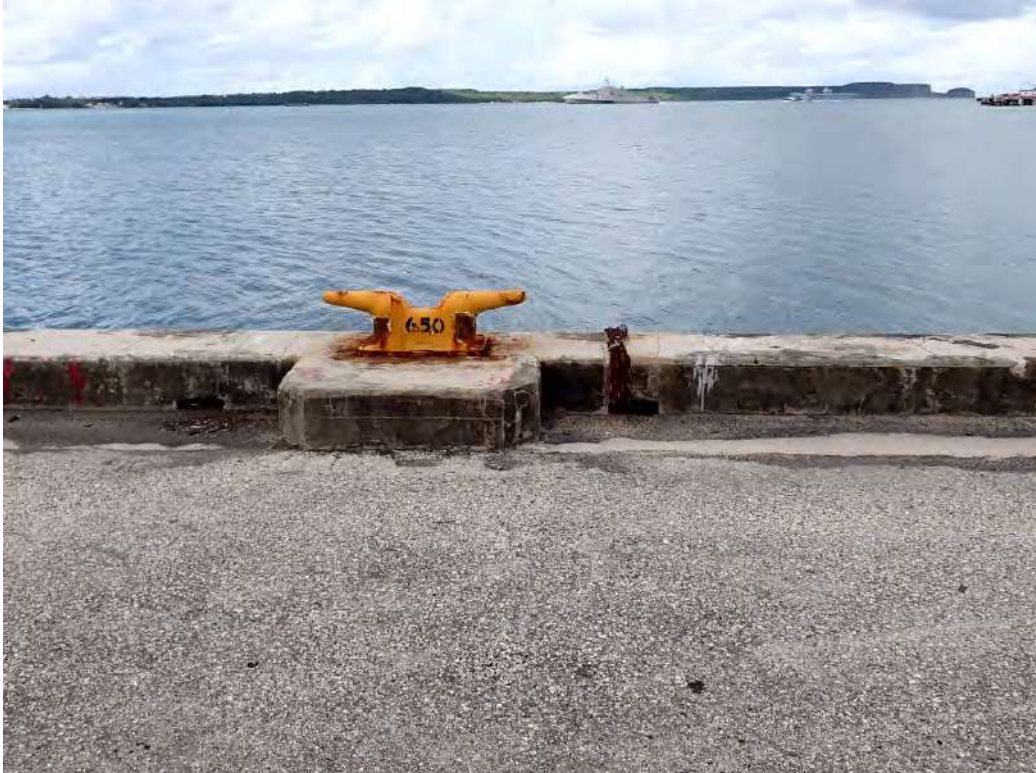
**Photo 7 – Berth F3 Typical Corrosion at Mooring Hardware**

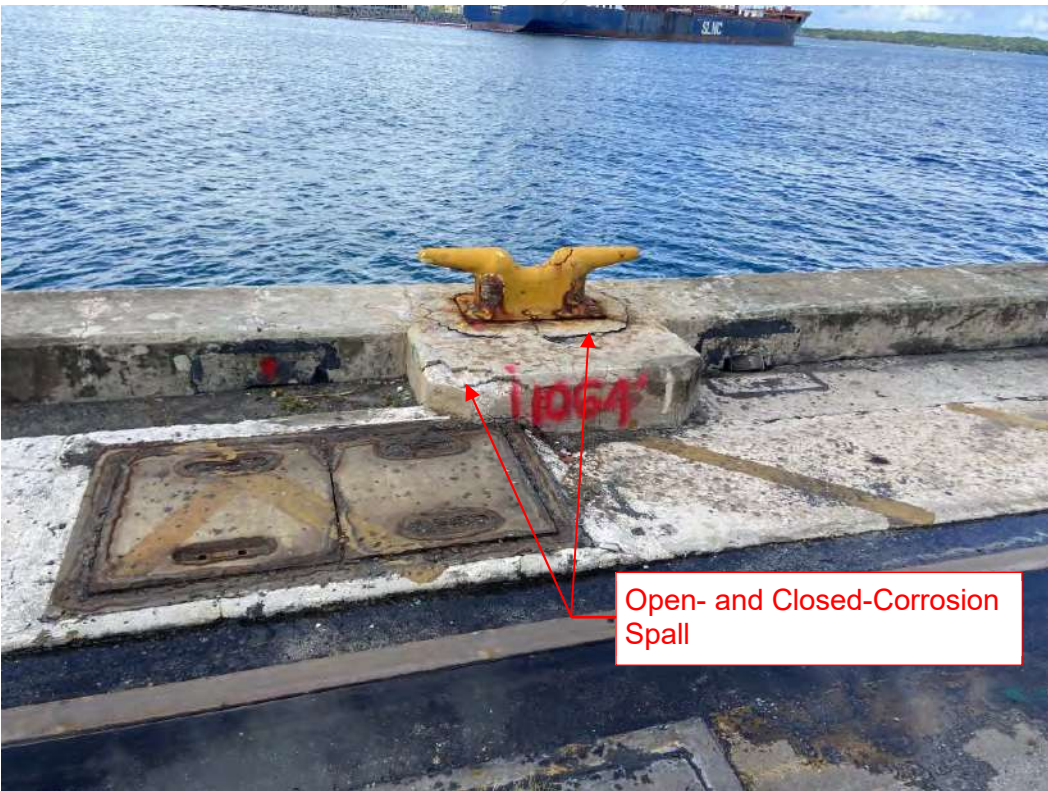
Photo 10 – Berth F4 Concrete Spall at Bullrail/Cavel

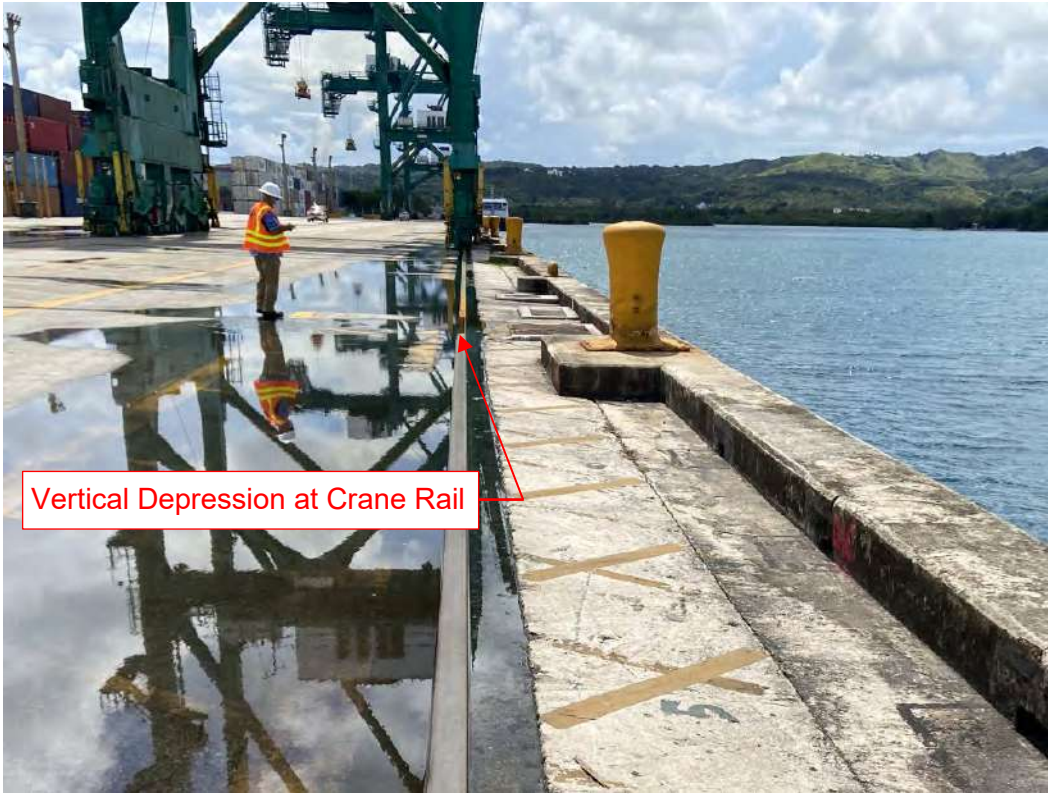
**Photo 11 – Berth F4 Depression at Crane Rail**

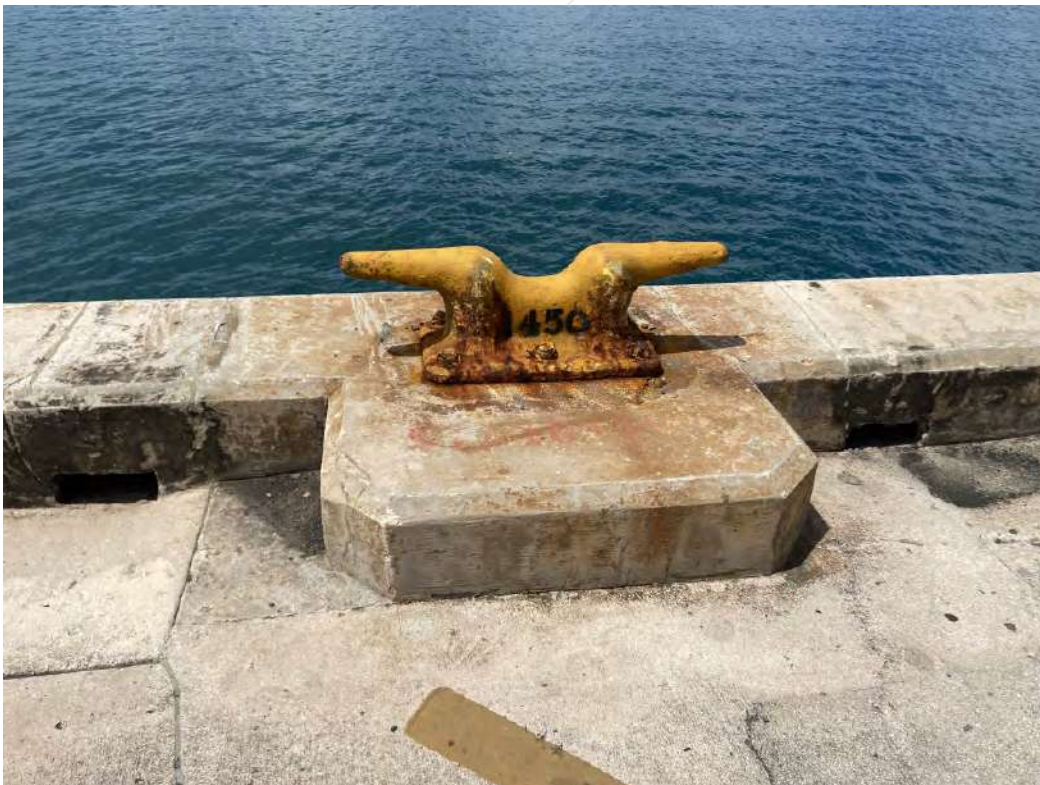
**Photo 14 – Berth F5 Typical Corrosion at Mooring Hardware**

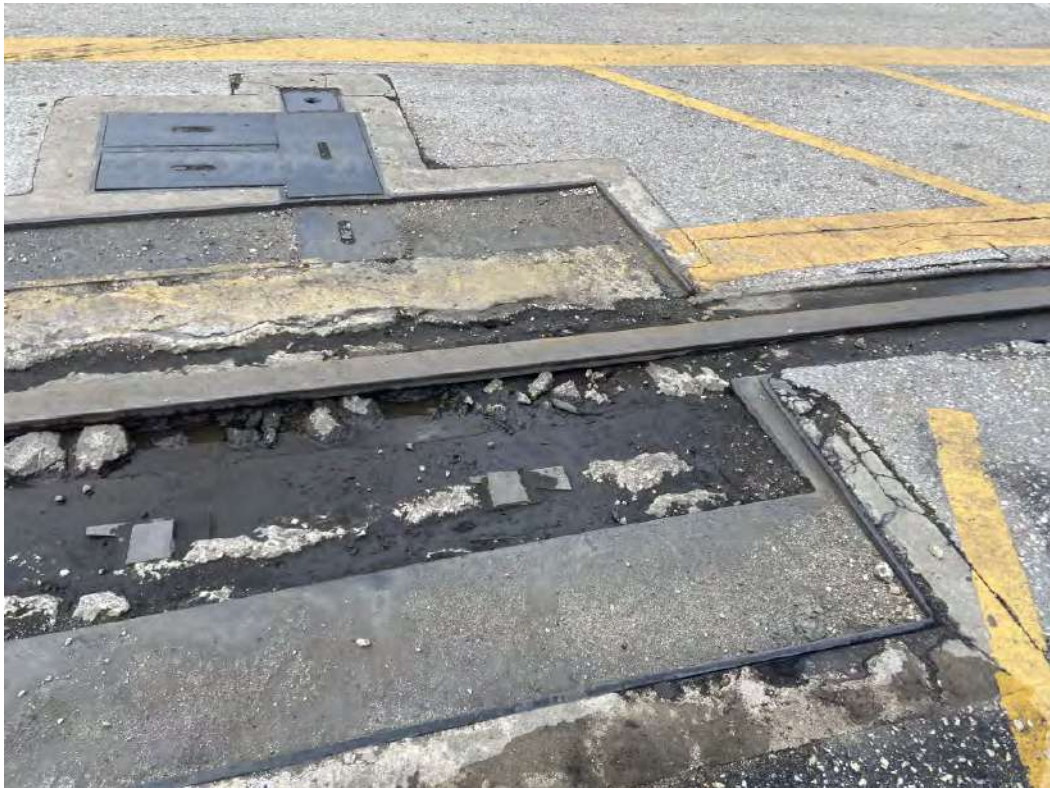
**Photo 16 – Berth F5 Damage at Asphalt Overlay**

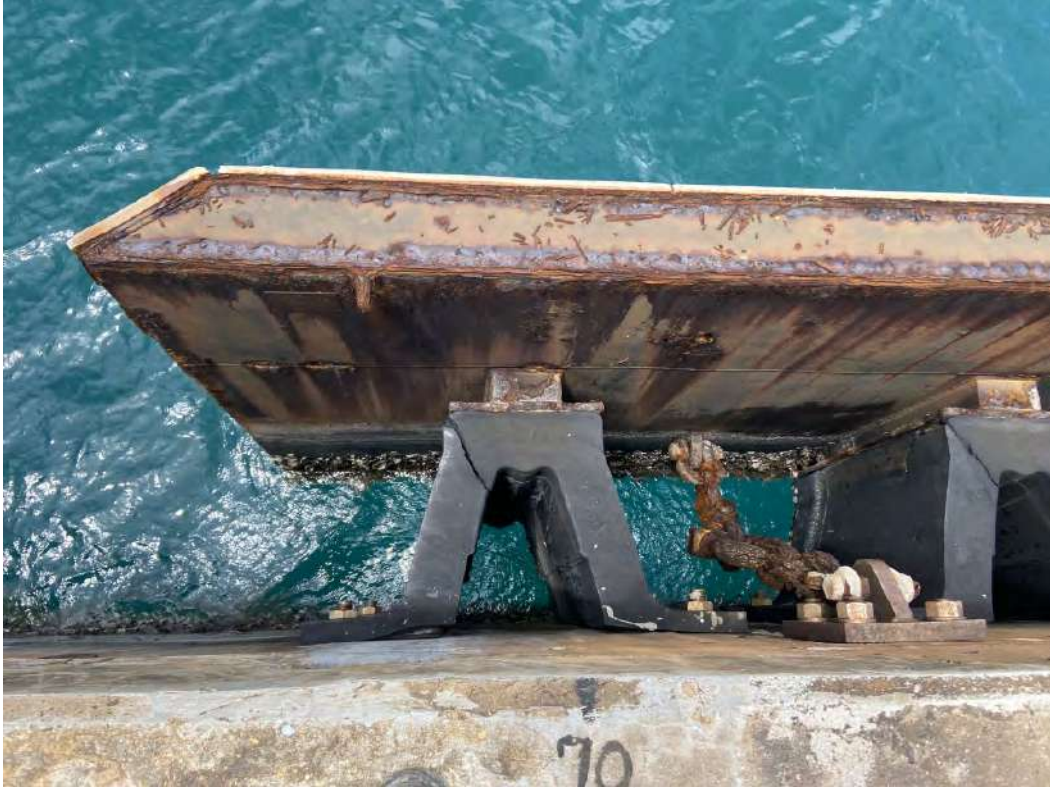
**Photo 17 – Berth F5 Typical Damaged Fender Elements**

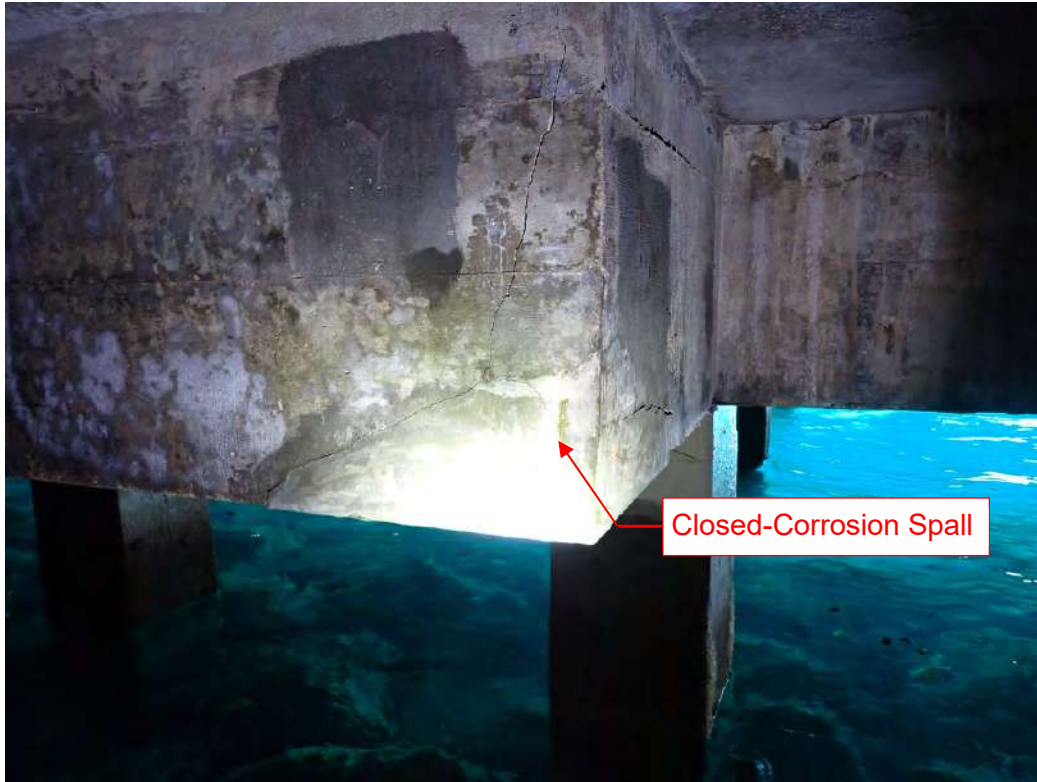
Photo 19 – Berth F5 Closed Corrosion Spall at Pile Cap

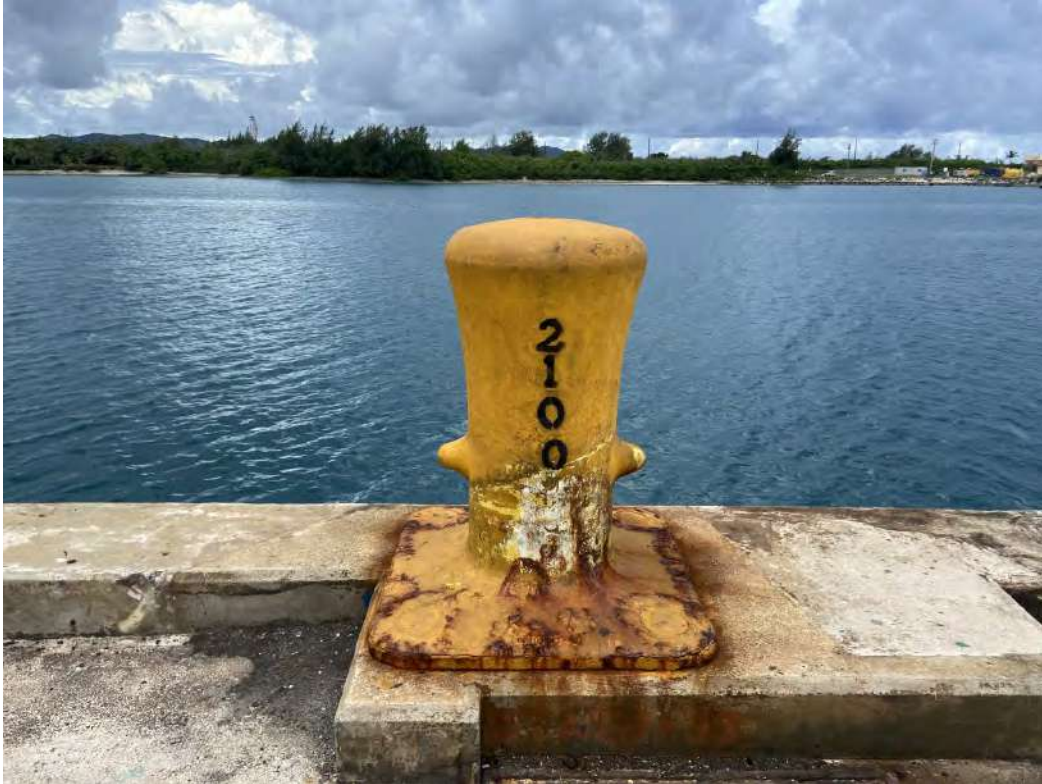
**Photo 21 – Berth F6 Typical Corrosion at Mooring Hardware**

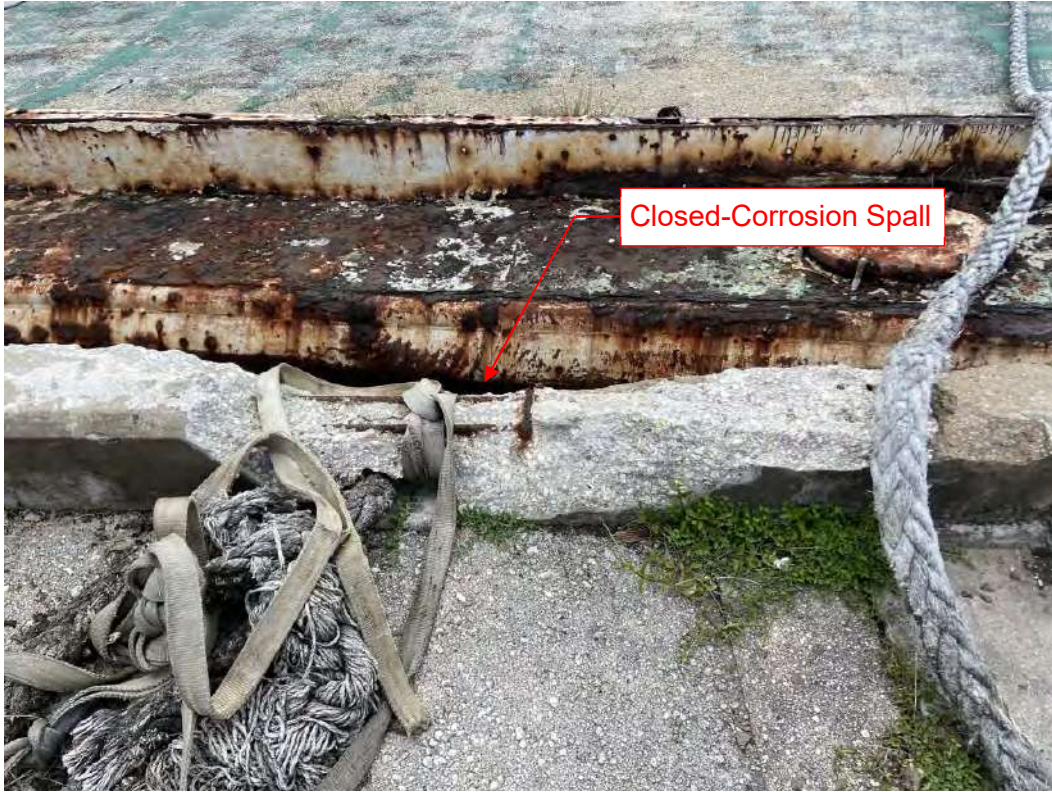
**Photo 23 – Berth F6 Open-Corrosion Spall at Bullrail**

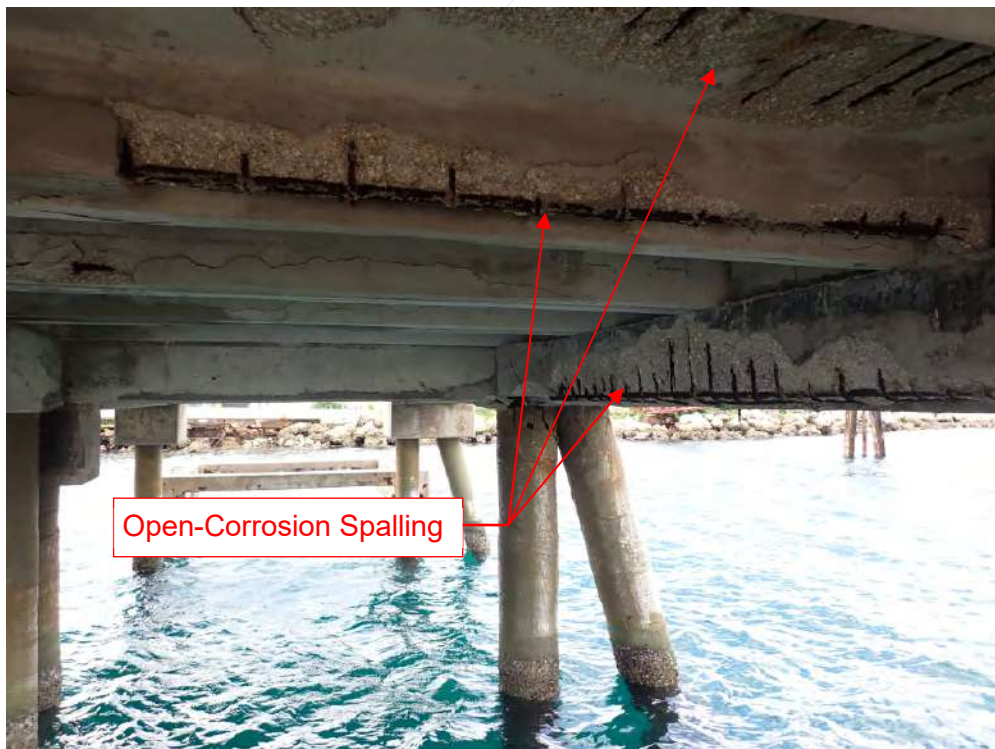
Photo 2 – Open Corrosion Spalling

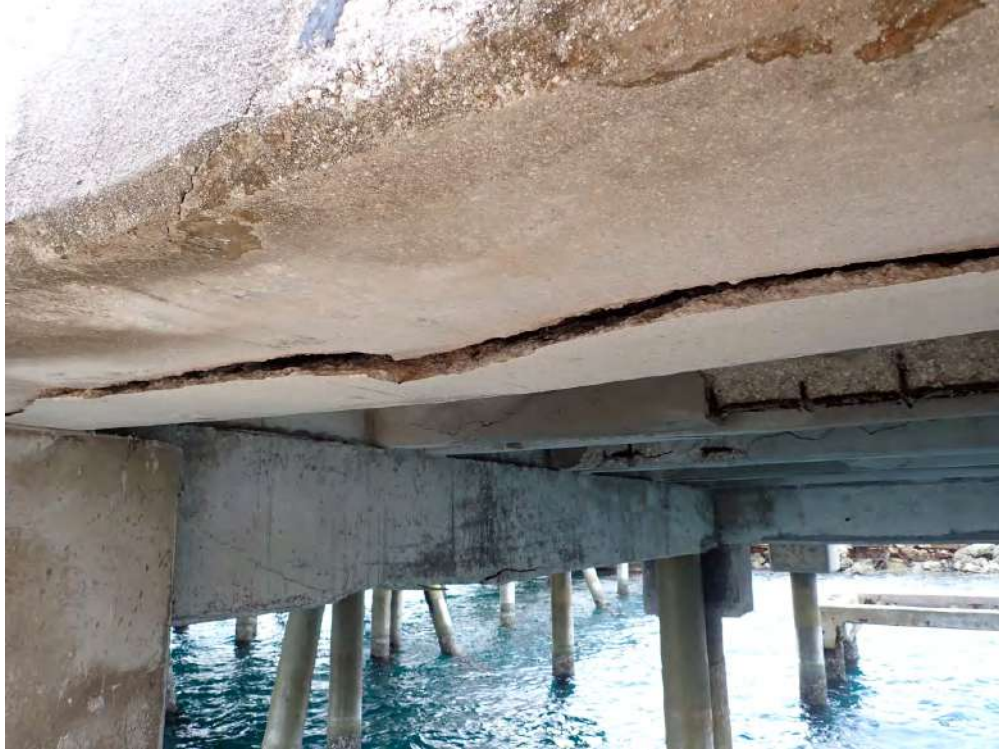
**Photo 3 – Crack at Waterside Pile Cap**
