# ENVIRONMENTAL ASSESSMENT

## PROPOSED HOTEL WHARF AND ACCESS ROAD MAINTENANCE AND REPAIR PROJECT Apra Harbor, Guam

**July 5, 2019**

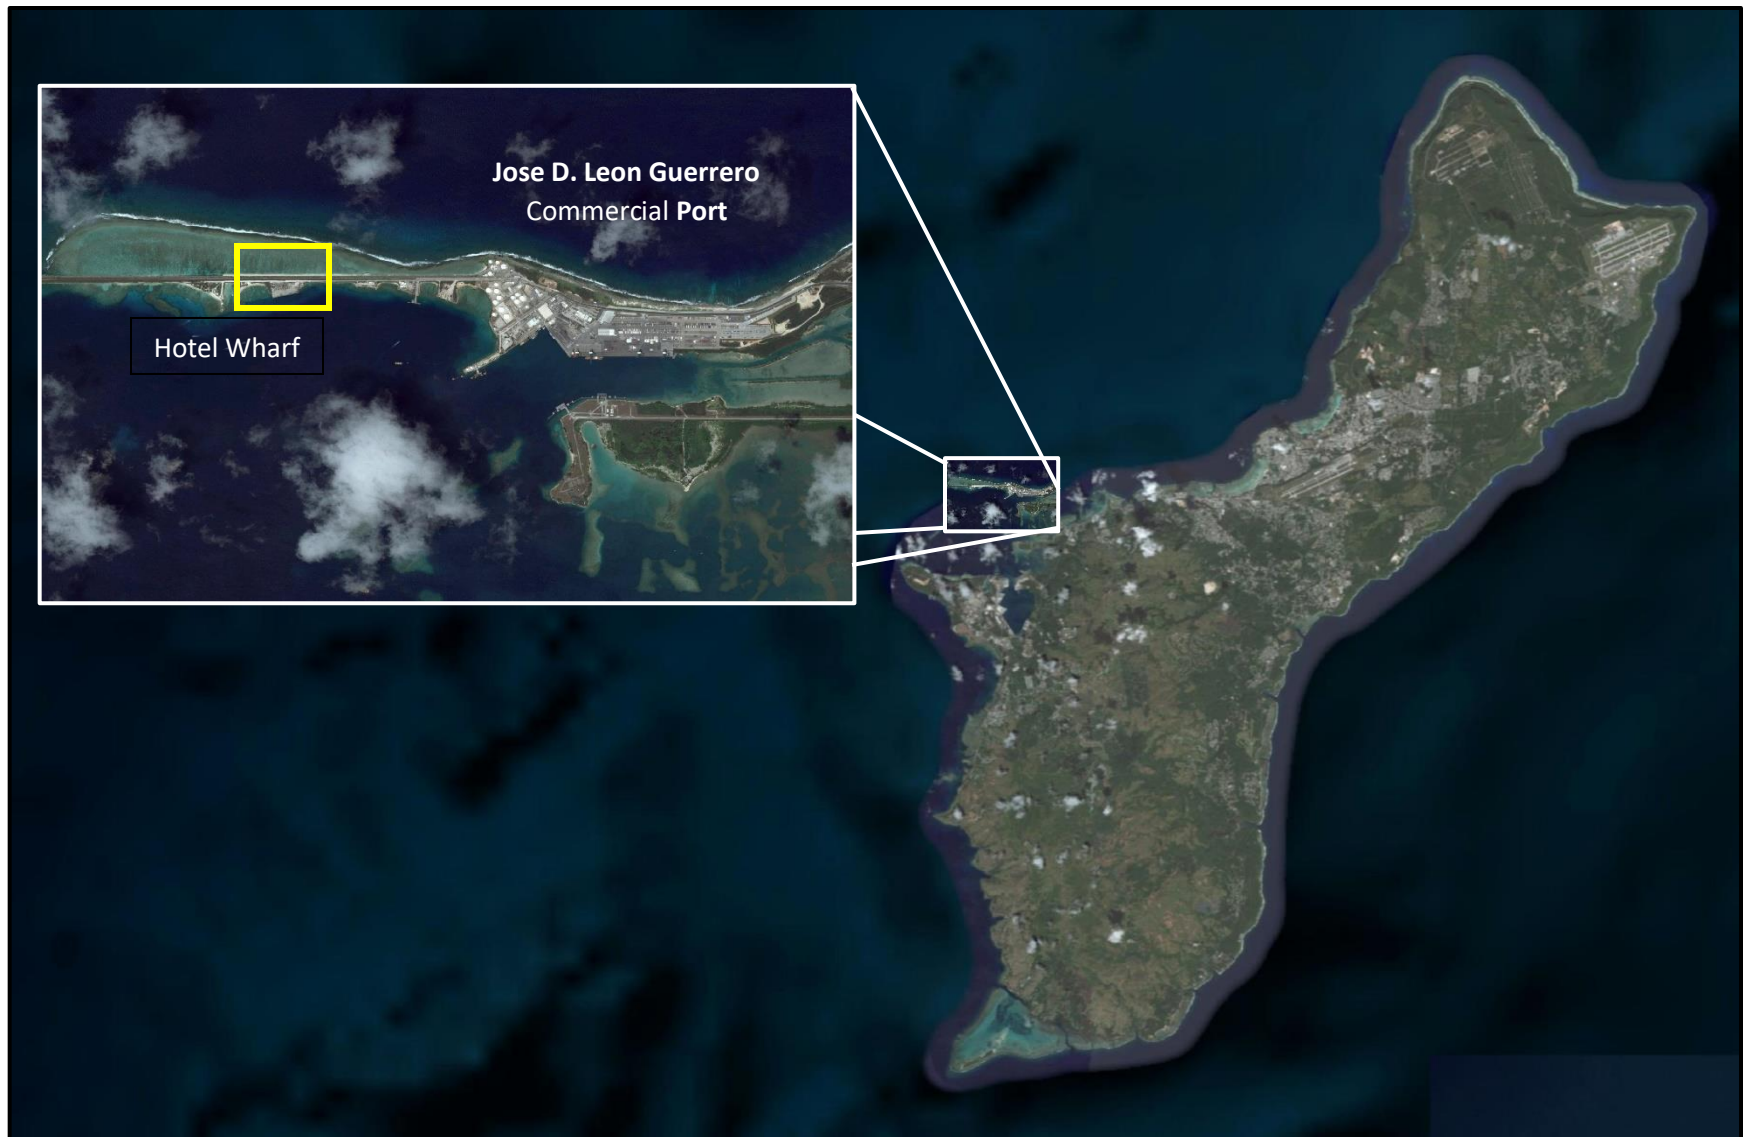
**Figure 1.** Map of Guam depicting the location of the Jose D. Leon Guerrero Commercial Port and Hotel Wharf, Apra Harbor.

Hotel Wharf is part of the Jose D. Leon Guerrero Commercial Port, which is located on the north side of Apra Harbor (Figure 1). The harbor hosts Guam's only deep (>40 m) lagoon environment, bounded to the south by Orote Peninsula and to the north by Cabras Island and the Glass Breakwater. Following World War II, the breakwater was built across the Luminao barrier reef and the Calalan Bank, a submerged bank that extends westward of the reef. The depth of the harbor and its relatively calm water conditions facilitate significant commercial, military, and recreational activities, but also support an environment unique among the islands of the Mariana Archipelago. This important marine environment is comprised of several biophysical zones, each supporting distinct marine communities, and hosts a large number of species not found anywhere else in Guam's waters (Paulay et al. 1997).

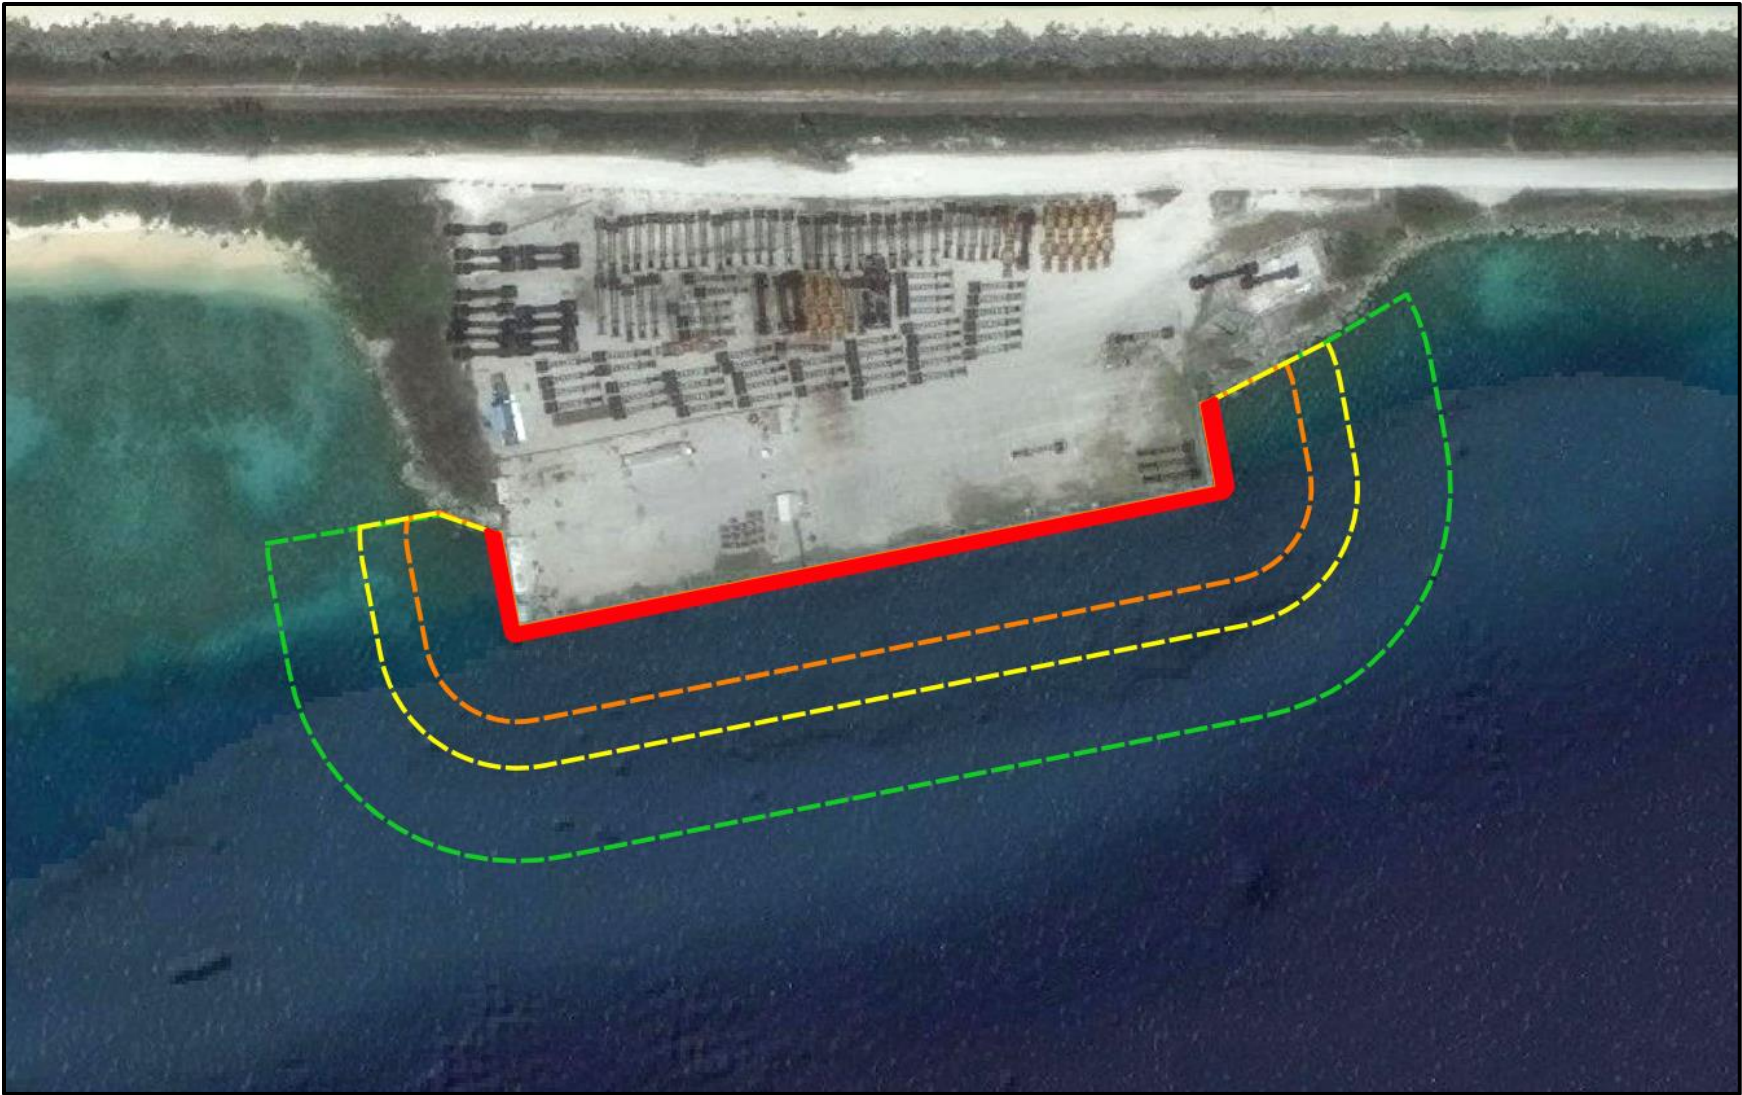
**Figure 3.** Map depicting the Direct Impacts Zone (red) and the 20 m (orange), 30 m (yellow), and 50 m (green) Indirect Impacts Zones. Note that this map depicts only the general location of the Direct Impacts Zone and not the exact placement of the new wharf face.

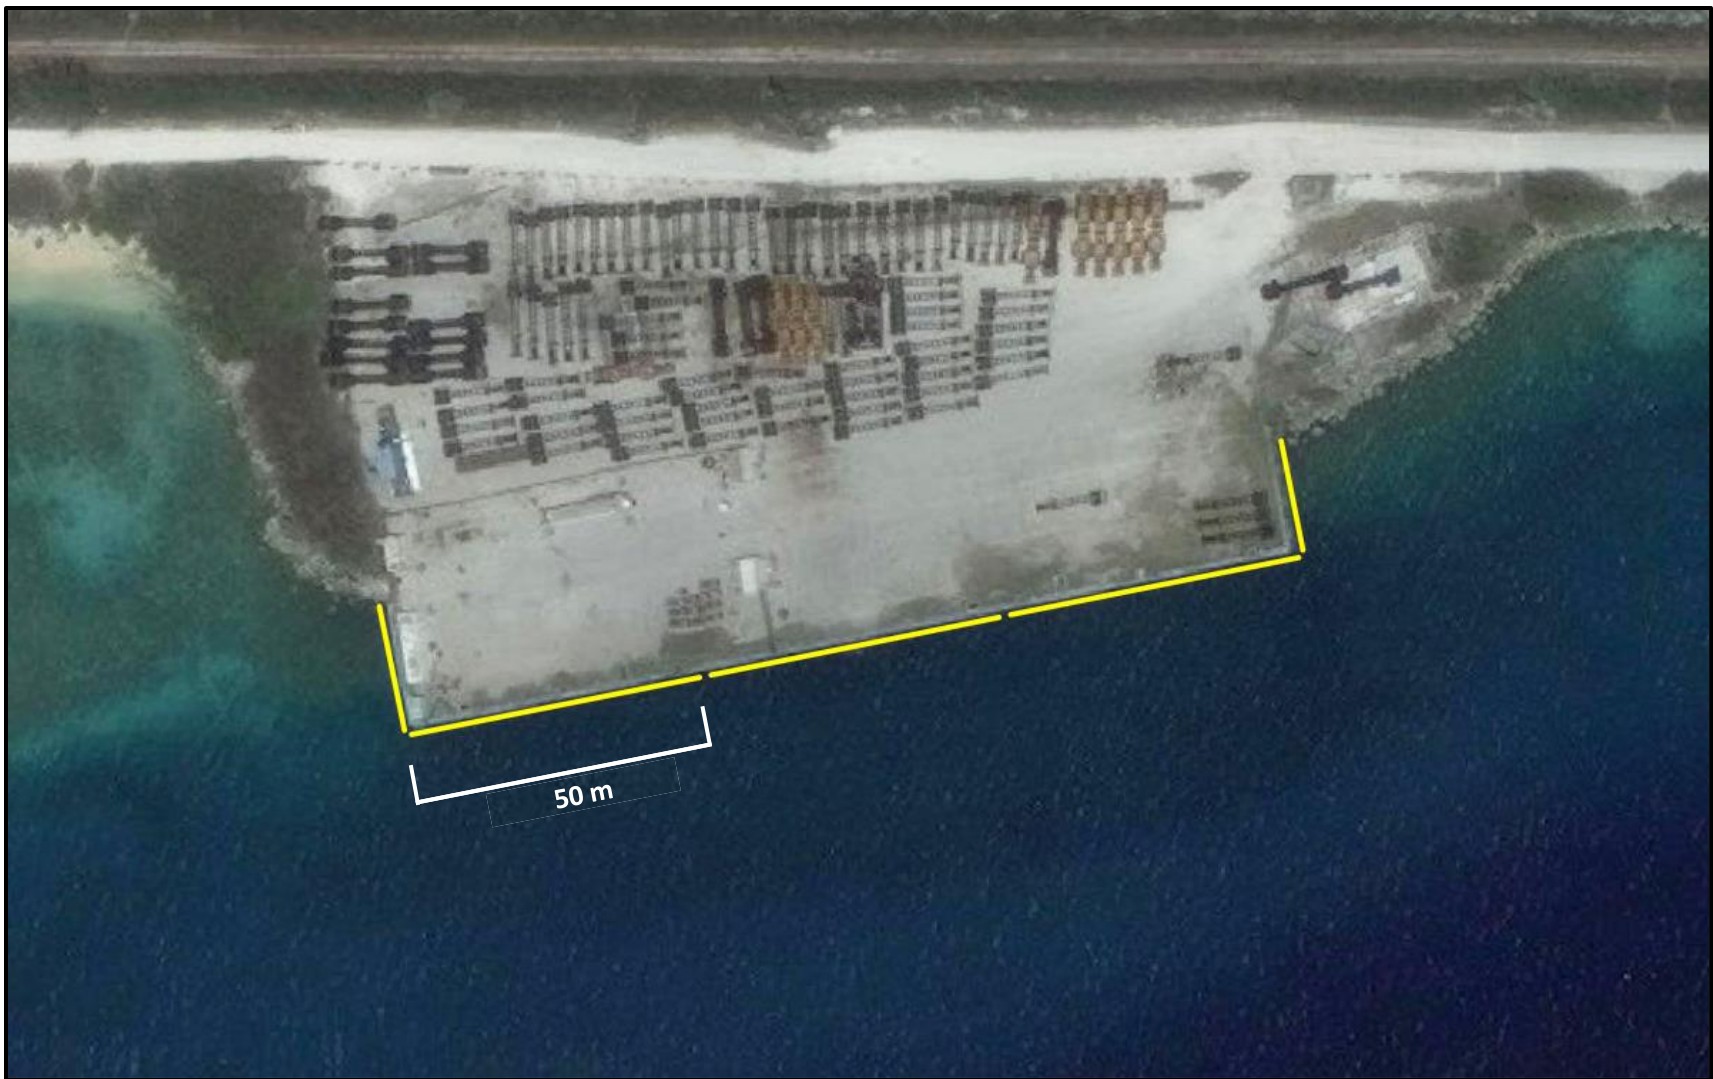
**Figure 4.** Map depicting the location of the transects placed at the base of the wharf (Direct Impacts Zone).

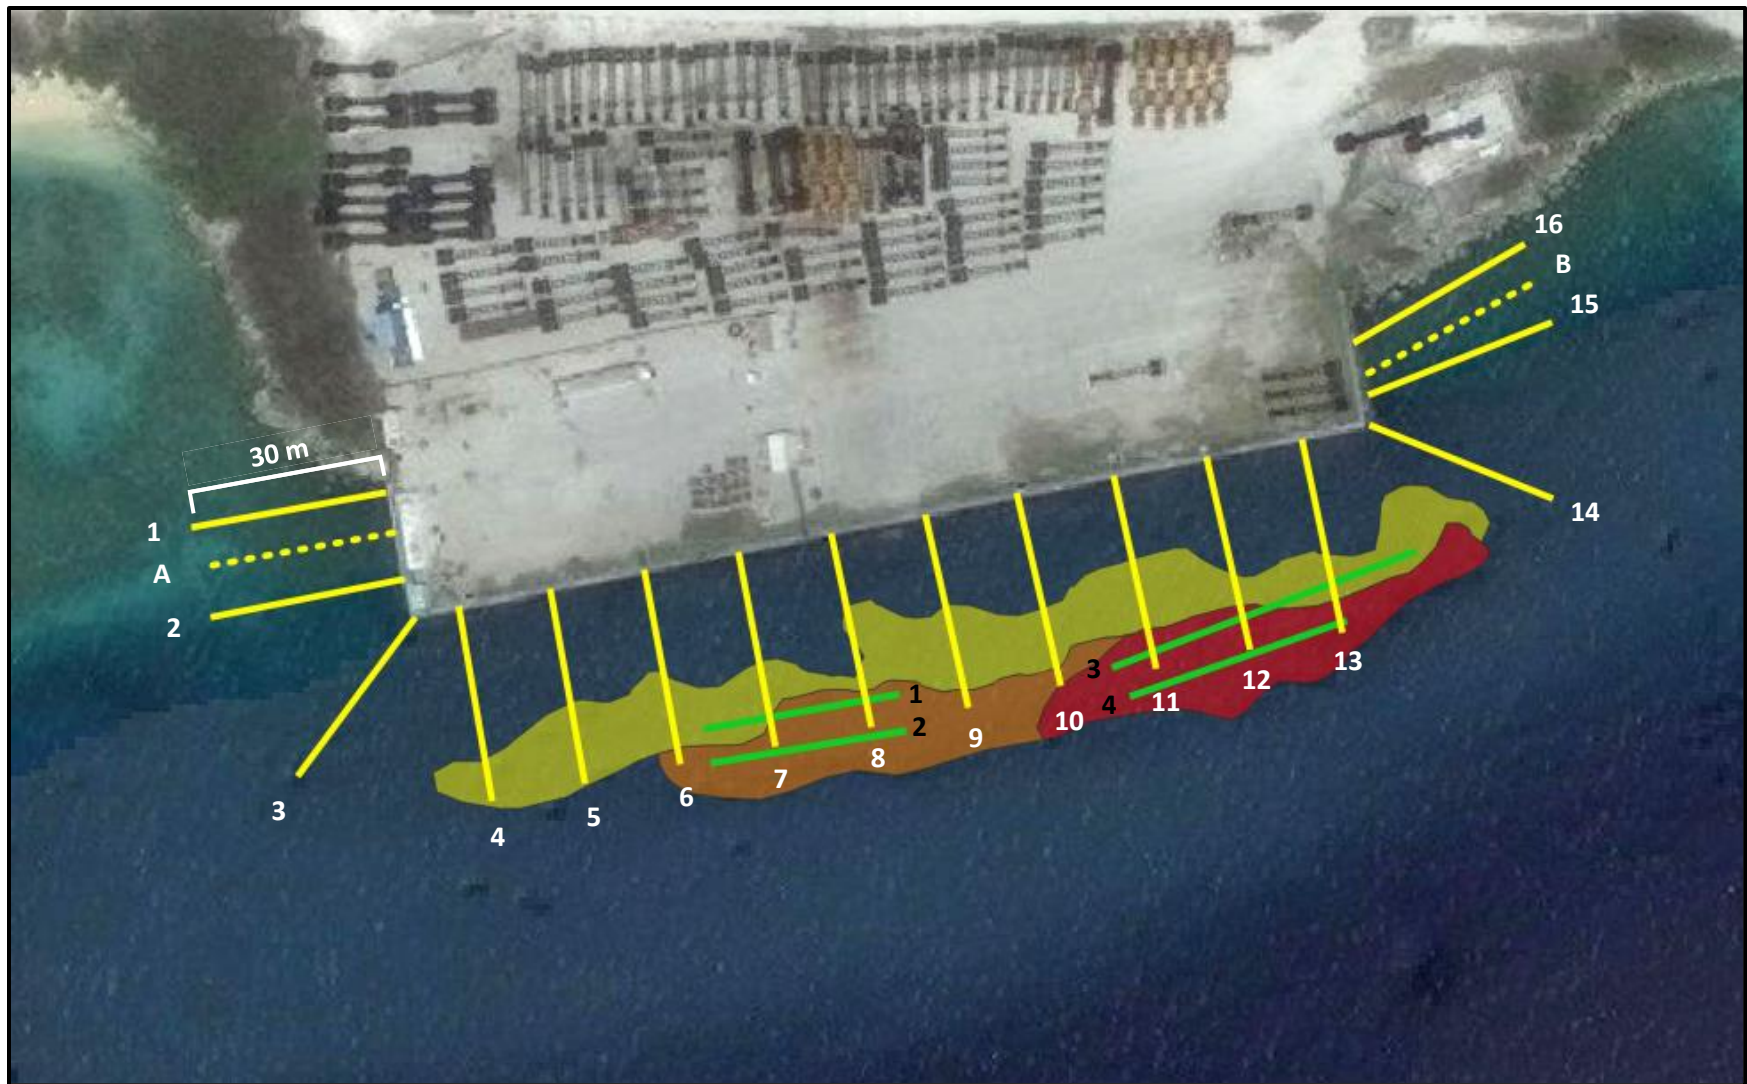
**Figure 5.** Map depicting the location of the seafloor transects Indirect Impacts Zone, including the 30-meter-long transects placed perpendicular to the wharf (yellow) and transects (mixed lengths) placed across an area of hardbottom oriented parallel to the south wharf face (green). The red, orange, and yellow polygons represent areas with aggregate reef and high coral cover (red), mixed sand and hardbottom with low coral cover (orange), and sand with widely scattered hardbottom and few coral colonies (yellow).

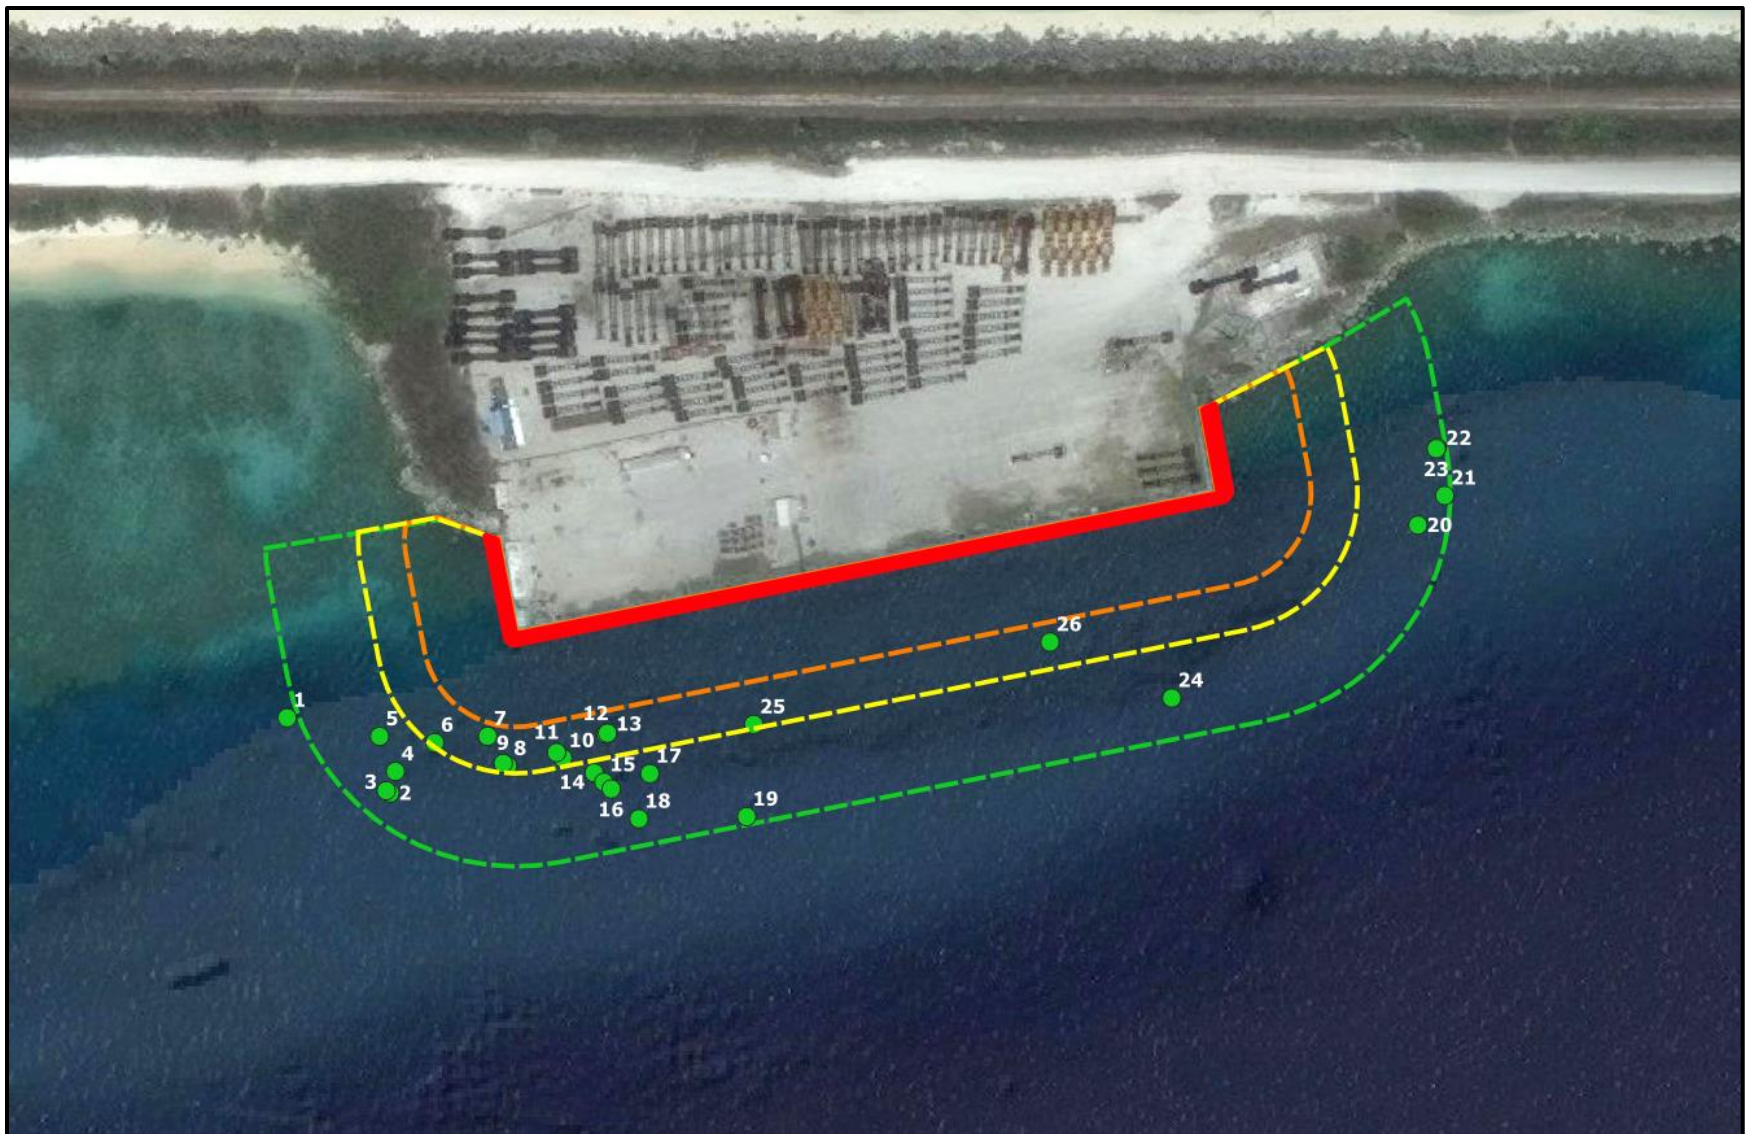
**Figure 6.** Map depicting the location of the surveyed patch reefs in relation to the Direct Impacts Zone (red) and the 20 m (orange), 30 m (yellow), and 50 m (green) Indirect Impacts Zones. Note that this map depicts only the general location of the Direct Impacts Zone and not the exact placement of the new wharf face.

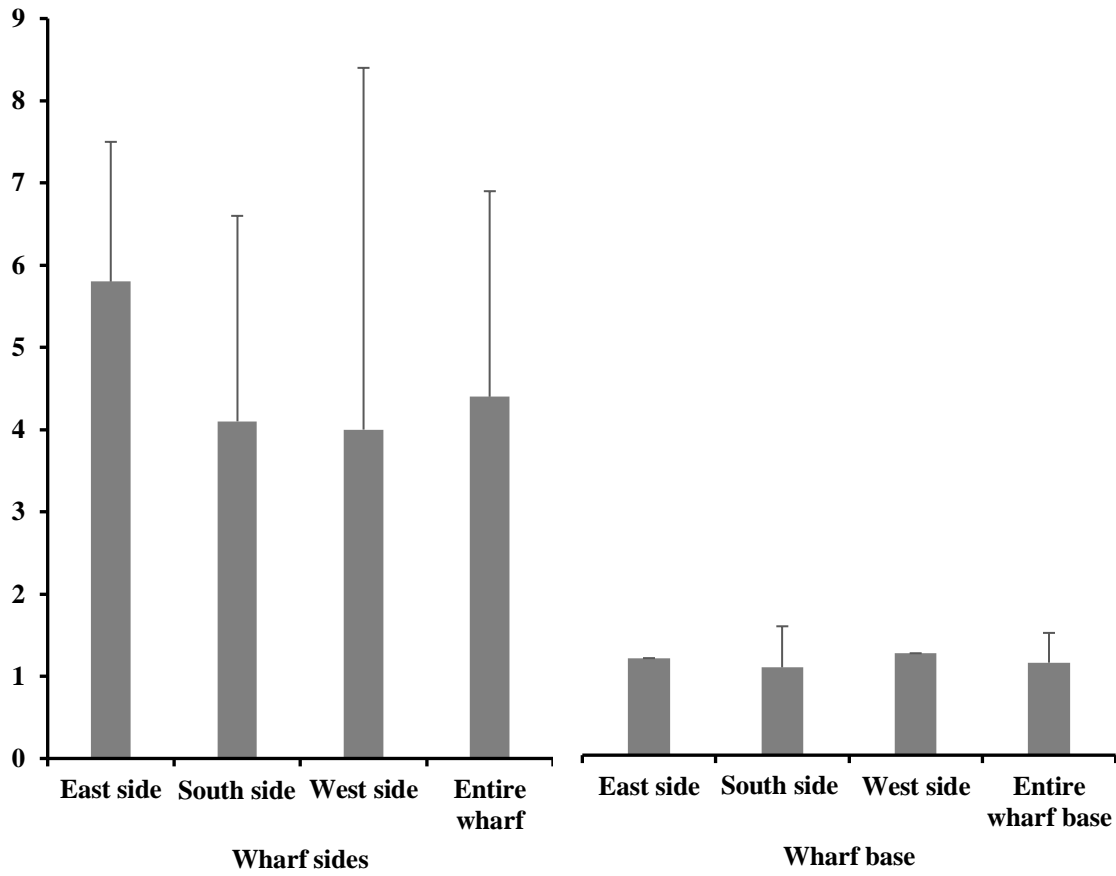
**Figure 7.** Mean coral colony density ( $\text{col}/\text{m}^2 \pm \text{SD}$ ) for transects surveyed on the wharf and the seafloor at the base of the wharf (Direct Impacts Zone).

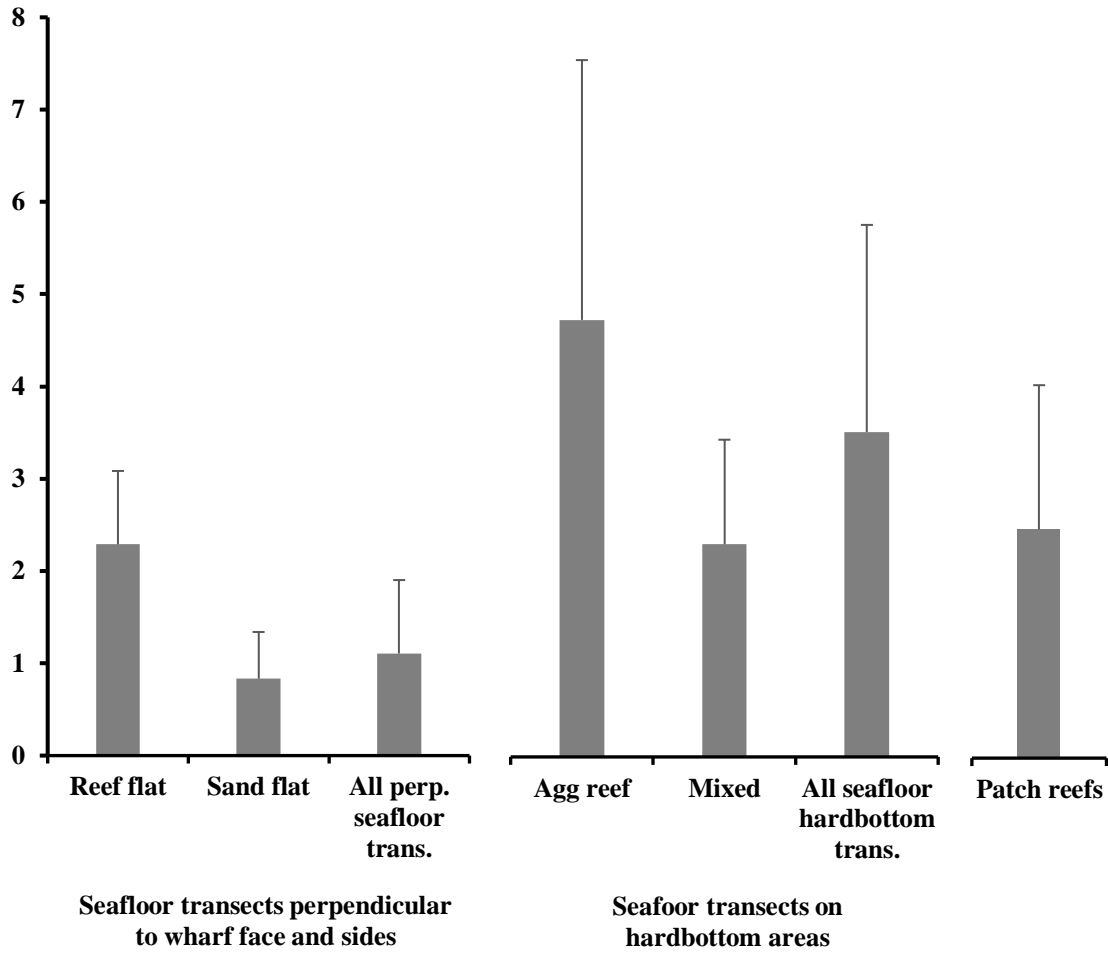
**Figure 8.** Mean coral colony density (col/m<sup>2</sup> ± SD) on seafloor transects and patch reefs surveyed within the 30 m Indirect Impacts Zone.

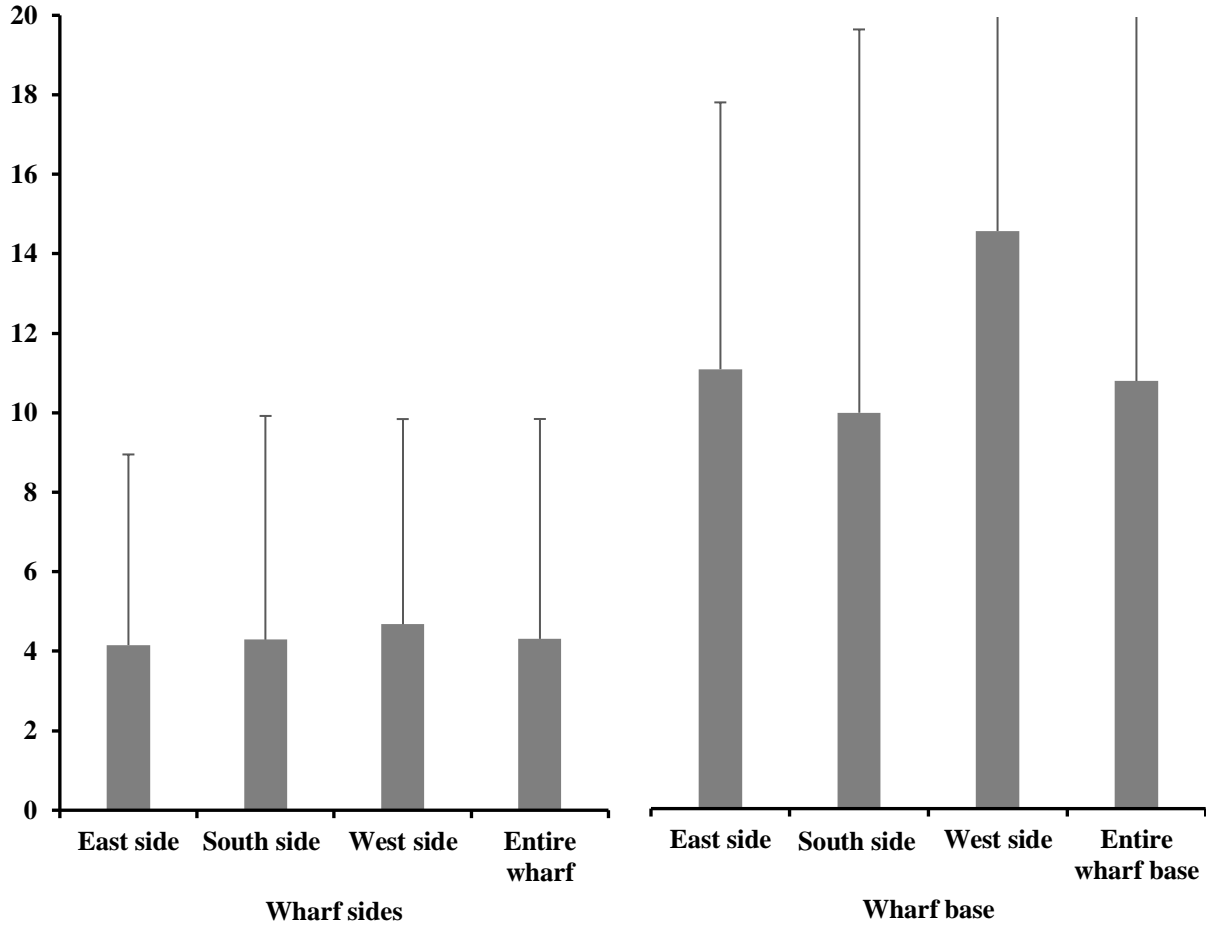
**Figure 9.** Mean coral colony diameter (cm  $\pm$  SD) for transects surveyed on the wharf and the seafloor at the base of the wharf (Direct Impacts Zone).

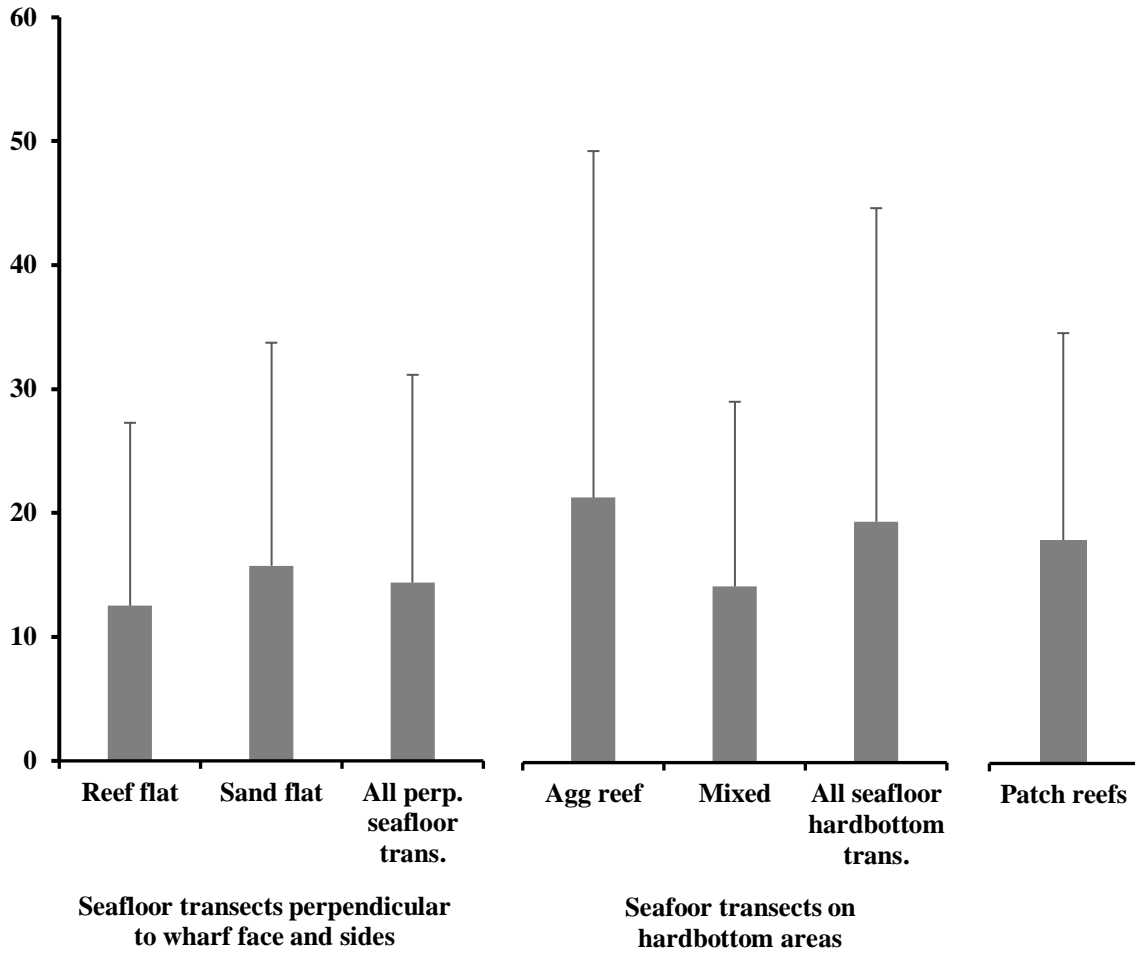
**Figure 10.** Mean coral colony diameter (cm  $\pm$  SD) for seafloor transects and patch reefs surveyed within the 30 m Indirect Impacts Zone.

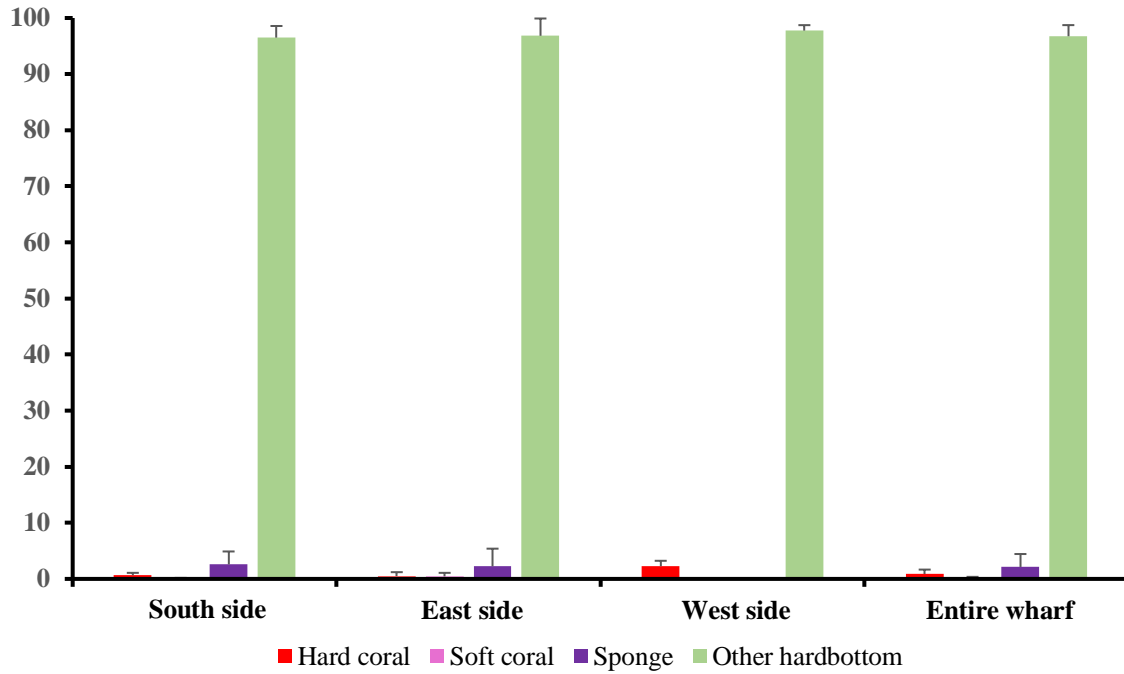
**Figure 11.** Percent cover ( $\pm$  SD) of major benthic classes for the wharf sides and the entire wharf within the Direct Impacts Zone.

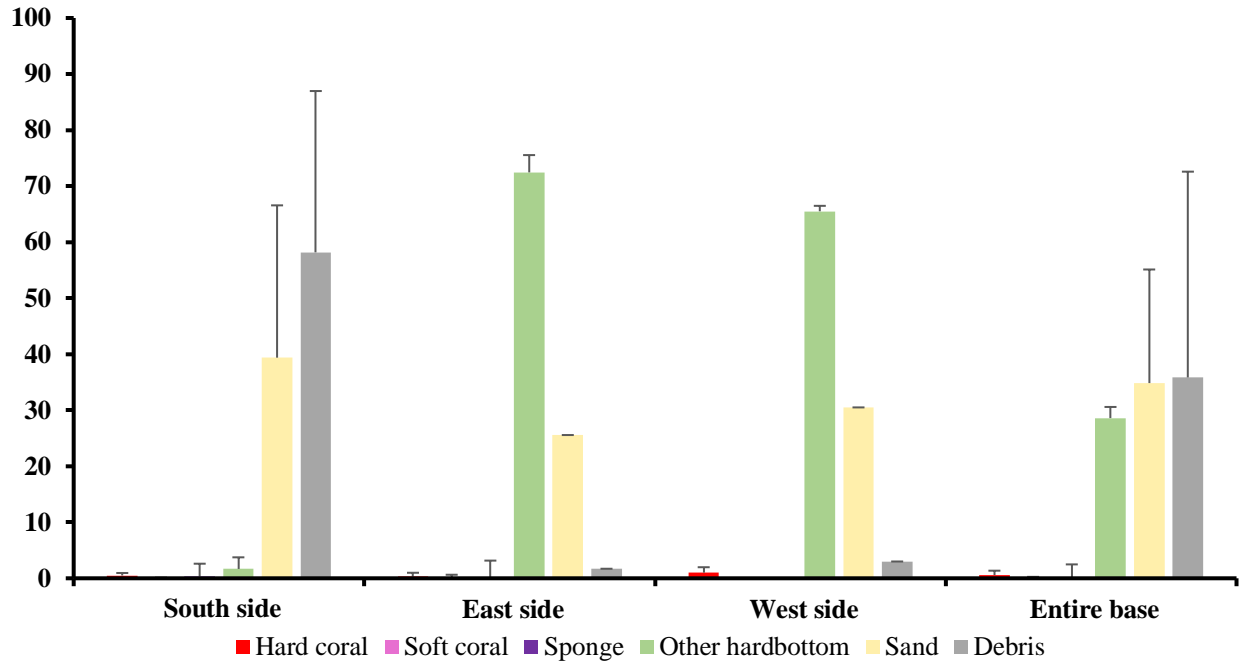
**Figure 12.** Percent cover ( $\pm$  SD) of major benthic classes for the area of seafloor at the base of the wharf within the Direct Impacts Zone.

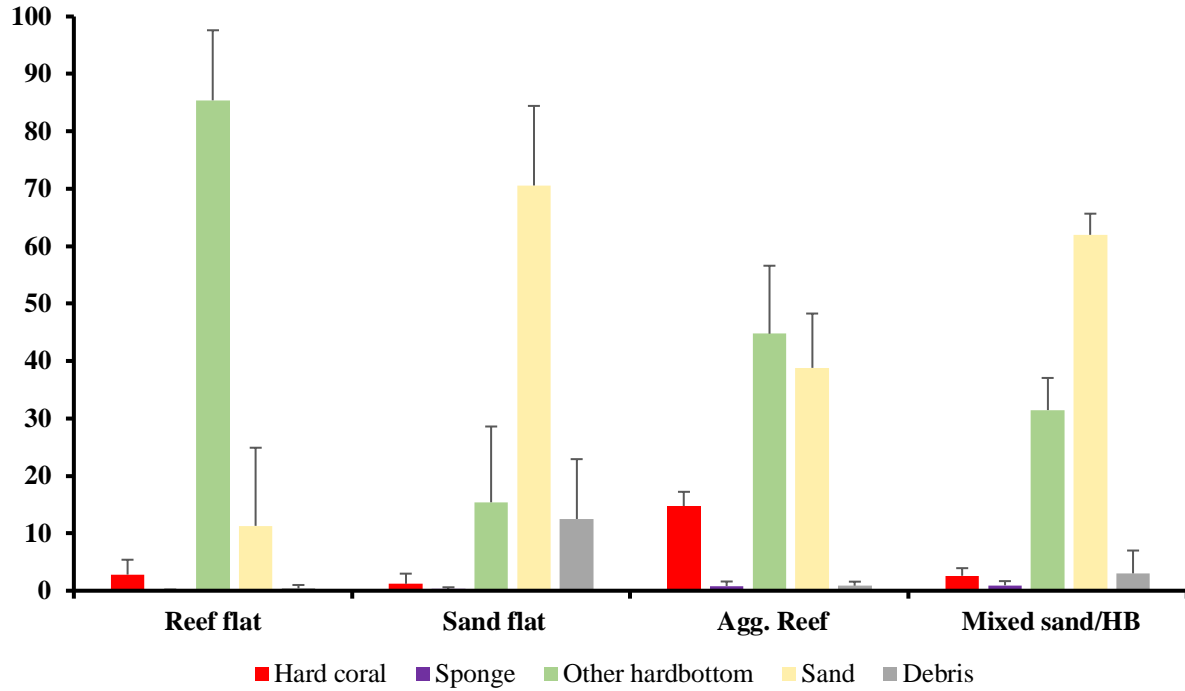
**Figure 13.** Percent cover ( $\pm$  SD) of major benthic classes for seafloor transects surveyed within the 30 m Indirect Impacts Zone.

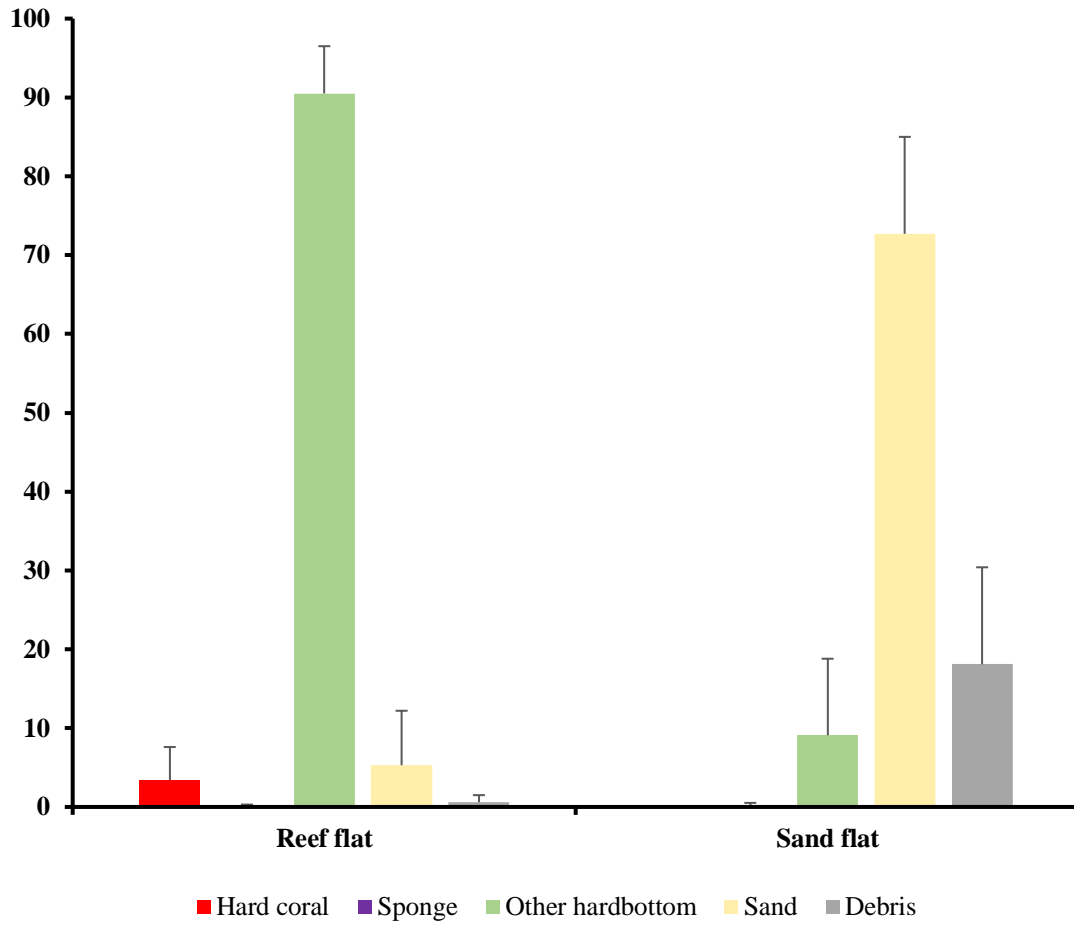
**Figure 14.** Percent cover ( $\pm$  SD) of major benthic classes for seafloor transects surveyed within the 20 m Indirect Impacts Zone.

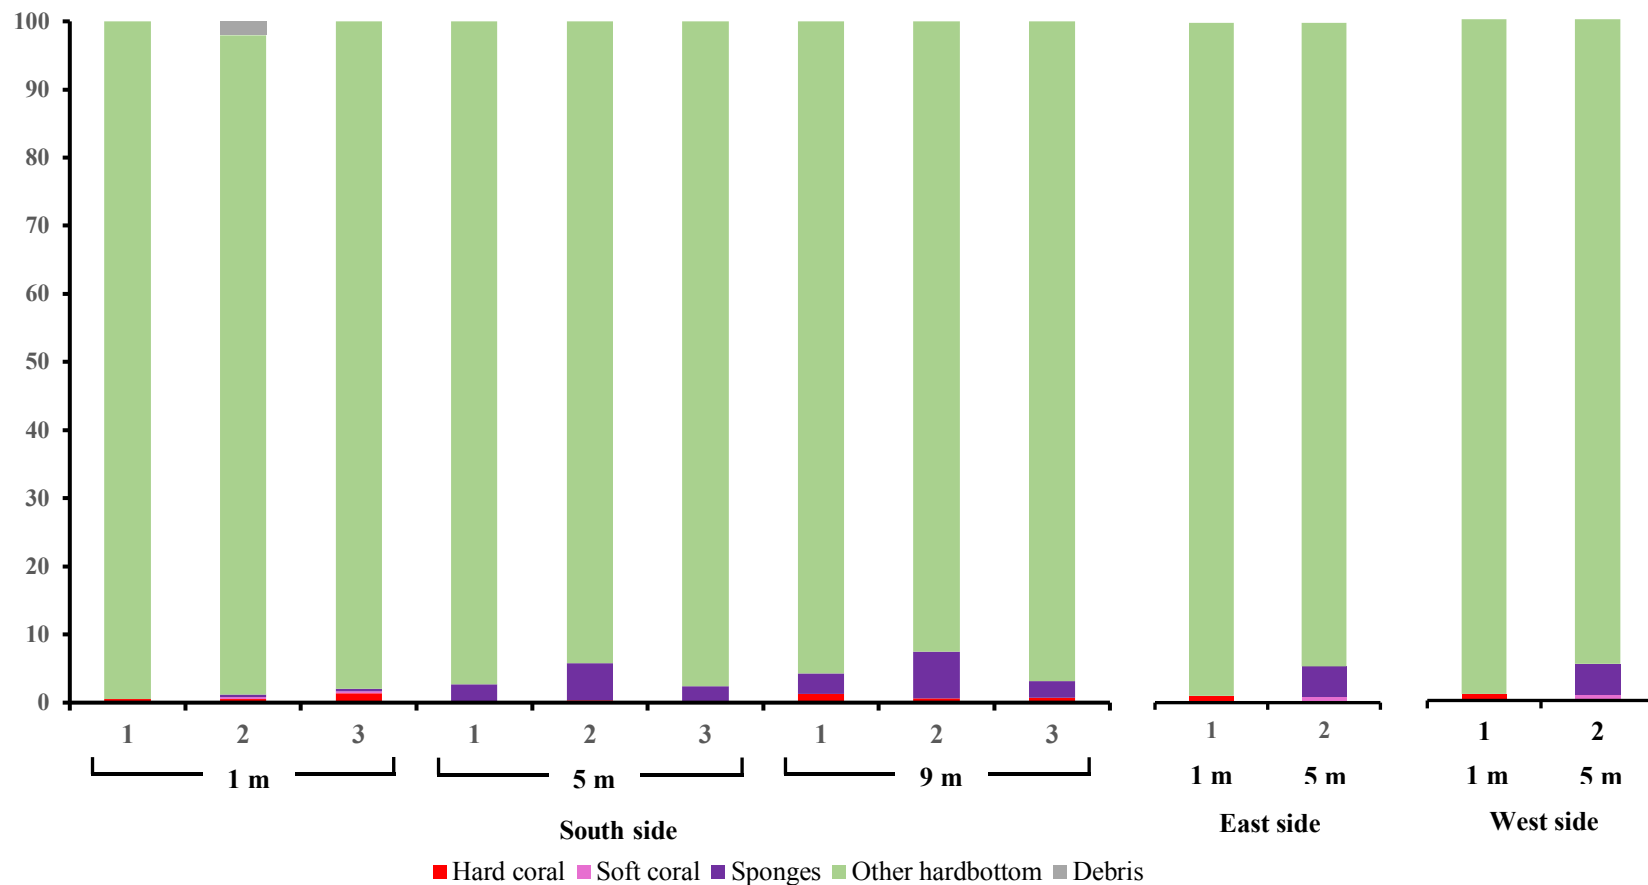
Figure 15. Percent cover of major benthic classes for the wharf transects surveyed within the Direct Impact Zone.

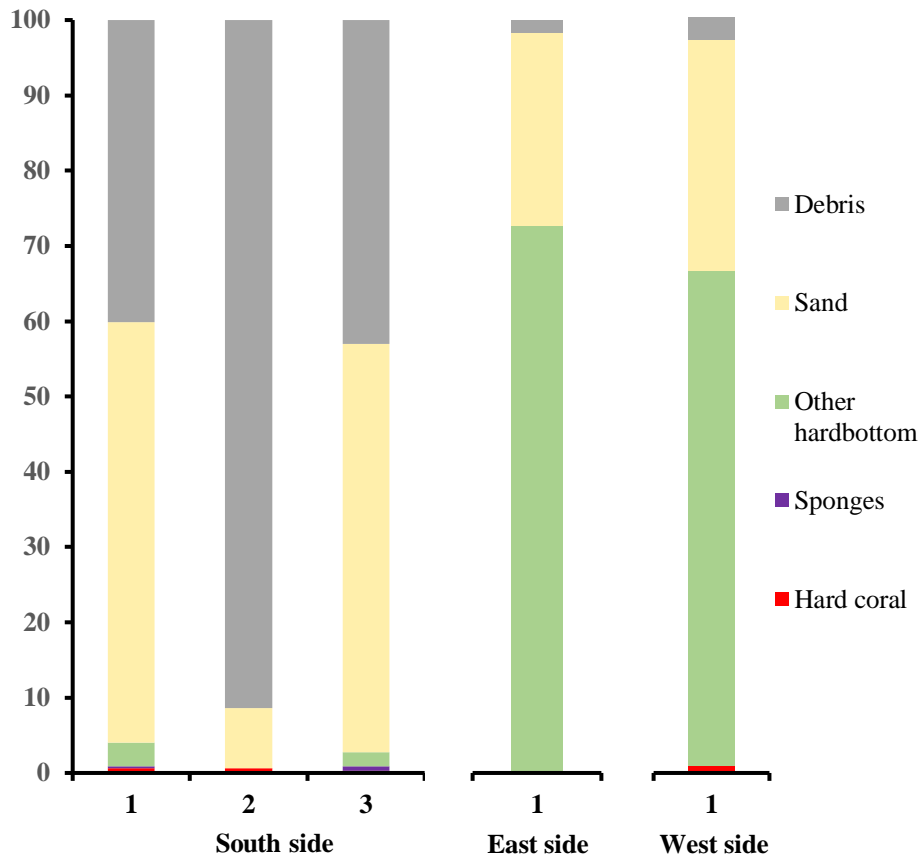
**Figure 16.** Percent cover of major benthic classes for seafloor transects at the base of the wharf (Direct Impacts Zone).

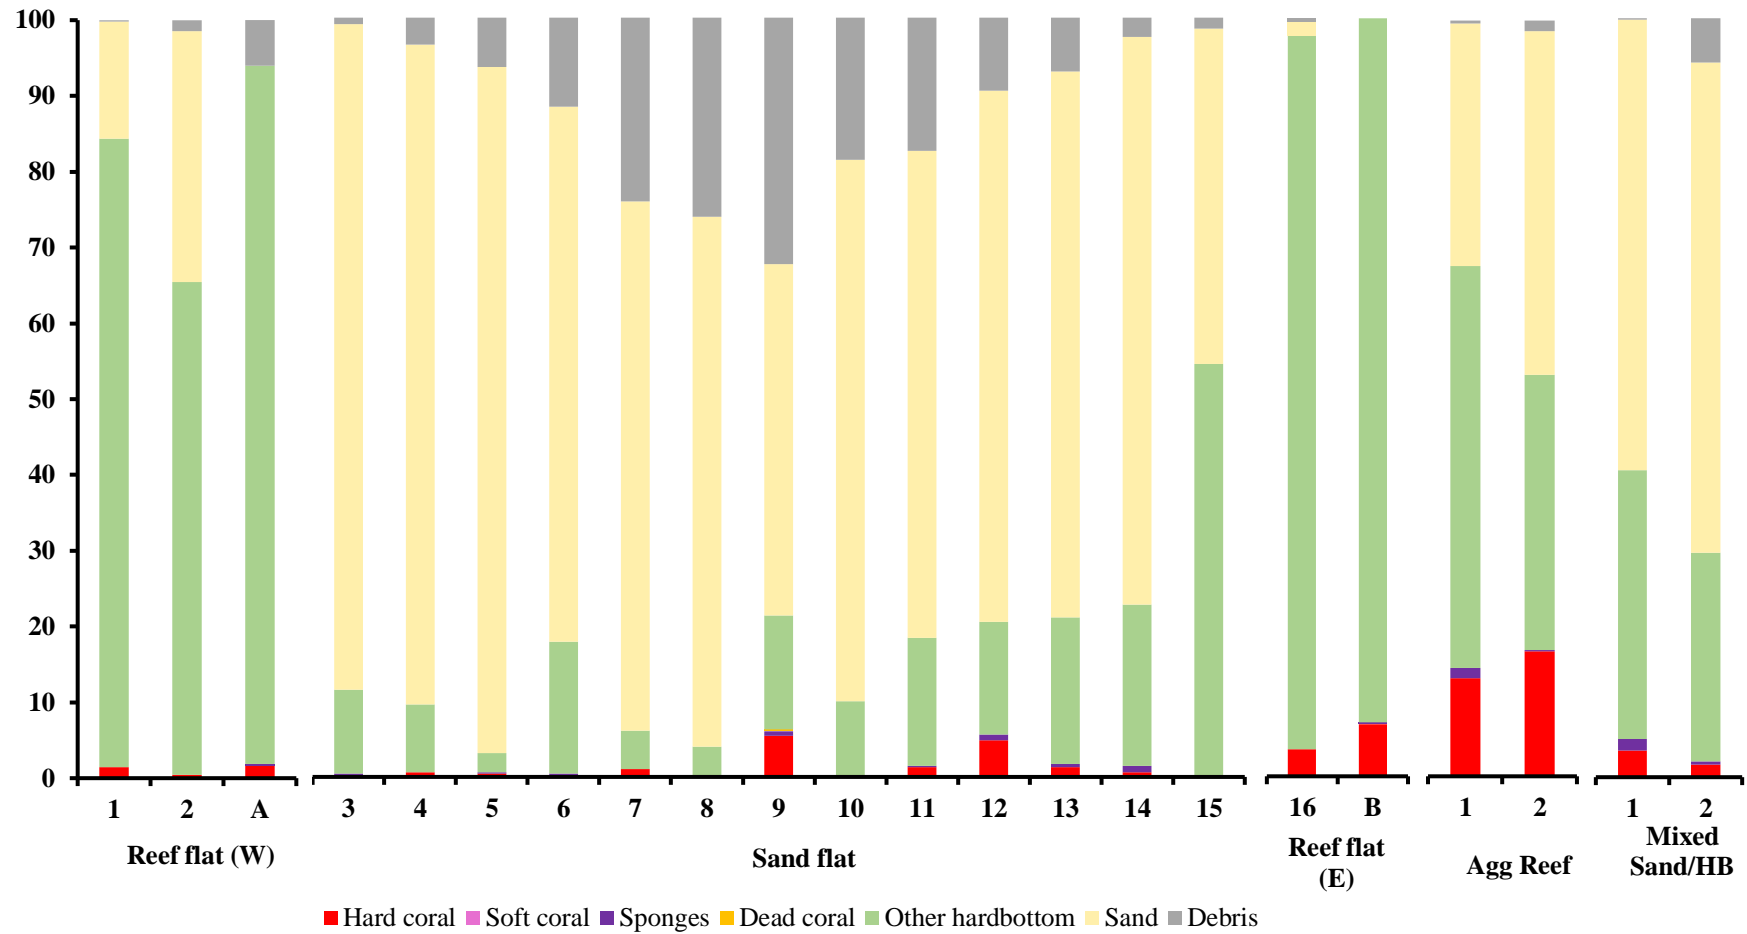
Figure 17. Percent cover of major benthic classes for seafloor transects within the 30 m Indirect Impacts Zone.
