# ENVIRONMENTAL ASSESSMENT

## PROPOSED HOTEL WHARF AND ACCESS ROAD MAINTENANCE AND REPAIR PROJECT Apra Harbor, Guam

**July 5, 2019**

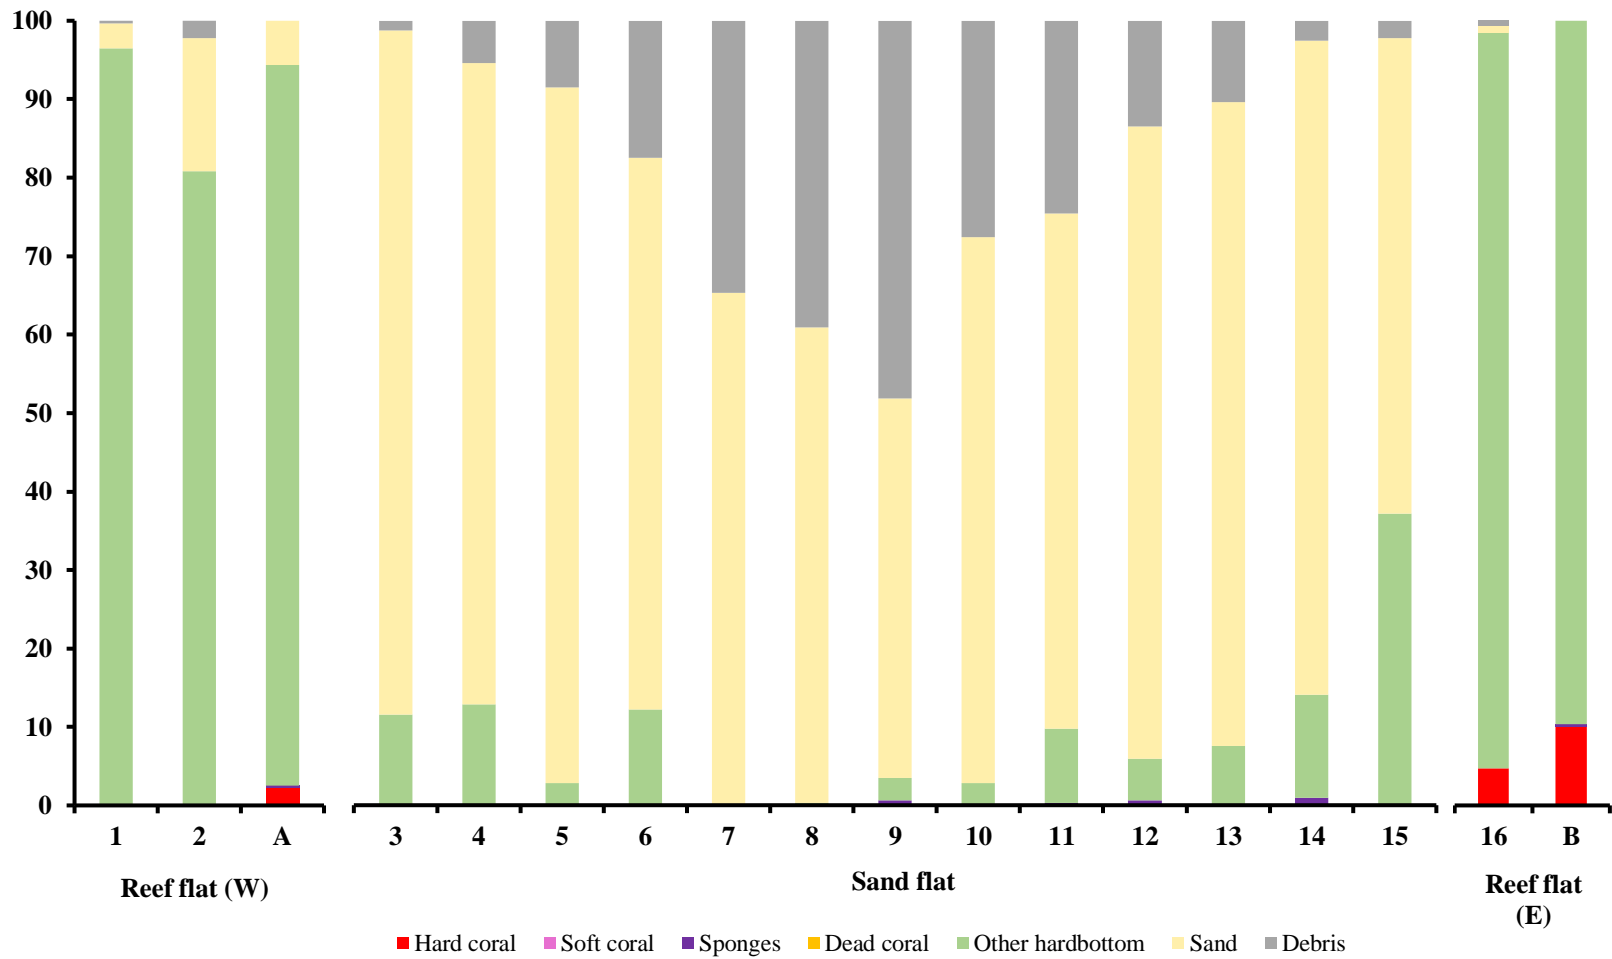
Figure 18. Percent cover of major benthic classes for seafloor transects within the 30 m Indirect Impacts Zone.

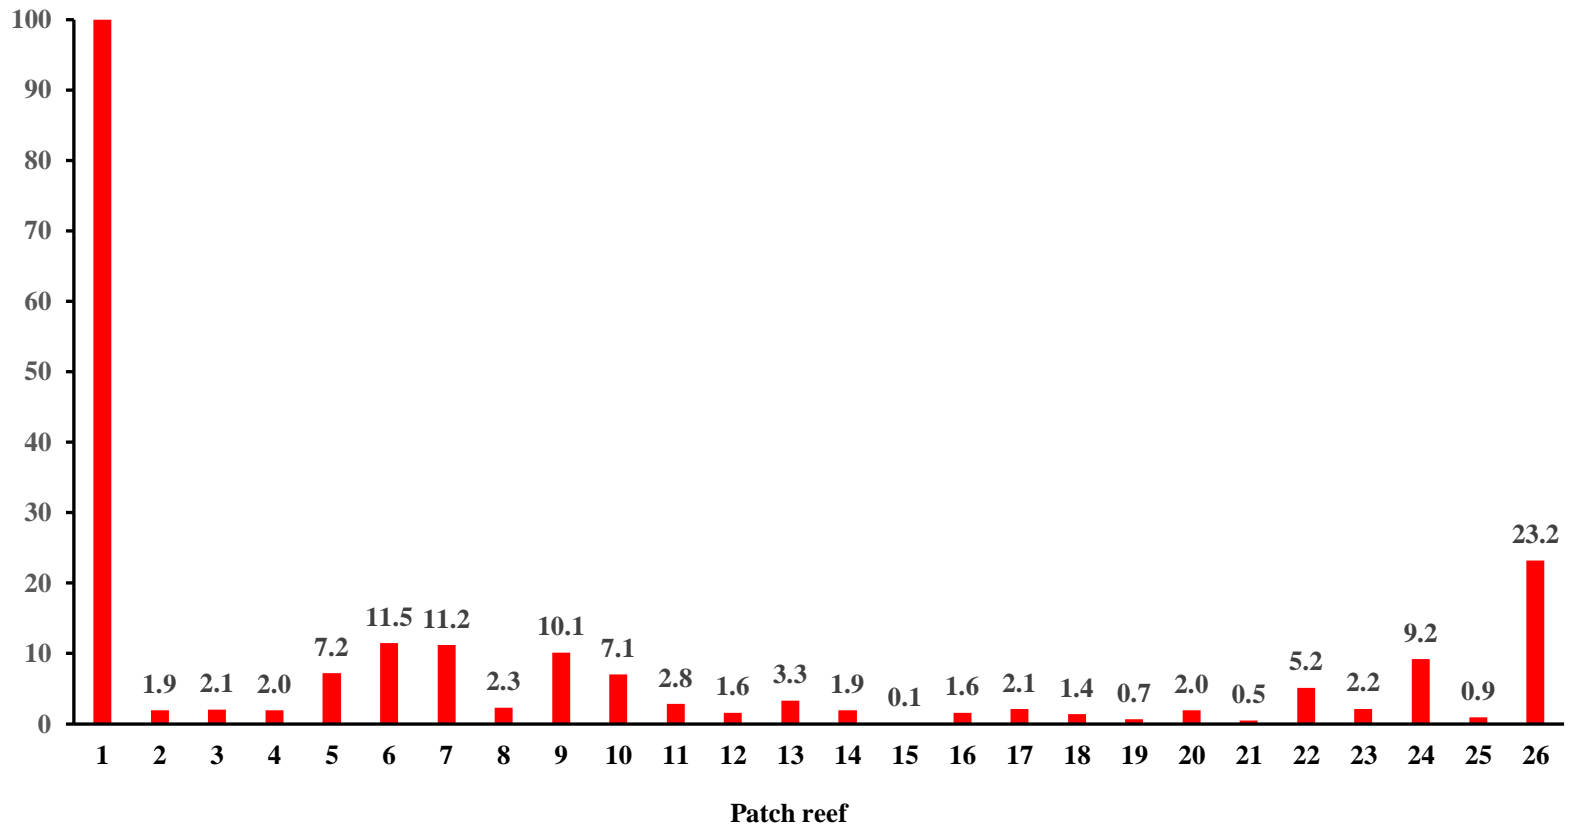
**Figure 19.** Percent coral cover for patch reefs surveyed within the Indirect Impacts Zone. While some patch reefs (including Patch reef 1, which was a single, large *Porites rus* colony) occurred beyond the 30 m zone (but within 50 m of the wharf), data for all patch reefs were included in the analysis for the Indirect Impacts Zone.

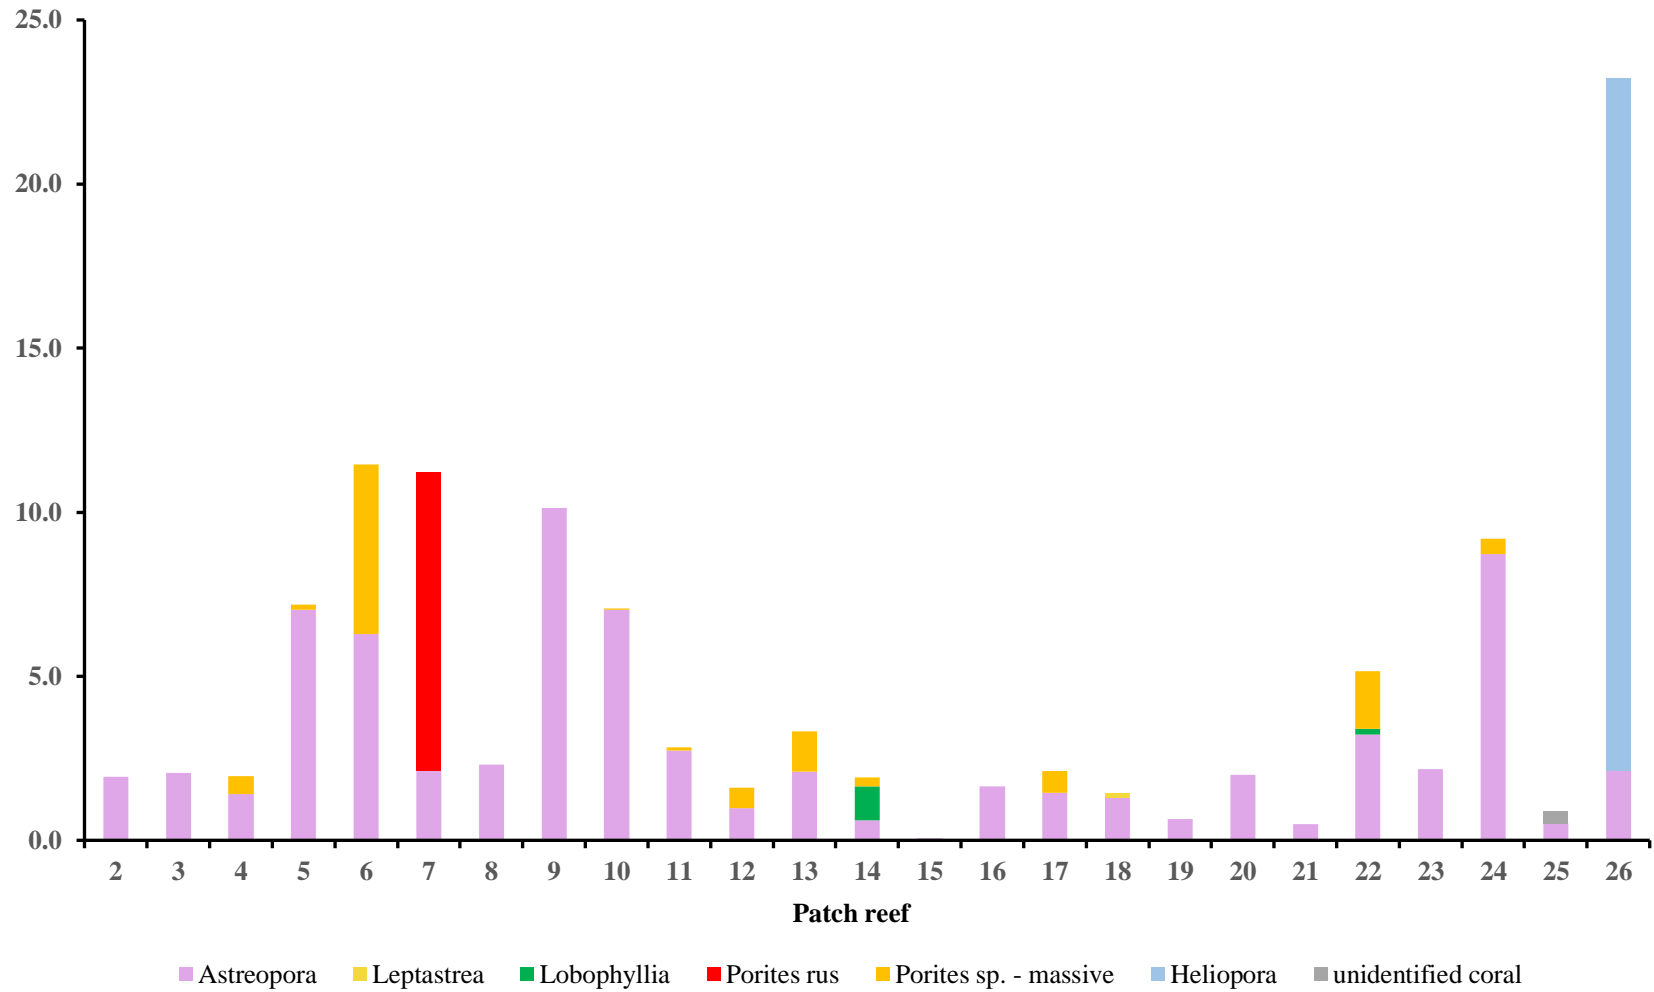
**Figure 20.** Percent cover of coral taxa for patch reefs surveyed within the Indirect Impacts Zone. Patch reef 1, which was comprised of a single, large *Porites rus* colony (100% coral cover), was excluded from this figure.

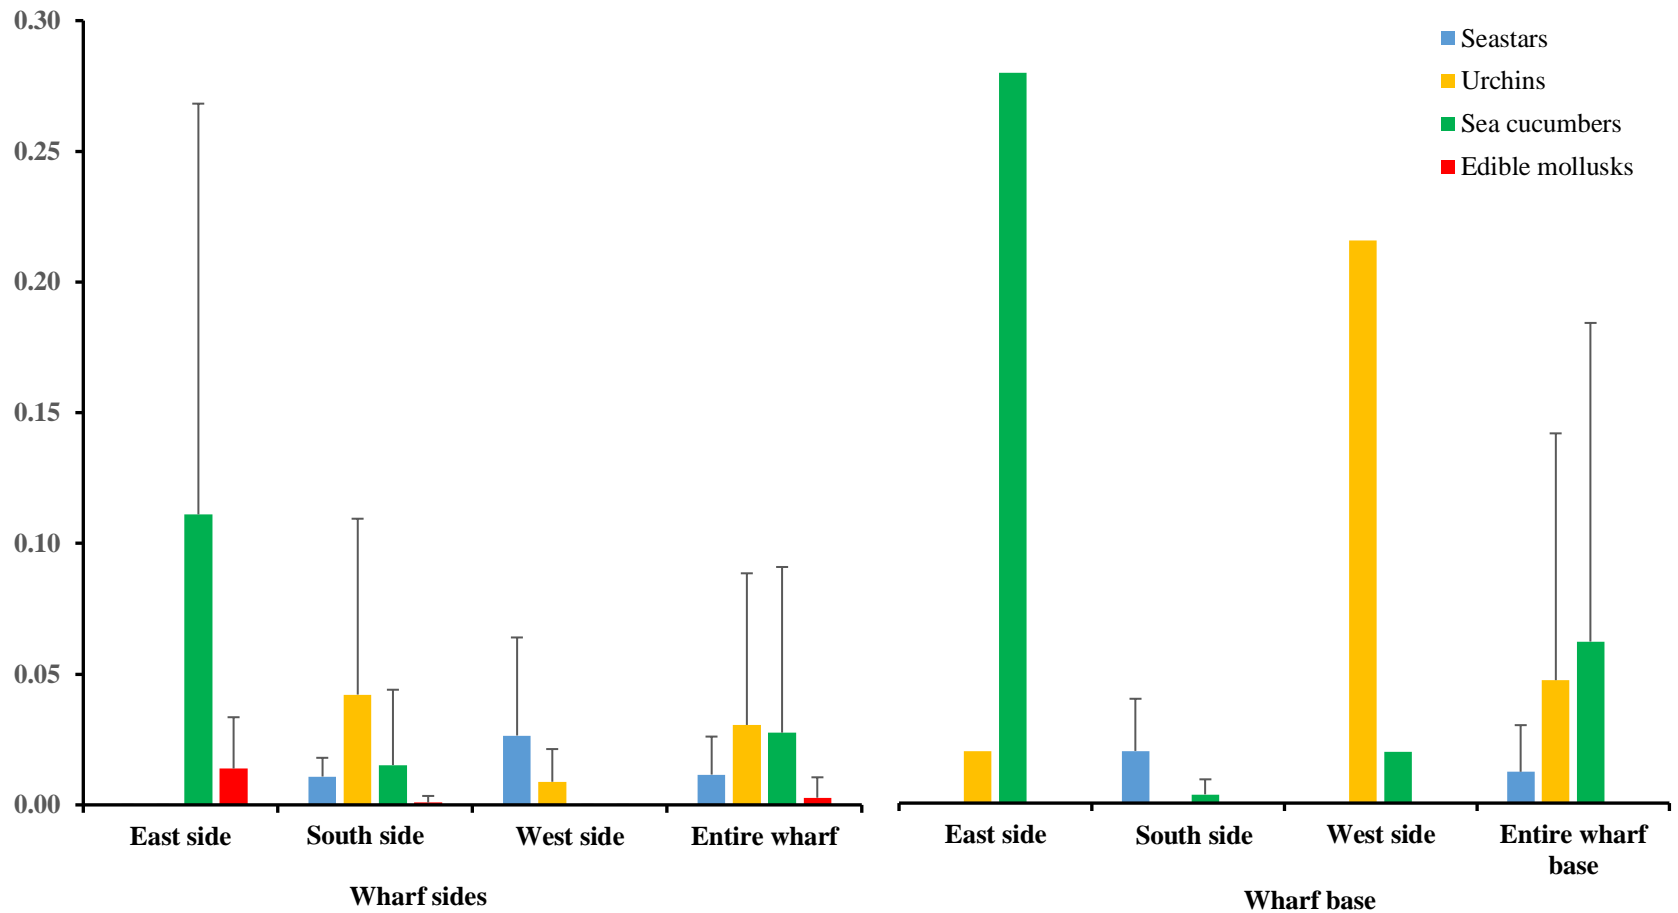
**Figure 21.** Density (ind/m<sup>2</sup>) of macroinvertebrate taxa observed within belt transects placed on the wharf sides and at the base of the wharf (Direct Impacts Zone).

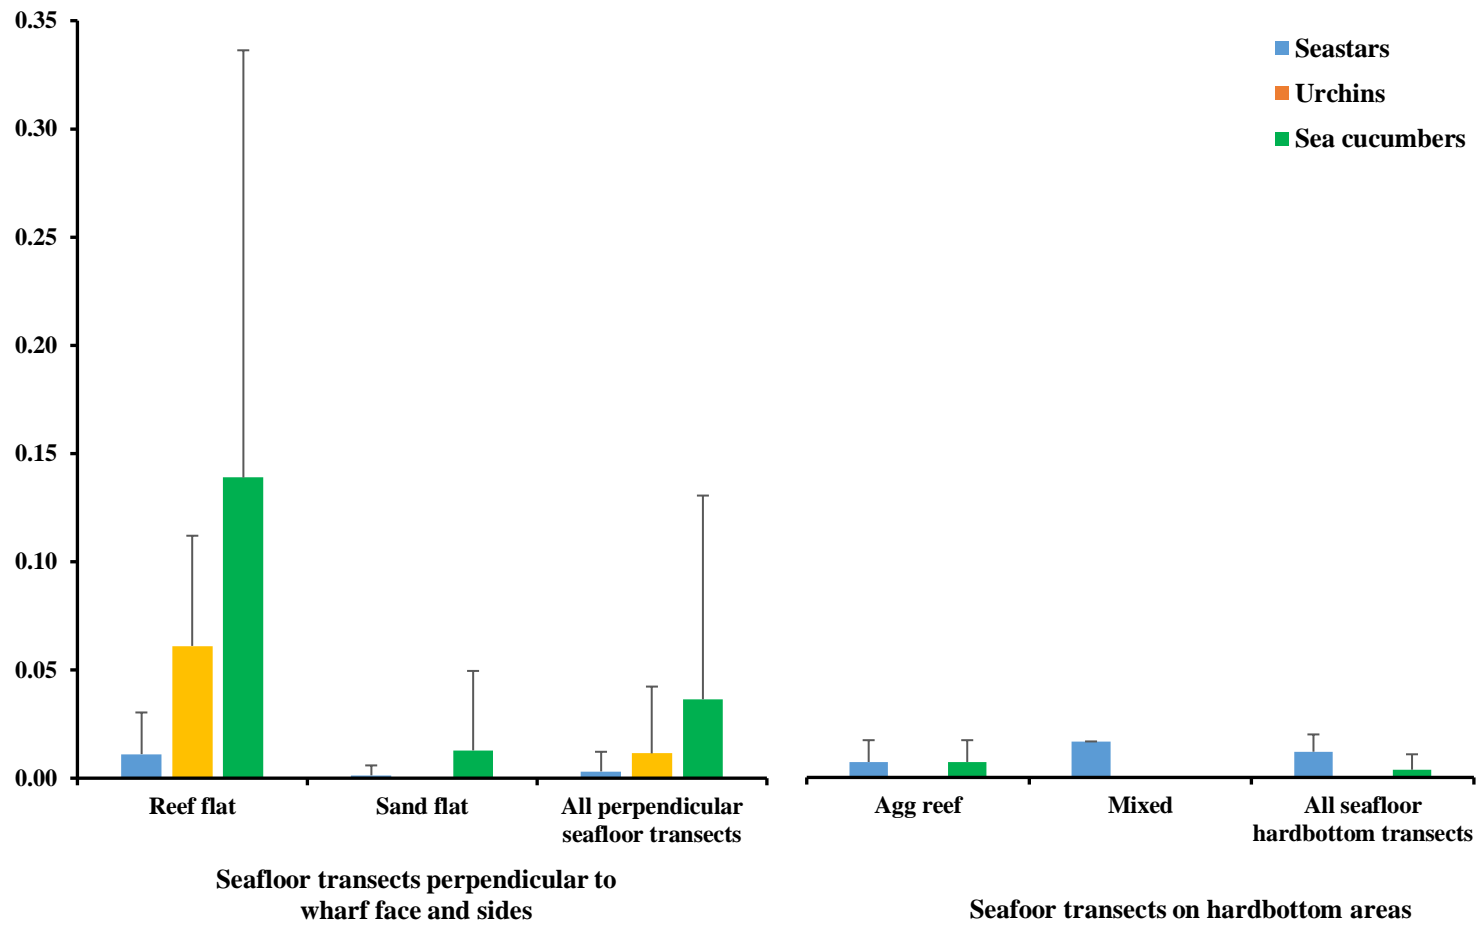
**Figure 22.** Density (ind/m<sup>2</sup>) of macroinvertebrate taxa observed in belt transects placed on the seafloor perpendicular to the wharf, and transects placed on an area of hardbottom that occurs parallel to the wharf face (30 m Indirect Impacts Zone).

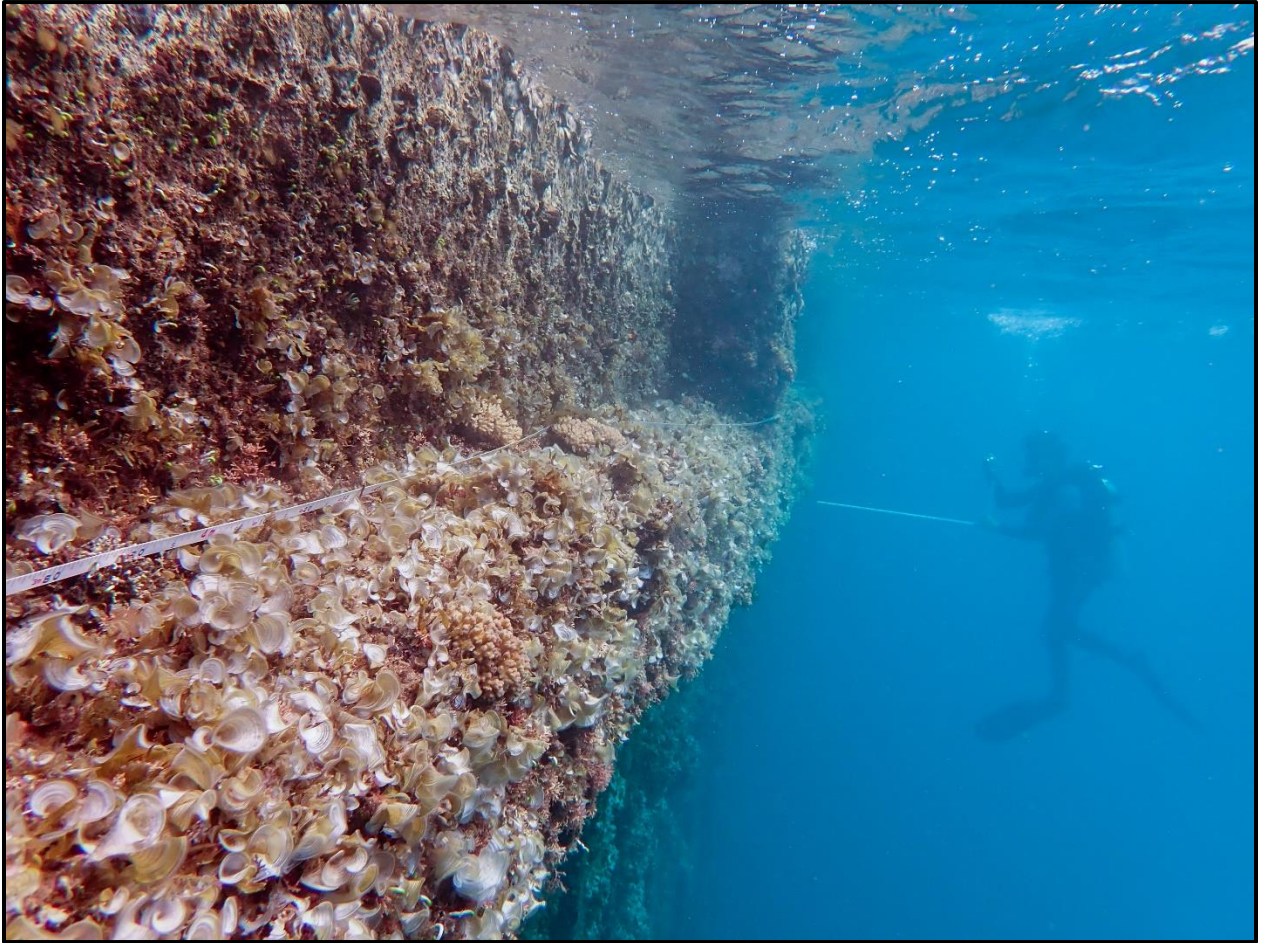
**Figure 23.** One of the shallow (~1.5 m) transects placed on a concrete beam that runs the length of the wharf sides.

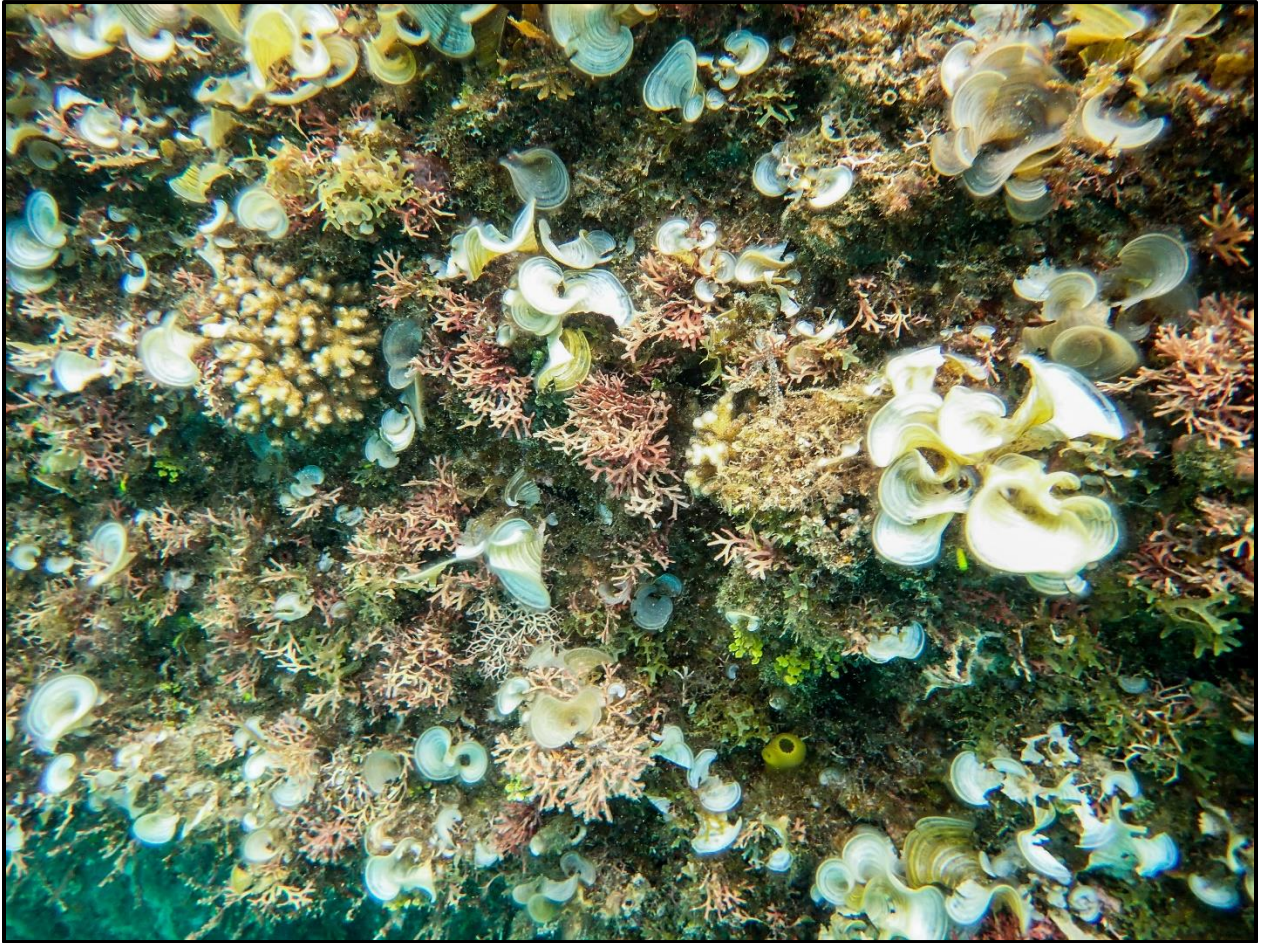
**Figure 24.** A shallow (~1.5 m) benthic community on the west side of the wharf dominated by erect macrophytic algae.

All sides of the wharf face hosted similar benthic communities, although some differences in the abundance and diversity of macrophytes and turf algae—likely related to light exposure— were observed. Common conspicuous algae taxa on the wharf face included the erect macrophytes *Padina* sp., *Dichotomaria marginata*, *Tricleocarpa fragilis*, *Halimeda* spp., and *Dictyota* spp., as well as several unidentified adherent fleshy and crustose coralline species. Solitary and colonial ascidians and encrusting sponges were also common on the wharf face, and an unidentified oyster species was abundant in the area of the wharf face above a depth of about 1 m. The abundance, biomass, and diversity of benthic organisms generally decreased with depth along the wharf face, likely in response to the reduction in light and greater accumulation of sediment (Figures 24–25). The benthic community occurring on the shaded underside of

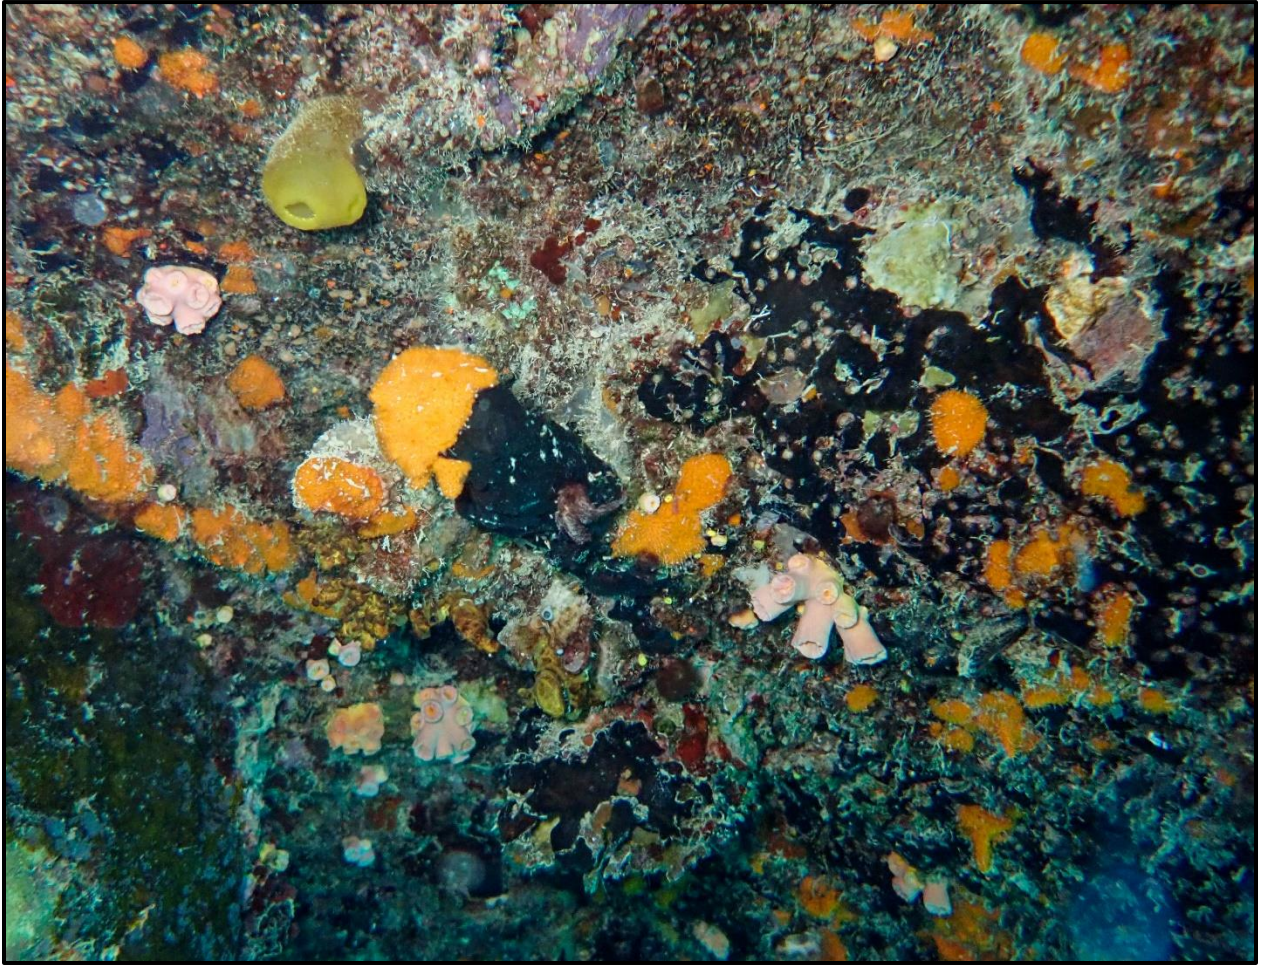
**Figure 26.** A benthic community dominated by encrusting sponges and turf algae, and numerous dendrophylliid corals, typical of the underside of the concrete beam that extends across the length of the wharf sides at a depth of approximately 1.5 m.

the concrete beam was distinct from other areas of the wharf face, being primarily comprised of encrusting sponges, crustose coralline algae, and *Halimeda* spp., with few other macrophytes. This area also hosted numerous dendrophylliid corals, also known as tube or sun corals (Figure 26), and at the southeast corner numerous colonies of an octocoral—possibly the non-native species, *Carijoa riisei* (snowflake coral)—were observed (Figure 27).

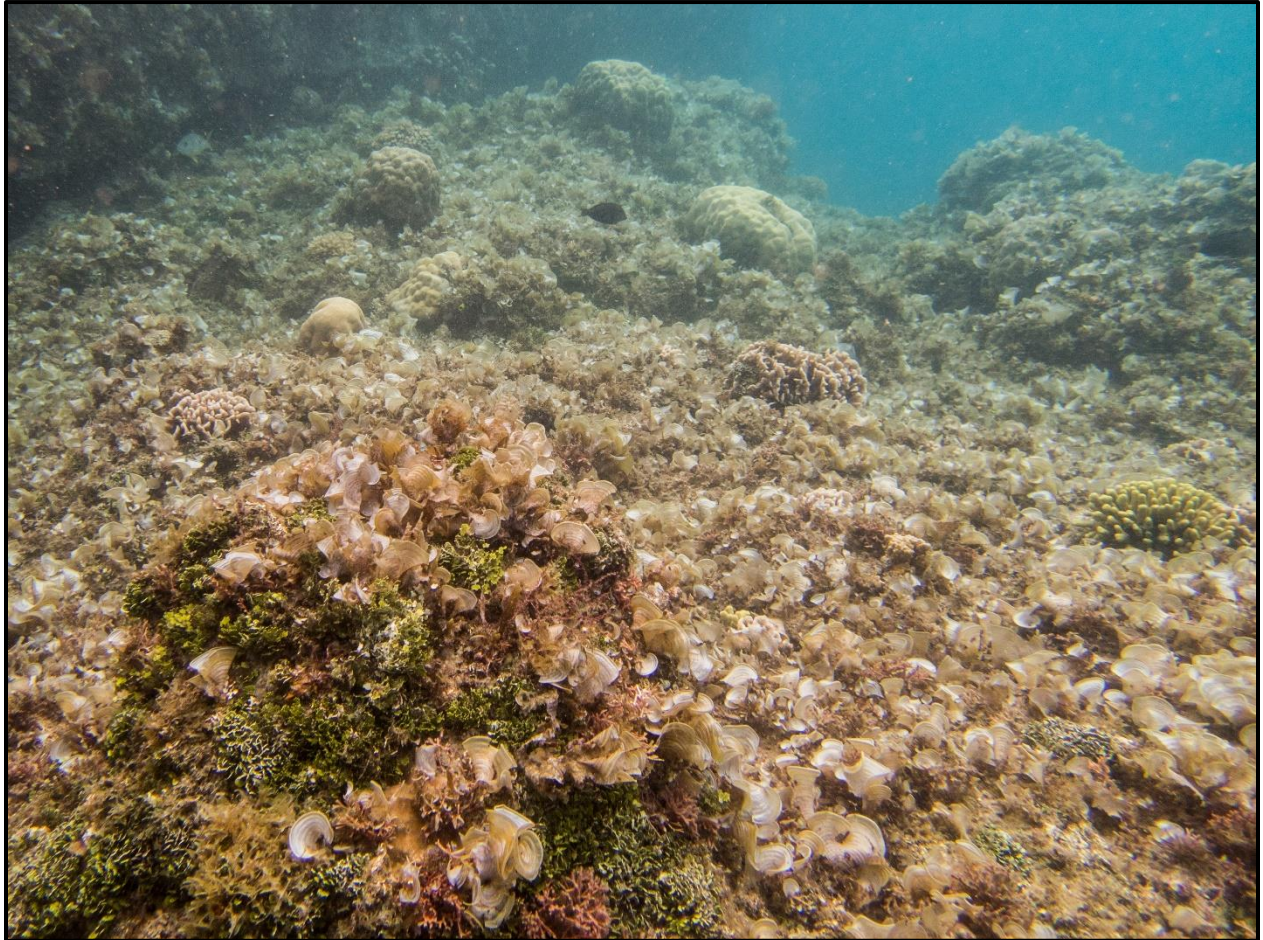
**Figure 28.** A benthic community on the reef flat adjacent to the west side of the wharf dominated by erect macrophytes, primarily *Padina* sp. and *Halimeda* spp. Coral cover is generally low across the reef flat, but notable colonies, such as the *Pavona decussata*, massive *Porites* spp., and *Porites cylindrica* colonies visible in this image, were observed in close proximity to the wharf.

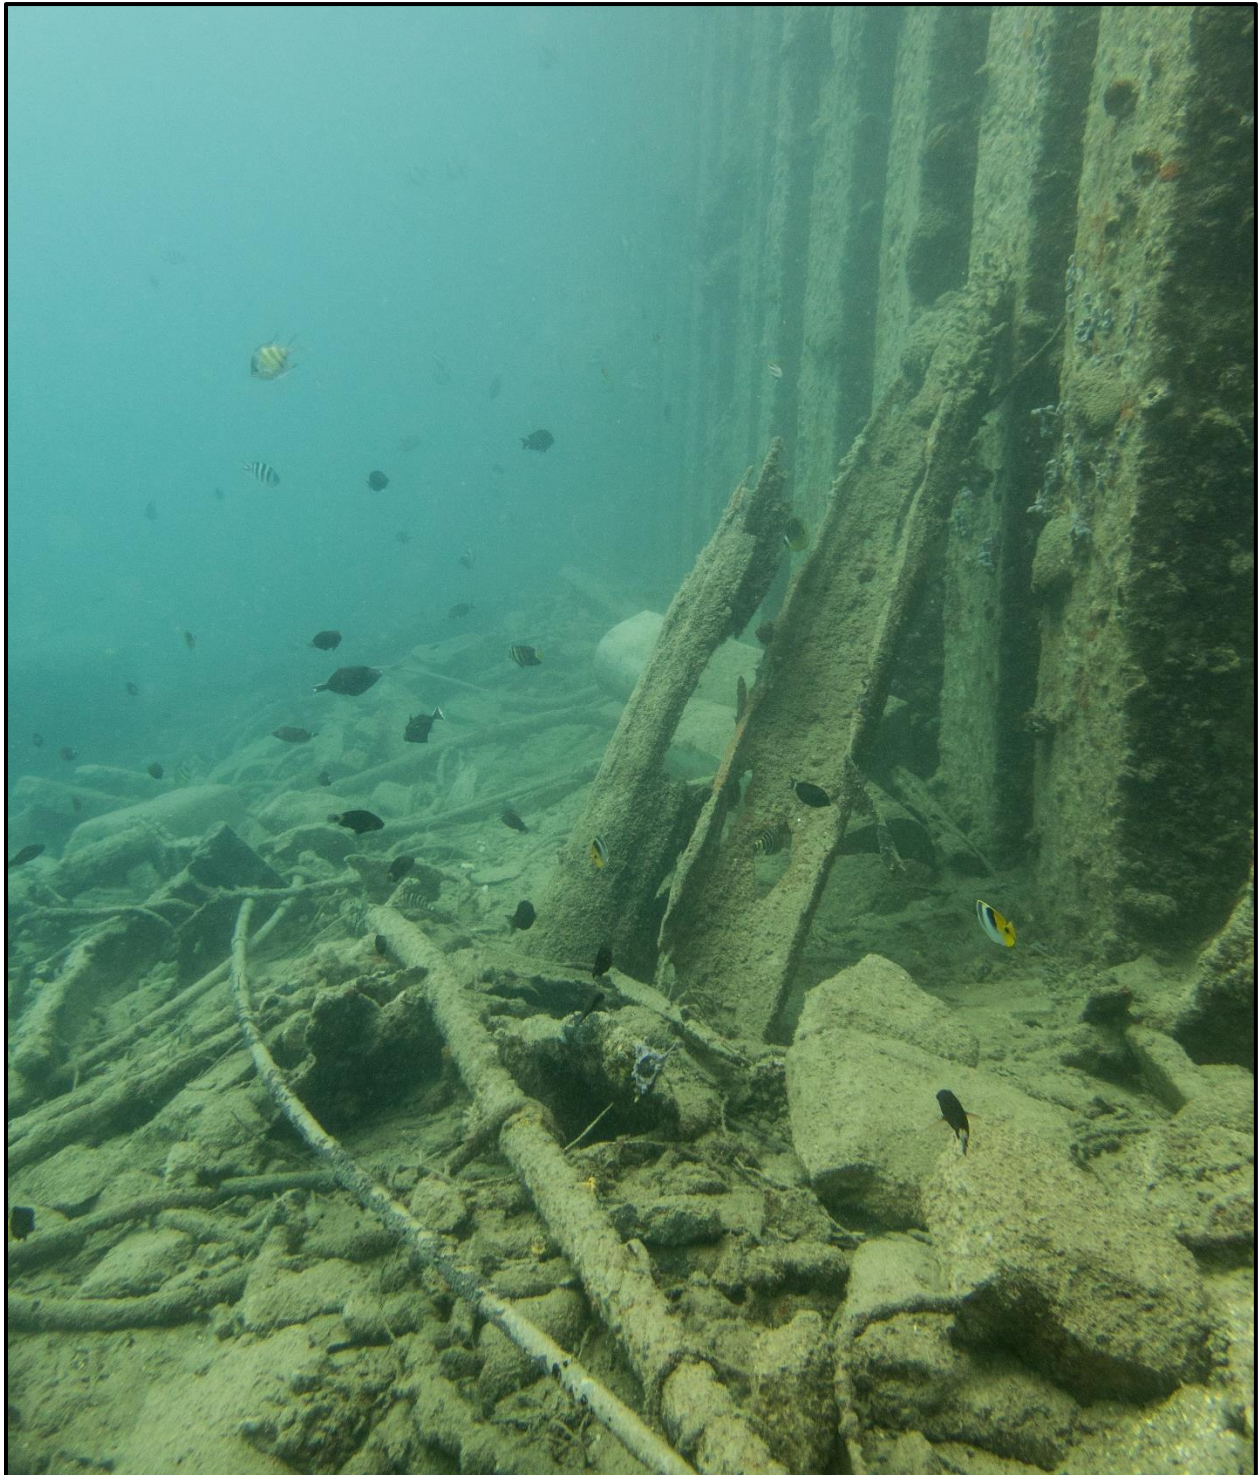
**Figure 29.** A portion of the debris field occurring at the base of the south wharf face at a depth of approximately 9 m. The debris are strewn across a seafloor dominated by uncolonized, unconsolidated sediment, but some coral colonies were observed growing on the debris.

During underwater surveys in March 2019, Dr. William Jeffery, Maritime Archaeologist and Assistant Professor, Anthropology, University of Guam (UOG), found the southern face littered with material associated with the use of the wharf that has been dumped, thrown, or has fallen onto the seabed. This debris included: rubber tires of various sizes, wharf fenders, a considerable amount of rope of various thicknesses as well as metal cable, thin strand wire, the rear section of a heavy duty forklift, a large scrap metal cube, two large concrete columns, various size shackles, a hand-trolley, sand bags, sections of various diameter pipe, metal plating, a small number of bottles and cans, fragmentary timber piles, and a few ceramics (one whole plate, a few ceramic sherds similar to the plate, and a cup) (Jeffery, 2019). The eastern and western faces contained very little debris, which is indicative of these sections of the wharf not being used in loading or unloading people or cargo (Jeffery 2019). A UXO dive team was present throughout the maritime survey; however, no MEC or Material Potentially Presenting an Explosive Hazard (MPPH) were found (UEG 2019).

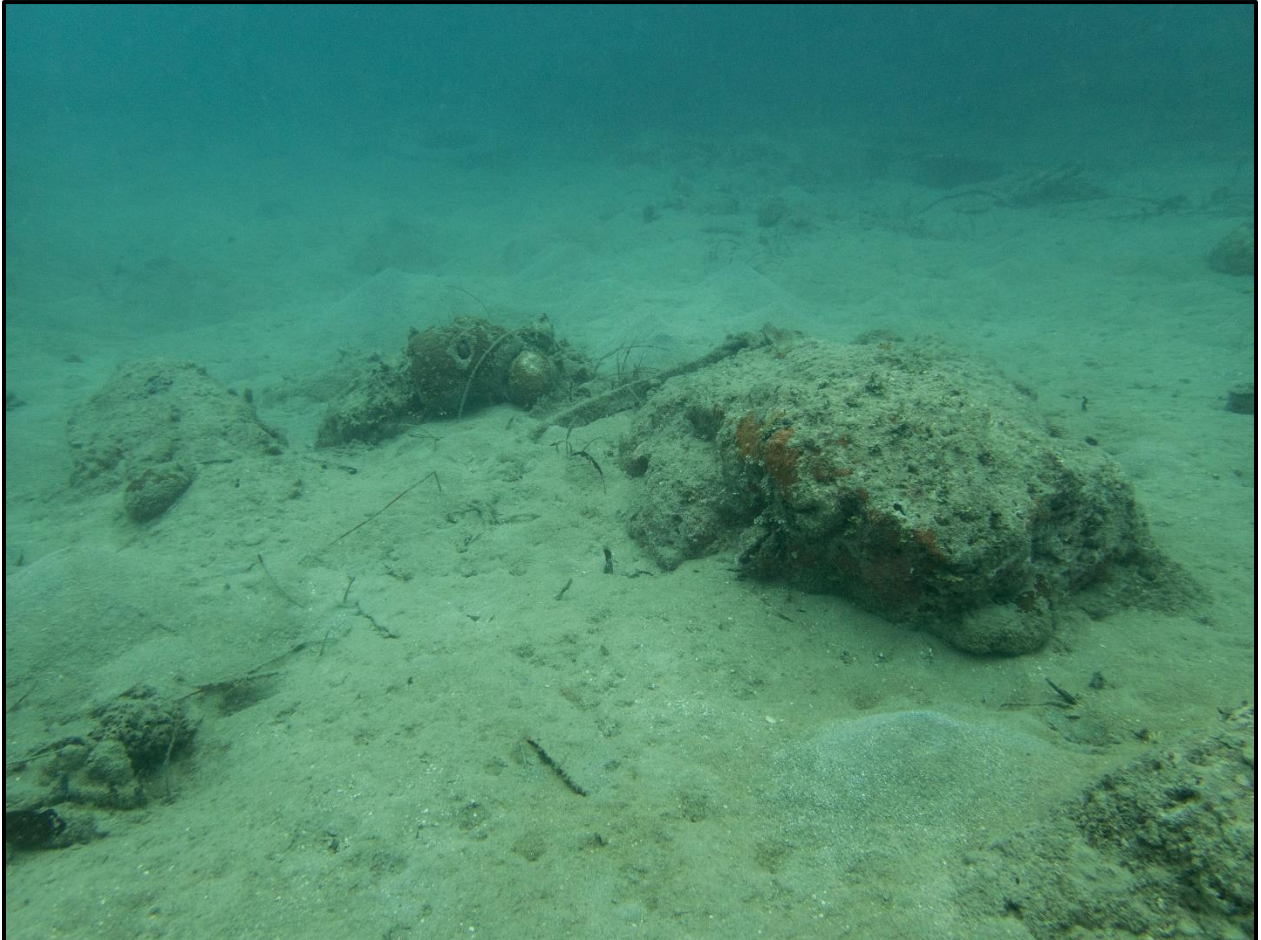
**Figure 30.** A view of the sand flat in the Indirect Impacts Zone, which is predominantly covered by uncolonized sand, with small patches of hardbottom.

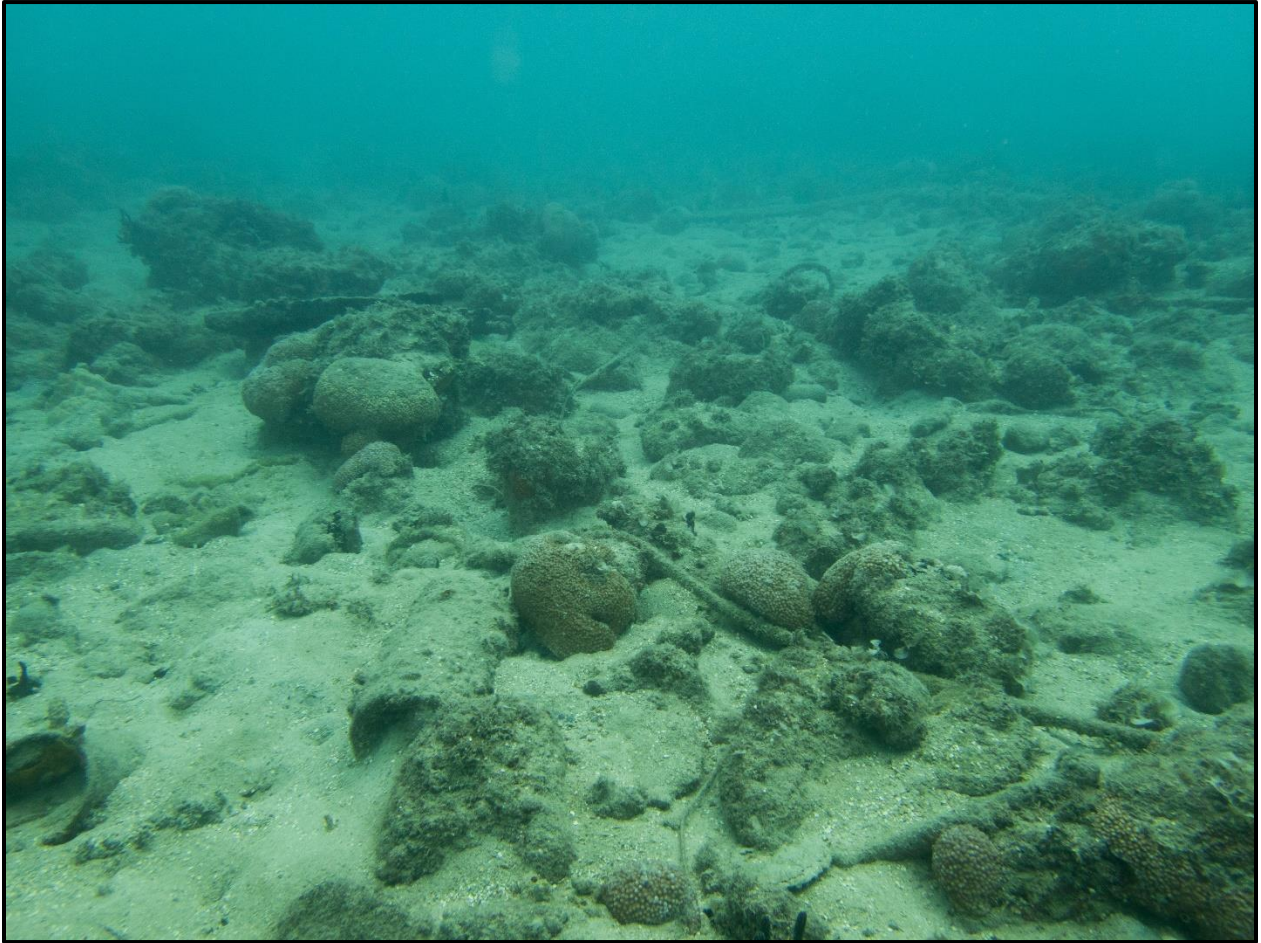
**Figure 31.** A view of the area of mixed sand/hardbottom that runs parallel to, and approximately 20–35 m from, the south wharf face. This area straddles the 30 m Indirect Impacts Zone but occurs beyond the 20 m Indirect Impacts Zone.

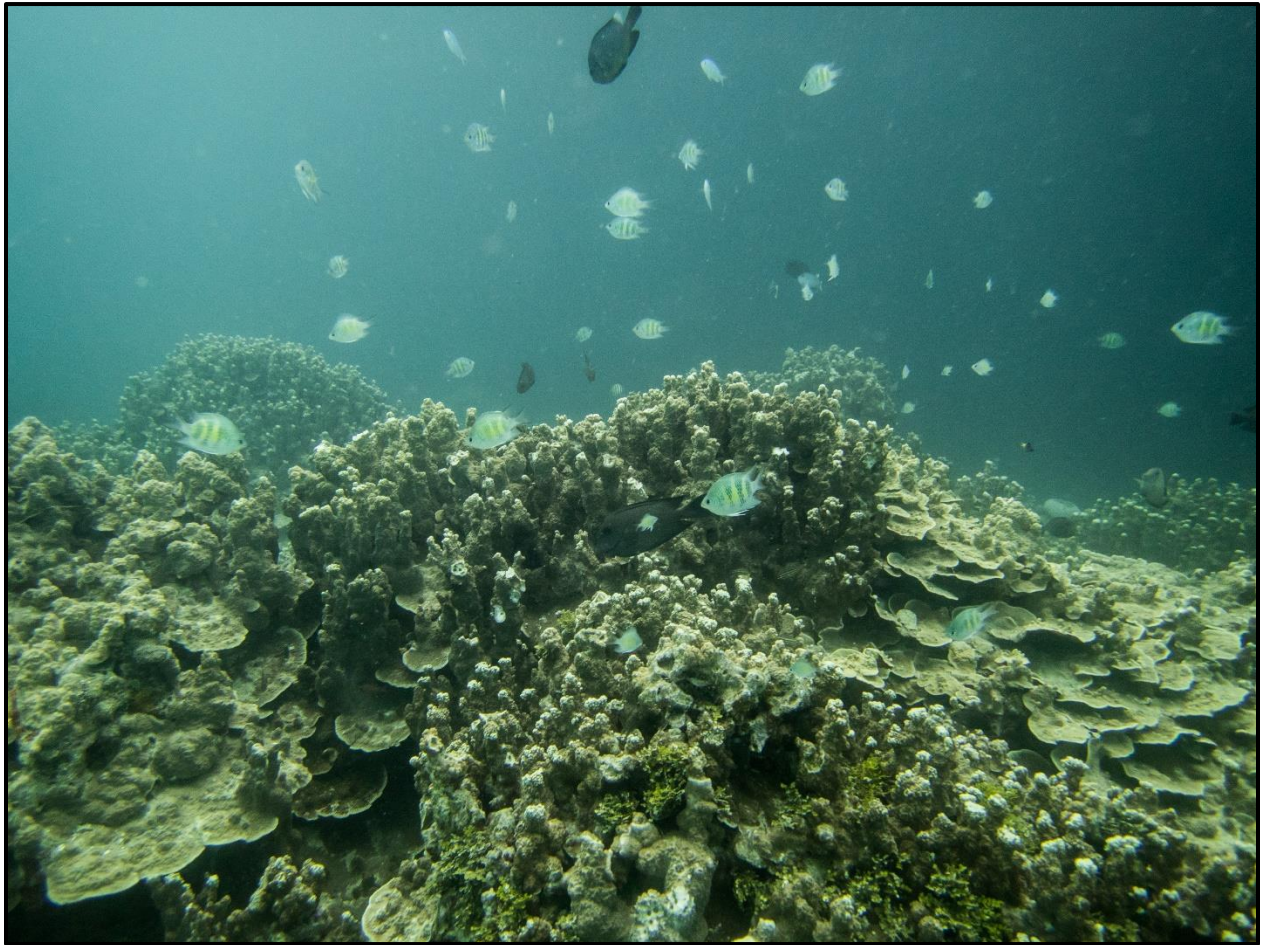
**Figure 32.** Dense growth of the plate-and-pillar coral, *Porites rus*, and associated reef fishes, in the area of aggregate reef running parallel to, and approximately 25–40 m from, the south wharf face. This area partially occurs within the 30 m Indirect Impacts Zone, but falls outside the 20 m Indirect Impacts Zone.

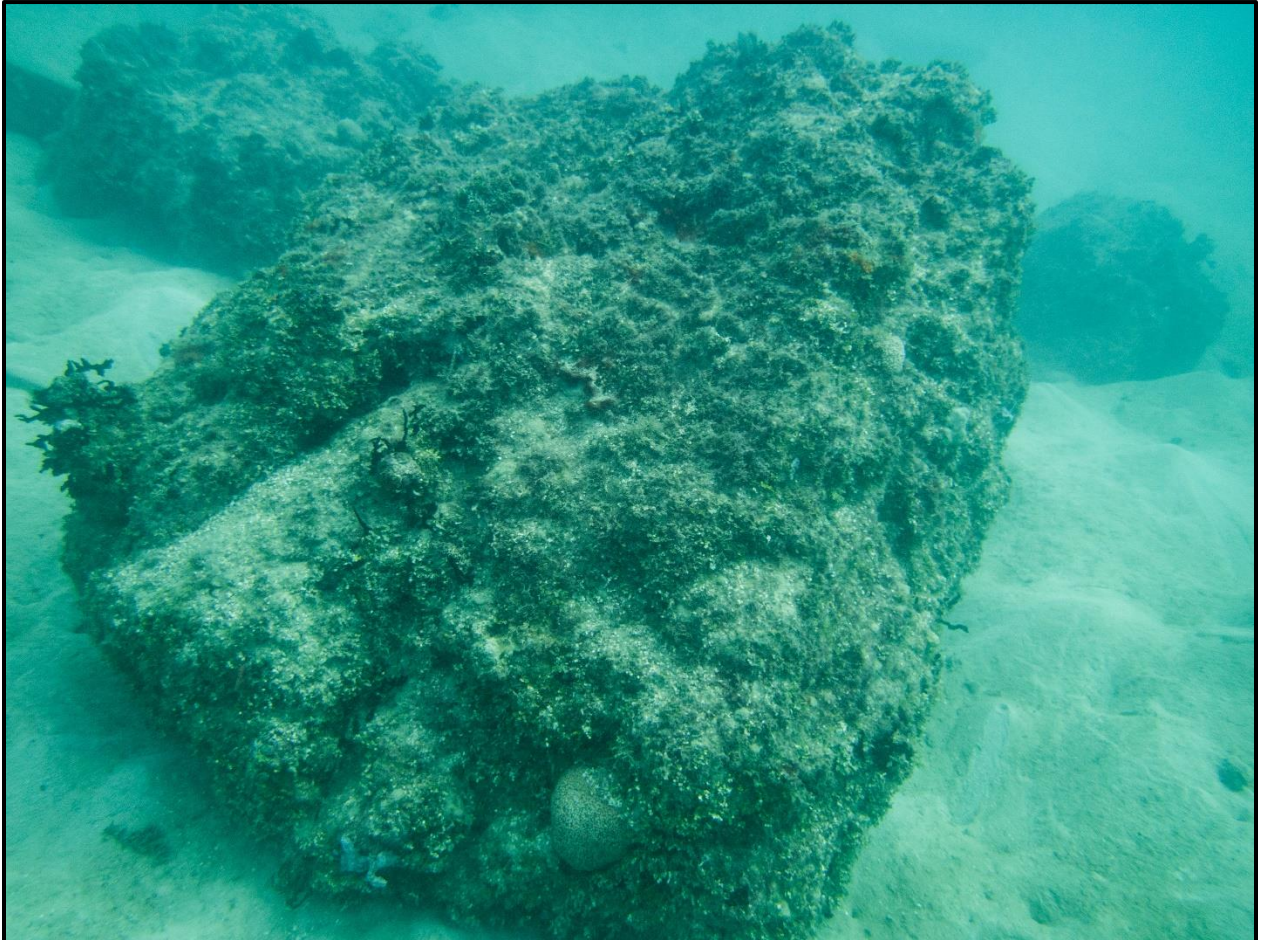
**Figure 33.** A typical patch reef on the sand flat within the Indirect Impacts Zone.
