# Coral Relocation Compensatory Mitigation for the Hotel Wharf and Access Road Maintenance and Repair Project, Apra Harbor, Guam

DOCUMENT NO. CSA-WSP-PAG-FL-20-80159-3550-03-REP-01-FIN-REV01

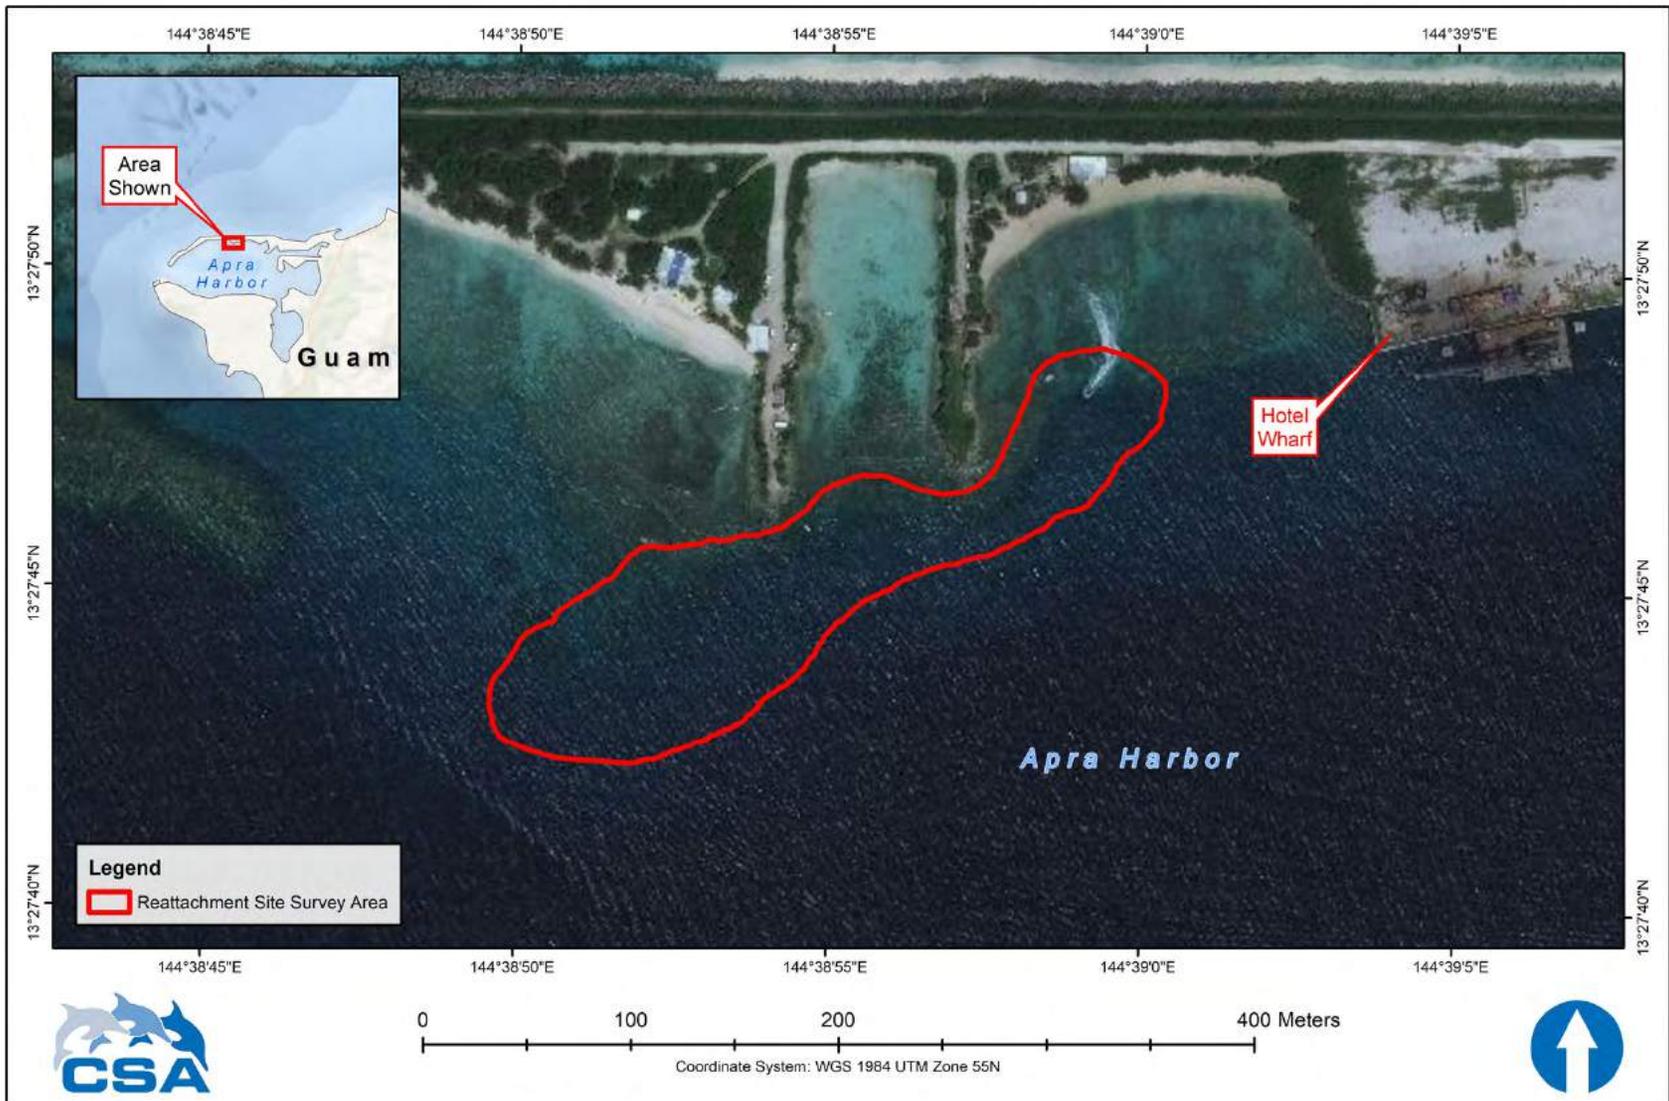
Figure 2. Area surveyed to identify coral reattachment sites for corals removed from Hotel Wharf and adjacent seafloor.

Dive teams then made dives at the potential coral reattachment area described in the Compensatory Mitigation Plan to assess suitability of the location for the receipt of corals observed on the wharf. Dives included areas to the east, south, and west of the Dog Leg Pier (**Figure 2**).

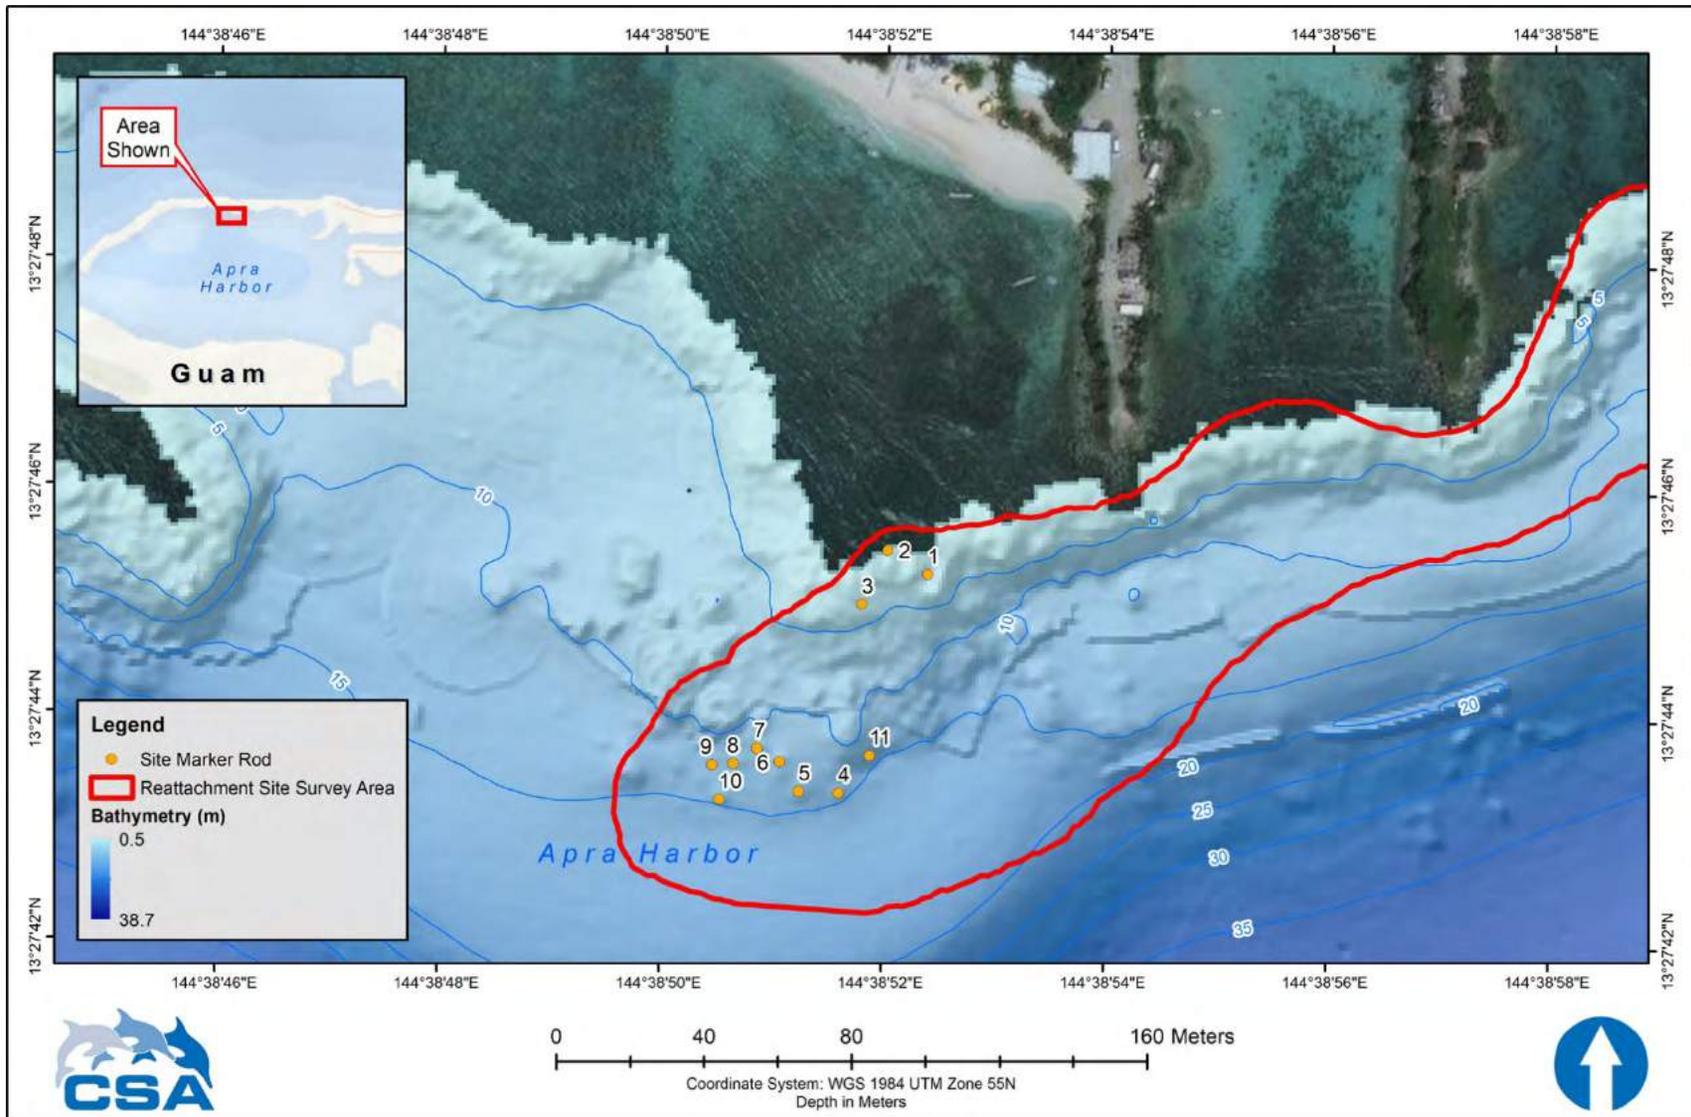
Figure 3. Locations of marker rods demarcating the approximate centers of selected coral reattachment sites.

Suitable reattachment sites were selected based on site-specific conditions, including relative proximity to the wharf, similar water depth, available exposed substrate for coral attachment, and the presence of other healthy corals of the same species. The available substrate at the potential reattachment area off the Dog Leg Pier identified in the Compensatory Mitigation Plan was deemed to be insufficient for the number of corals to be relocated, as well as being covered with layers of surficial sediments with fairly heavy *Padina* (macroalgae) growth. Additionally, the bottom between the Dog Leg Pier jetties at water depths up to nearly 6 m was heavily disturbed, with exposed rock and rubble, as well as significant amounts of loose sediments settling out on corals and cascading down the slope. This may be partly due to jet skiing and flyboarding in this area, as mentioned in the mitigation plan. Because of these conditions, reattachment sites were identified slightly to the west in an area to the southwest of the western Dog Leg Pier at depths ranging from about 2 to 13 m. A total of 11 distinct reattachment and reference sites or areas were ultimately selected and were marked with centrally positioned fiberglass rods cemented into the bottom. The three shallowest sites were along the reef flat and slope at water depths of from 2 to 4.5 m. The other 8 sites were on individual reef rock outcrops and along the base of the reef slope at depths ranging from 9.5 to 12.8 m (**Figure 3**). **Table 1** lists coordinates of marker rod for each reattachment site.

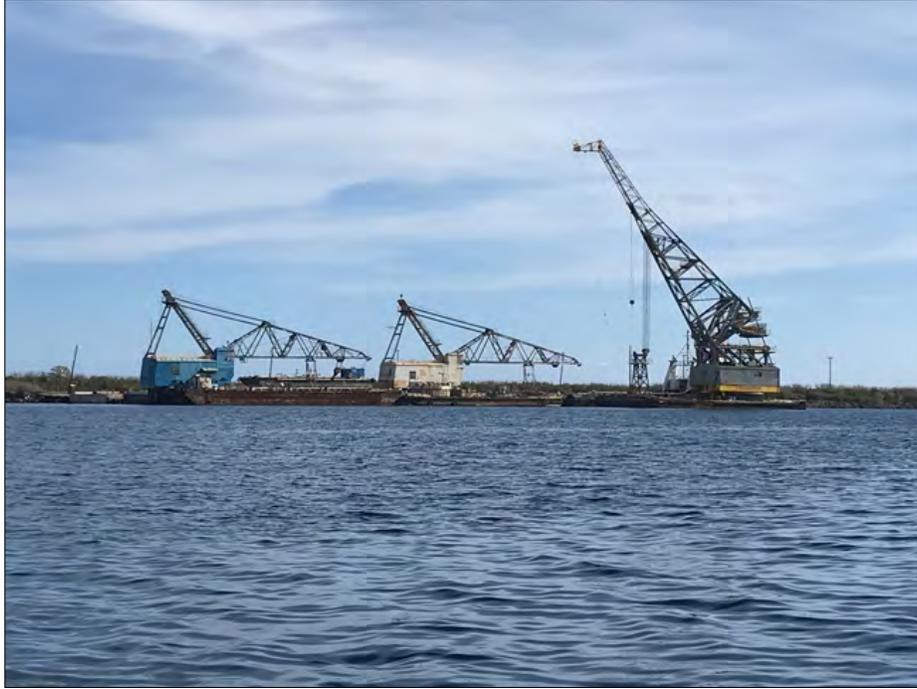
Photo 1. Barges and cranes tied up at Hotel Wharf during coral relocation project.

Dive teams systematically assessed the face of Hotel Wharf from east to west, making notes relative to coral size, relative abundance, distribution, and species, and collecting video and still photographs. Hotel Wharf was fully utilized during the site survey and coral relocation timeframe, with four large barges as well as an offshore supply vessel tied alongside (**Photo 1**). This caused a nearly total shading of the face of the wharf and adjacent seafloor out at least 15 m from the base of the wharf, aside from small areas within two gaps between the barges/vessels.

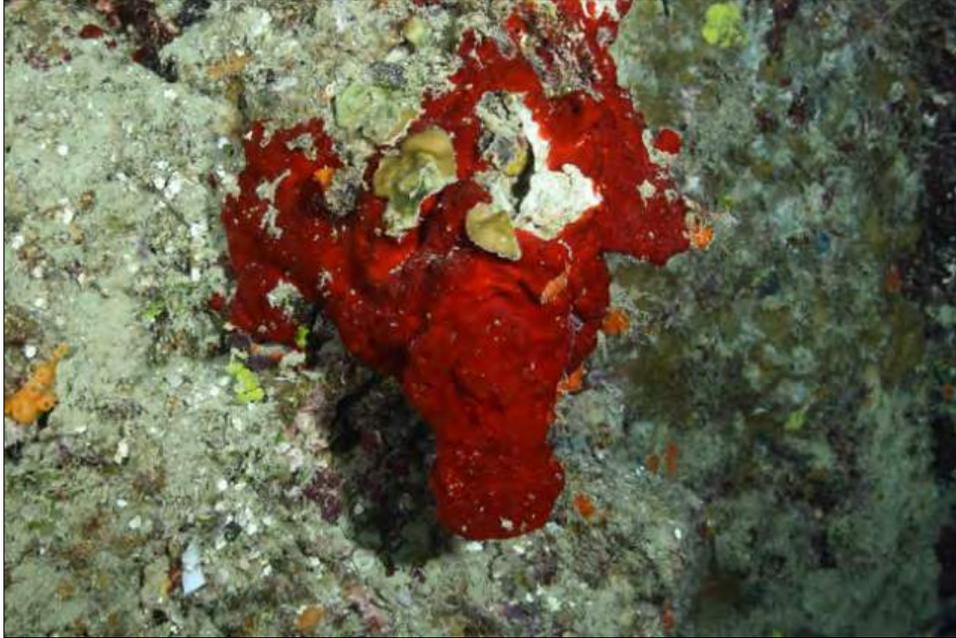
During the assessment dive teams recorded areas of higher coral abundance for the subsequent focus of collection efforts. Higher densities of healthy stony corals occurred along the eastern and western ends of the wharf and adjacent shallow rock shelves than on the long southern wharf face. These healthy corals included *Pavona decussata*, *Pocillopora damicornis*, *Porites cylindrica*, *Porites rus*, and several species of “massive” *Porites*. Along the southern side of the wharf the density of living corals was much lower and dominant species included *Pocillopora damicornis*, *Astreopora cucullata*, *Astreopora gracilis*, *Lobophyllia hemprichii*, *Lobophyllia corymbosa*, and several massive *Porites* species. The *P. damicornis* colonies were nearly all found within the upper 2 m depths on the wharf face. The *Astreopora* and massive *Porites* colonies were observed along the deeper sections of the wharf face and attached to debris on the surrounding seafloor, while the *Lobophyllia* occurred primarily on the deeper face of the wharf. More than 2 dozen dead or nearly dead colonies of *Lobophyllia* spp. were observed on the wharf face along with numerous other unidentified dead and bioeroded coral colonies. Most of these dead or dying colonies were covered with varying amounts of silt and encrusting sponges (**Photos 2 and 3**).

Photo 3. Unidentified dead coral encrusted with sponge.

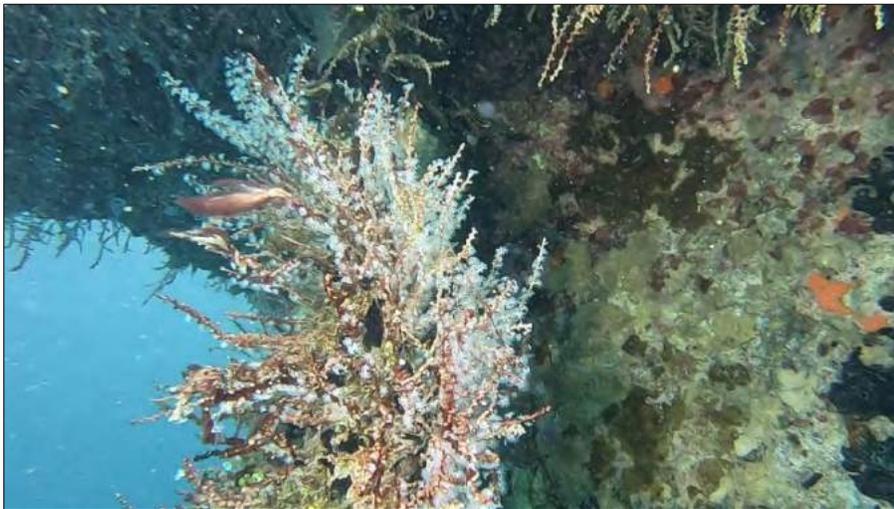
A clump of the invasive octocoral *Carijoa riisei* was identified at the southeastern corner of the wharf below the upper ledge at about 1.5 m depth (**Photo 4**). As its distribution was limited to this specific area, divers carefully detached all visible pieces of the colonies, placed them in a fine-mesh bag, and delivered the colonies to DCA for appropriate disposal.

Photo 4. The invasive octocoral *Carijoa riisei* on southeastern corner of wharf.

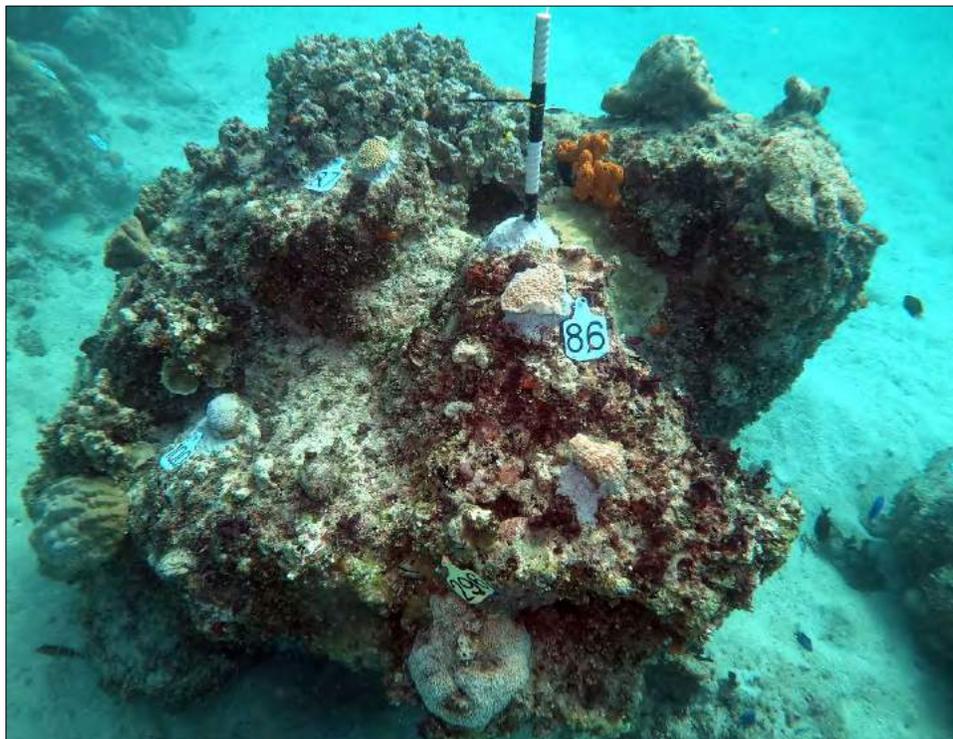
Photo 5. Marker rod embedded in rock at Site 7 along with corals tagged for monitoring.

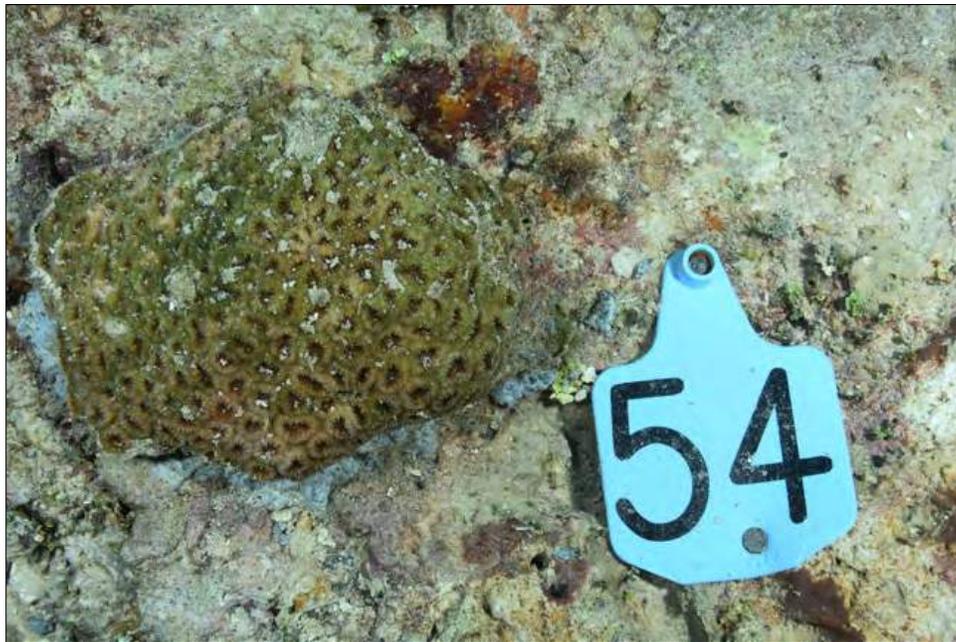
Paling tissue was the second most frequently recorded condition on monitored corals and was observed on 52 relocated corals (39.4%) and only 22 reference corals (21.8%). The paling was most commonly observed as isolated areas on colony tissues (**Photo 6**), although large portions of nearly all of the *Pocillopora damicornis* reference colonies in shallow water were pale (**Photo 7**).

Photo 6. A reattached colony of *Favia matthai* with patches of pale tissue.

A higher percentage of the tagged relocated corals showed tissue paling (39.4%) compared to the tagged reference corals (21.8%). This could be partially due to declining health conditions of the corals removed from the southward-facing side of the wharf where four large barges and an offshore supply vessel have been tied off for an extended period, causing a significant reduction in sunlight reaching corals. The shading caused by the vessels, and possible resultant stress to shaded corals, could be a contributing factor in the lower number of corals identified and relocated from the project area compared to the higher number estimated as available for relocation in the Compensatory Mitigation Plan. There were several dozen nearly dead colonies observed on the wharf face, especially from mid-depths down to the seafloor, which were not relocated because of their poor condition. Many other dead colonies, fouled with silt, encrusting sponges and algae, were also observed on the face of the wharf.

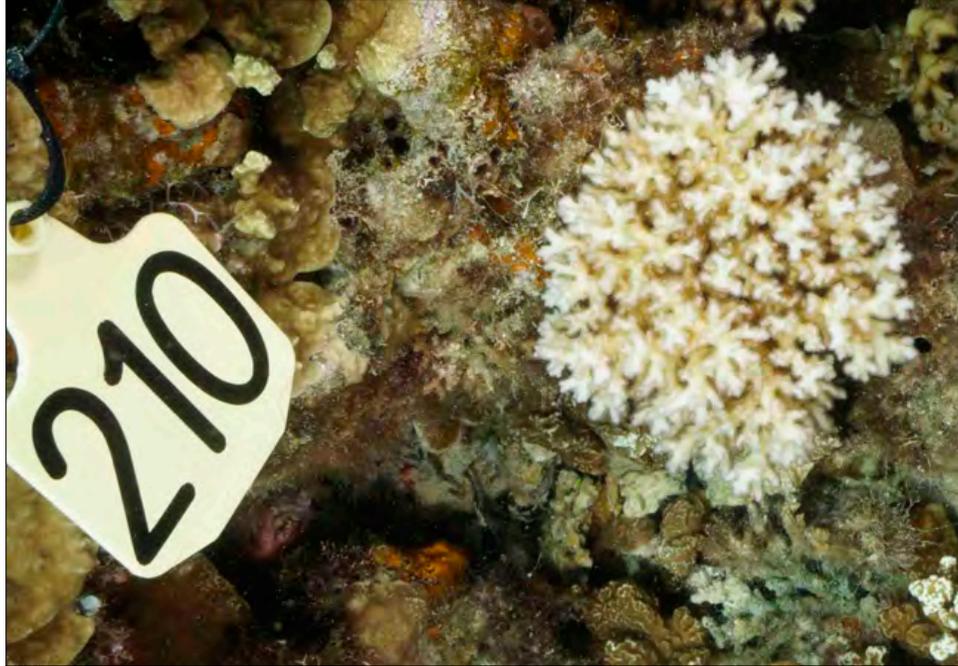
Photo 7. A reference colony of paling *Pocillopora damicornis* in shallow water.

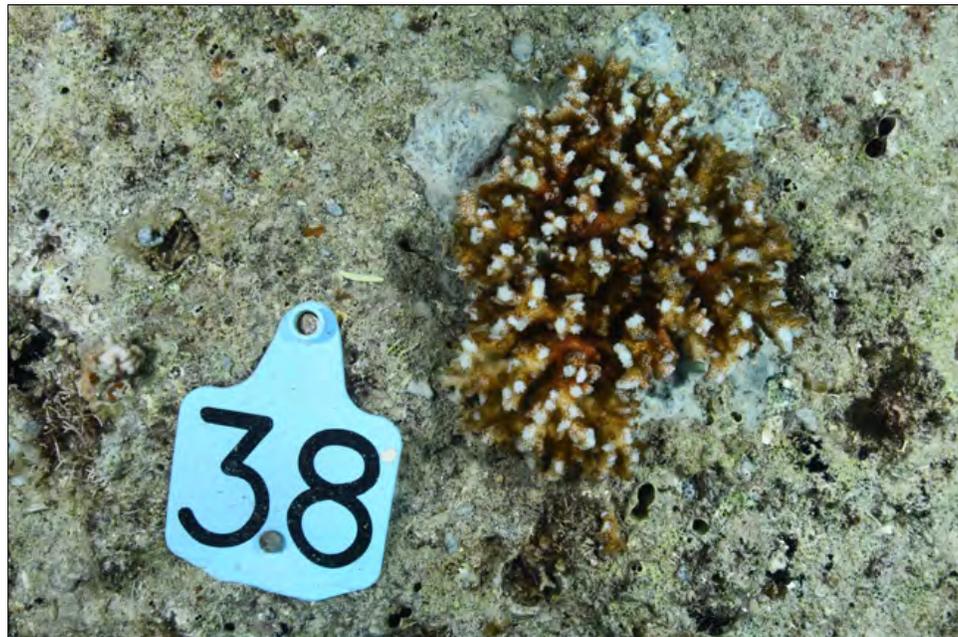
Bioerosion included two different types of damage - the grazing of coral tissue by parrotfish and the intrusion of the boring bivalve *Lithophaga* sp. Relocated colonies of *P. damicornis* were noticeably impacted by parrotfish nipping the tips off of branches shortly after reattachment (**Photo 8**). *Lithophaga* was observed in nearly all colonies of massive *Porites* sp. greater than approximately 15 to 20 cm diameter, with abundance generally increasing with colony size (**Photos 9 and 10**).

Photo 8. A reattached colony of *Pocillopora damicornis* with branch tips eaten by parrotfish.

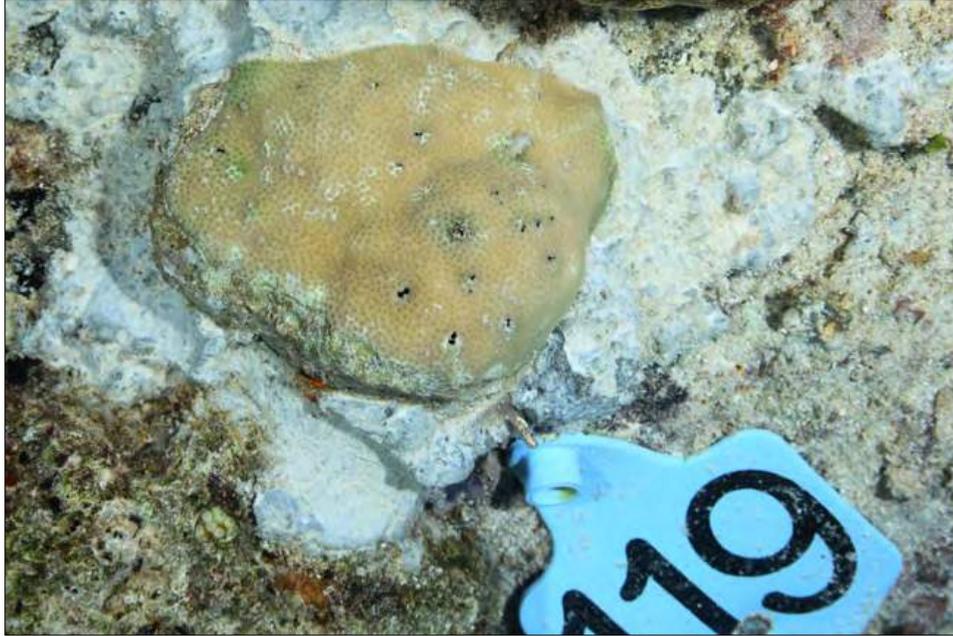
Photo 9. A small colony of *Porites lobata* with the boring bivalve *Lithophaga* sp. (small dark dumbbell-shaped holes).

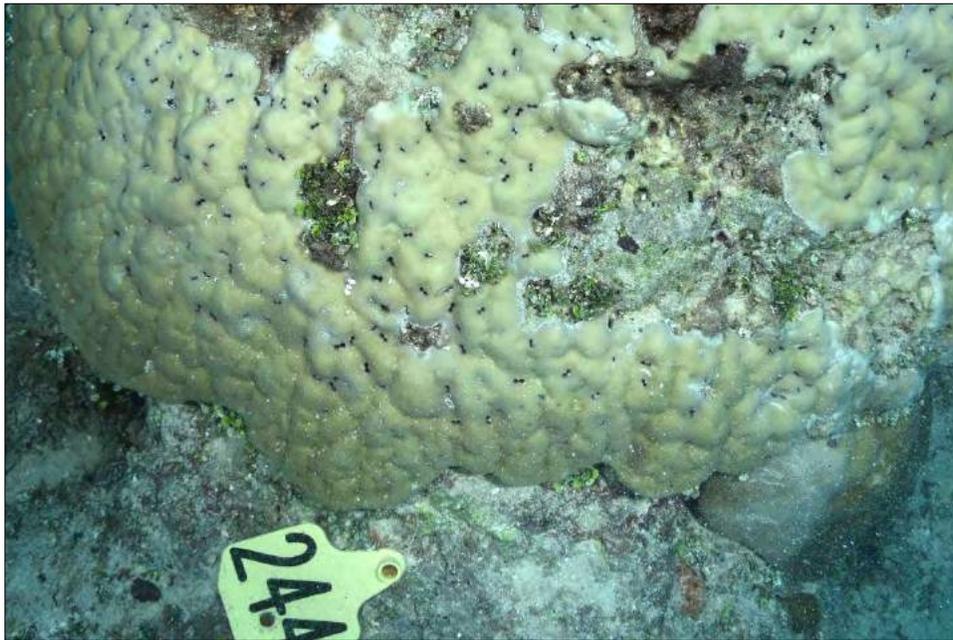
Photo 10. A large colony (71 cm diameter) of *Porites lobata* with high abundance of *Lithophaga* sp.

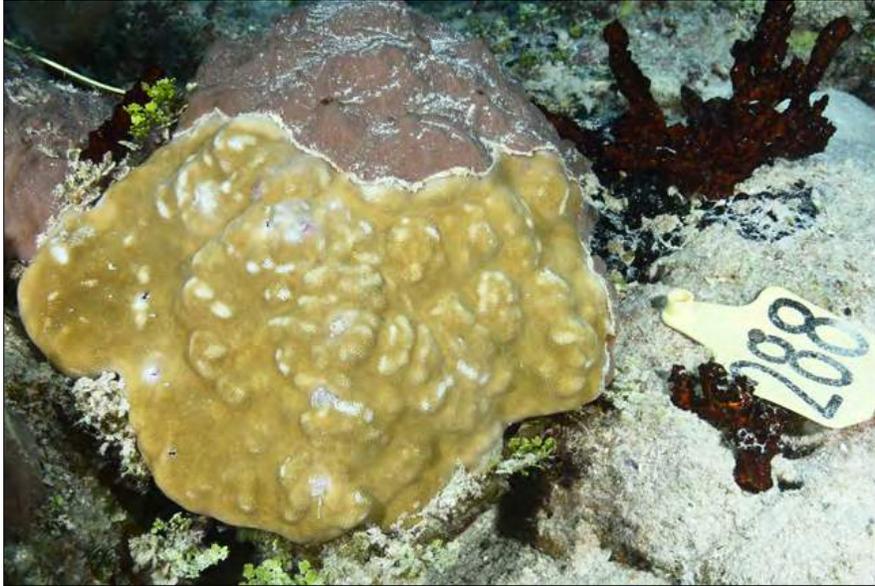
observed in high abundance on reef substrate at the deeper reattachment sites, in many cases overgrowing healthy coral colonies (**Photo 11**).

Photo 11. The sponge *Clathria eurypa* (brown) overgrowing the top of a colony of *Porites lobata*.

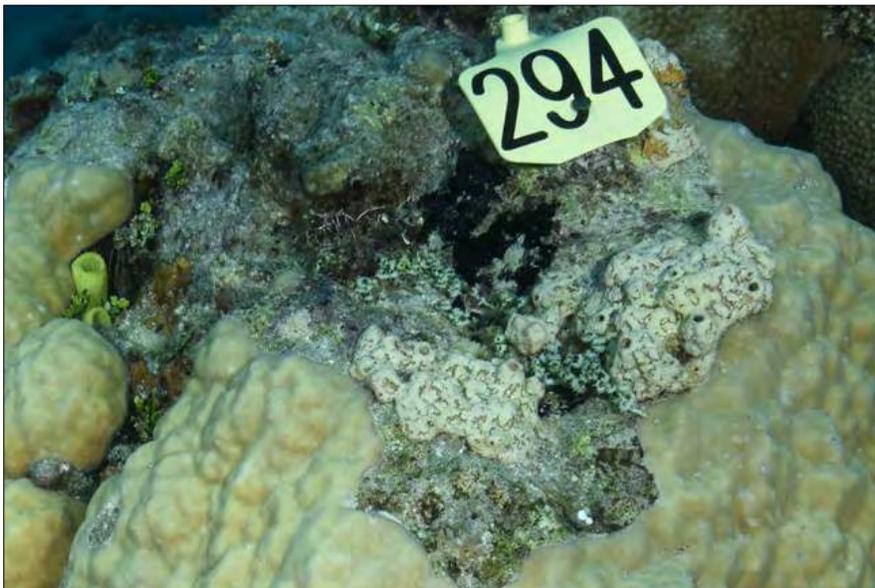
Tissue loss was primarily due to branch or column breakage/fragmenting during the removal process. In most cases the branch fragments were also relocated. Tunicate overgrowth was observed but uncommon for both relocated and reference corals. Reference coral #294 (**Photo 12**) exhibited sponge (*Liosina granularis*) and algae (*Caulerpa serrulata*) overgrowth, as well as the yellow tunicate (*Phallusia julinea*).

Photo 12. The coral *Porites lutea* with a yellow tunicate (*Phallusia julinea*; left), the beige-colored sponge *Liosina granularis* (right), and the green algae *Caulerpa serrulata* (center).
