## 2023 Master Plan

# Jose D. Leon Guerrero Commercial Port of Guam 2023 Master Plan

Prepared by:  
WSP  
Guam International Trade Center  
South Marine Corps Drive, Suite 808  
Tamuning, Guam 96913  
Telephone: 671-646-6872

# Port Authority of Guam Facility Condition Assessment Report Berths F2, F3, F4, F5, and F6

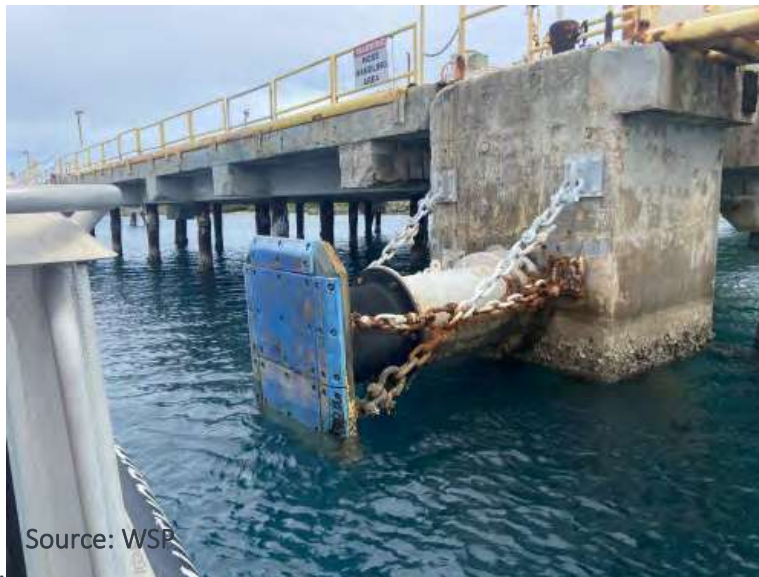
Overall, Golf Pier is in **serious** condition. See Photo 31 and Photo 32. Major and severe corrosion of steel piles is present at multiple locations. Open- and close-corrosion spalls are present at multiple concrete pile cap locations. Moderate to major corrosion is present at multiple mooring bollards. At the walkways east and west of the pier leading to the breasting dolphins, severe corrosion of the steel walkway was observed. Walkways leading to the mooring dolphins northwest and northeast of the pier are missing. For this reason and because ladders are not present, crews are unable to use the mooring dolphins to tie off vessels. For these reasons, managers at Mobil Oil Guam have expressed concern related to fire escape paths for crews. If a fire were to occur on the main pier, the distance between the east and west breasting dolphins and the main pier does not provide a sufficient distance for crews to muster.

**Photo 31: Golf Pier (Pier and Breasting Dolphin)**

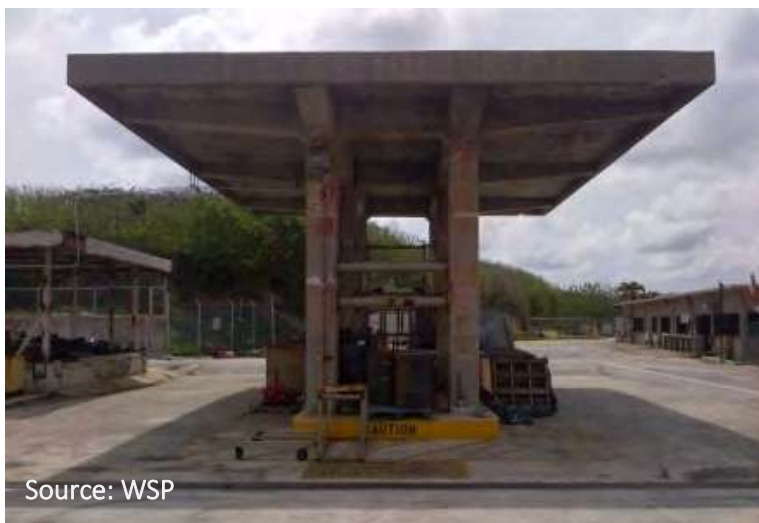
**Photo 36: Truck Loading Facility**

The loading rack structure is in **good** condition with isolated areas of concrete spalling. All of the piping has been removed on the rack and the existing piping underground appears to be in **poor** condition. The layout of the facility allows the movement of service vehicles near to the tanks within the internal road network. See Photo 36.

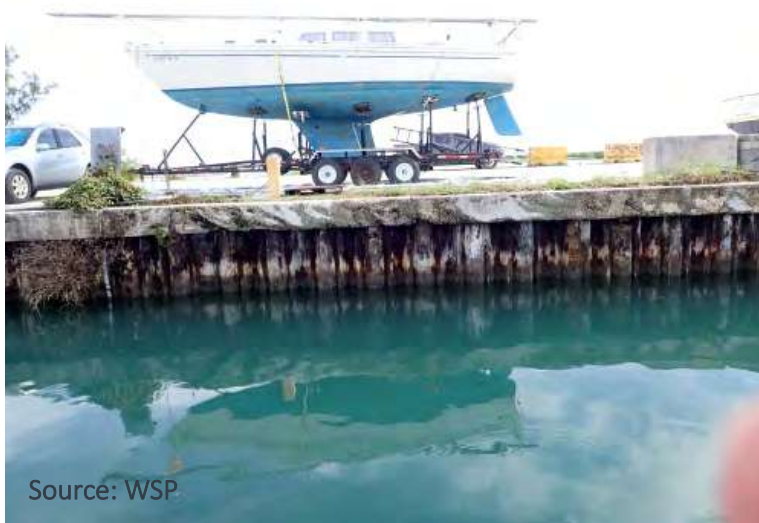
**Photo 46: GDP Marina (Deteriorated Sheet Pile Wall)**

In general, GDP Marina is in **poor** condition. Widespread corrosion of the sheet pile wall at the breakwater is present above the water line. From discussions with PAG staff, it is understood that Phase 3 repairs to replace the severely deteriorated sheet pile wall is being discussed. Erosion of the slope armoring on the north side of the breakwater is present. Failure or partial failure of this structure may impact the ability for vessels to enter/exit the marina. At several locations, floats are listing and present a safety hazard to pedestrians. See Photo 45, Photo 46, and Photo 47.

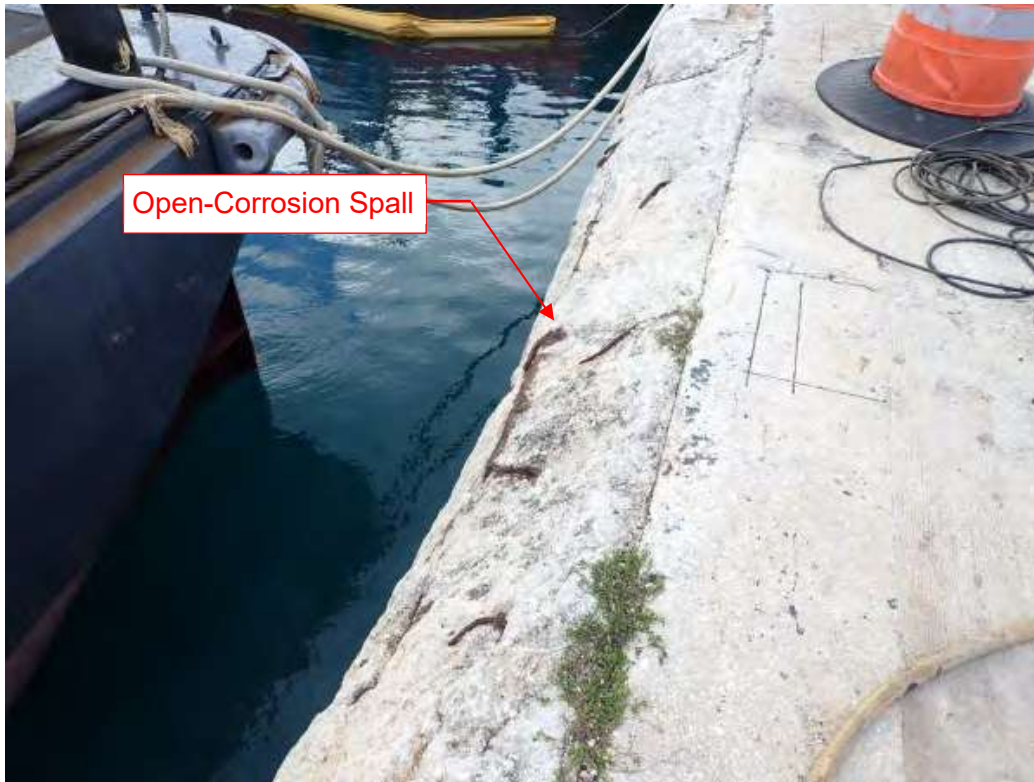
**Photo 3 – Berth F2 Typical Concrete Pile Cap**

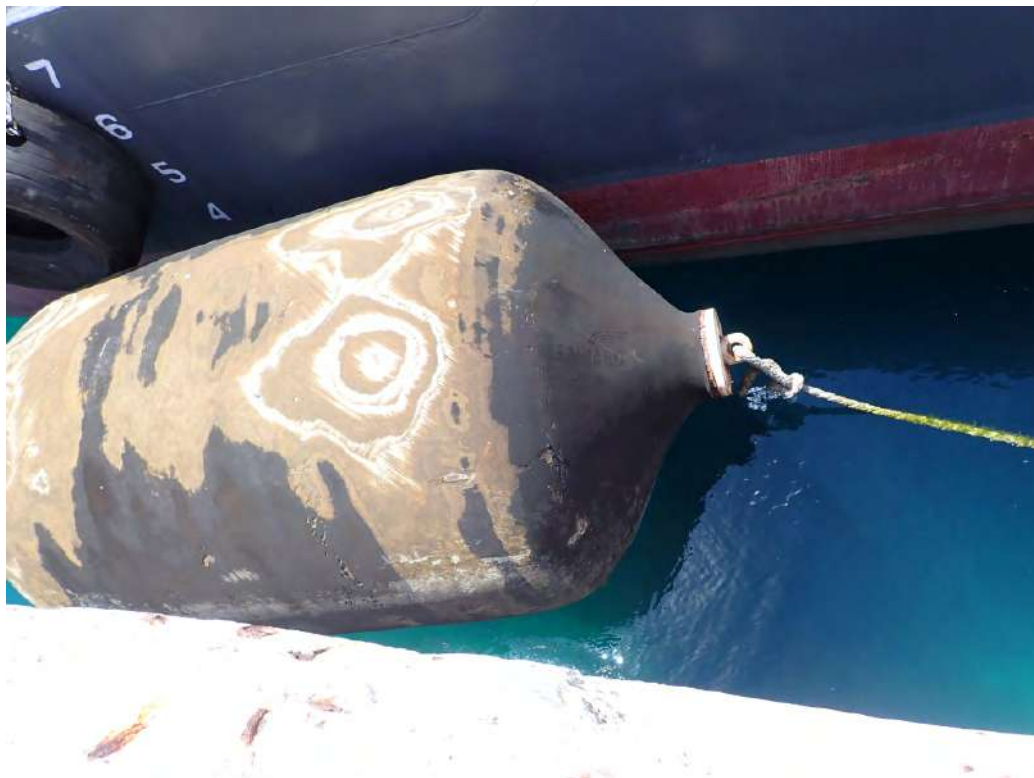
**Photo 4 – Berth F2 Typical Floating Pneumatic Fender**

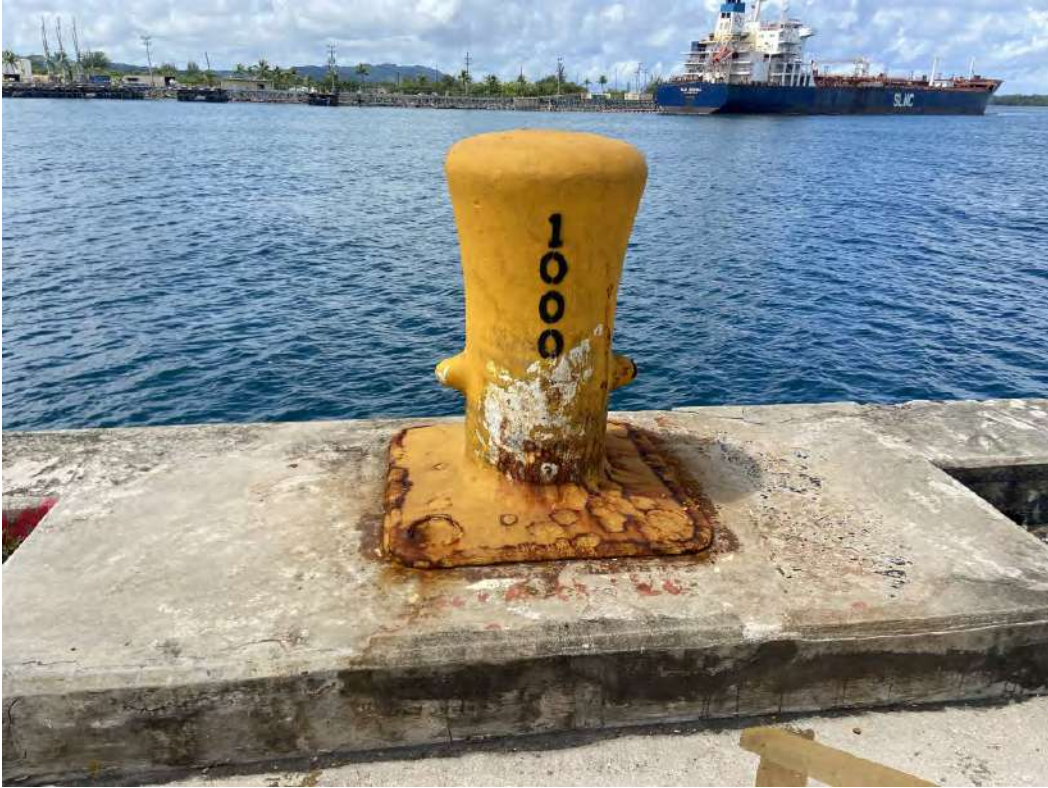
Photo 9 – Berth F4 Typical Corrosion at Mooring Hardware

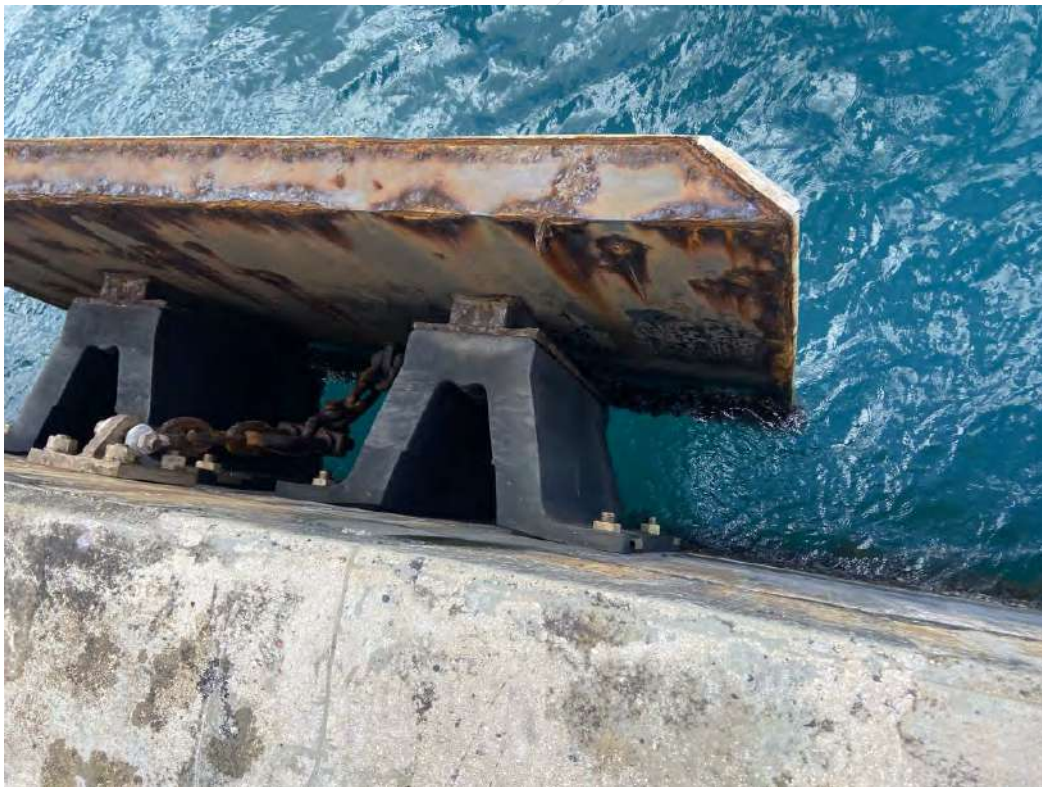
**Photo 12 – Berth F4 Typical Fender Panel**

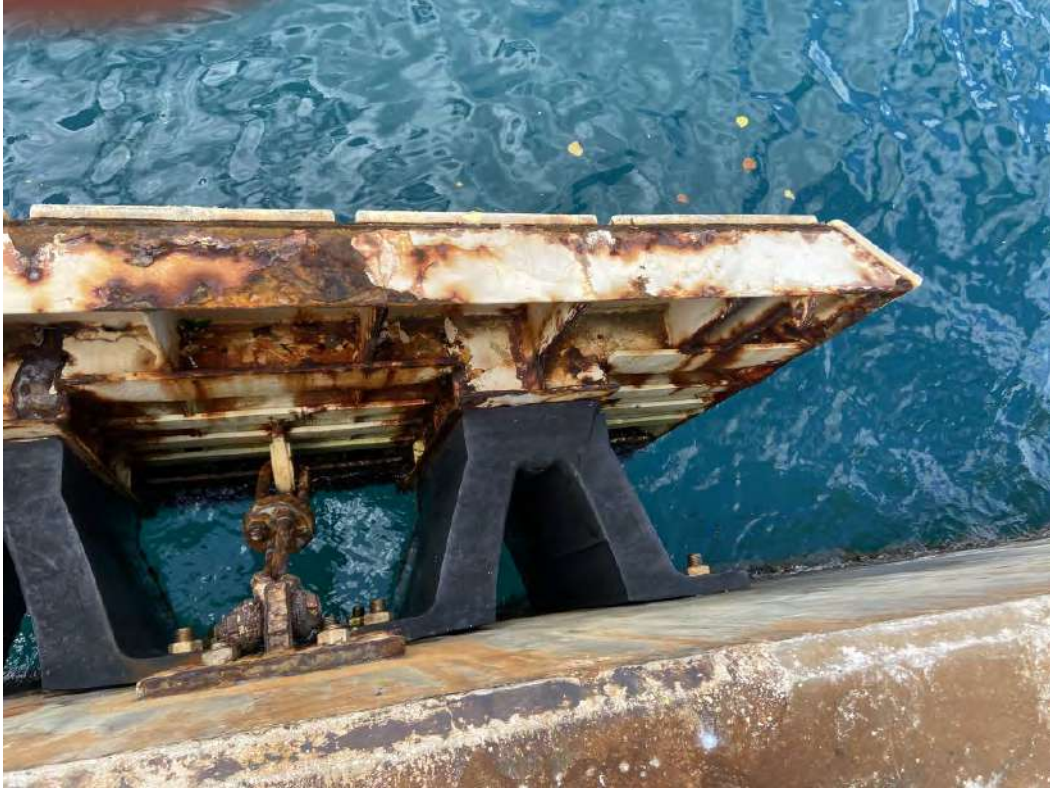
**Photo 15 – Typical Fender Panel**

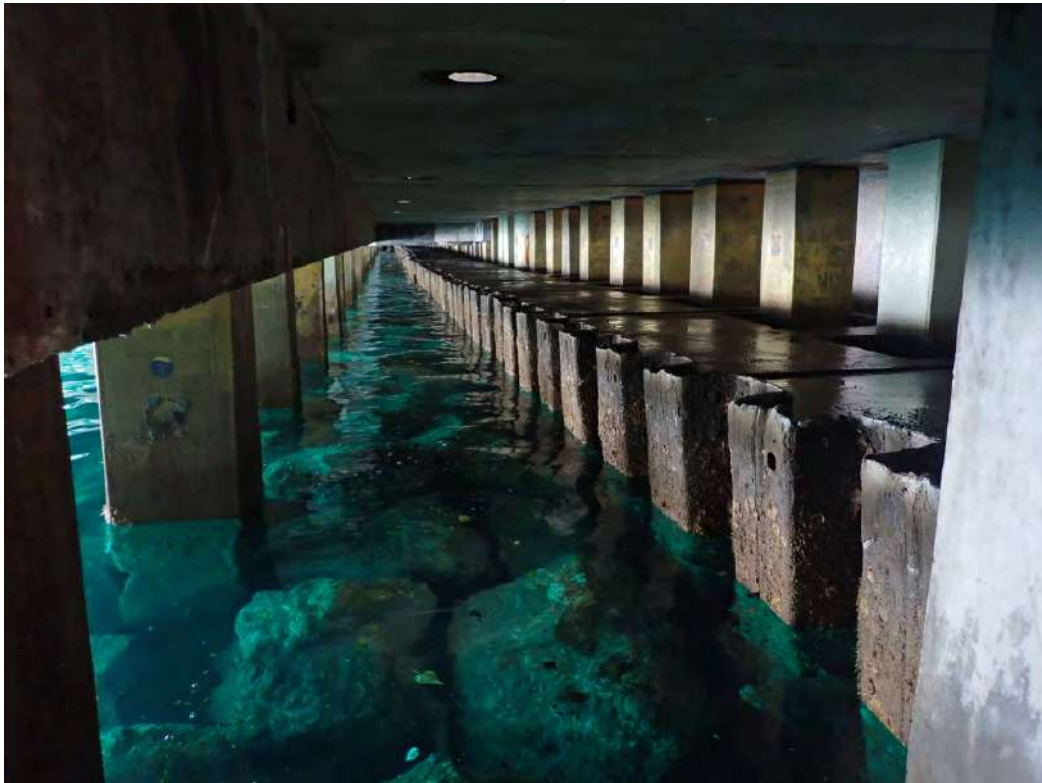
**Photo 18 – Typical Landside Sheet Pile Wall**

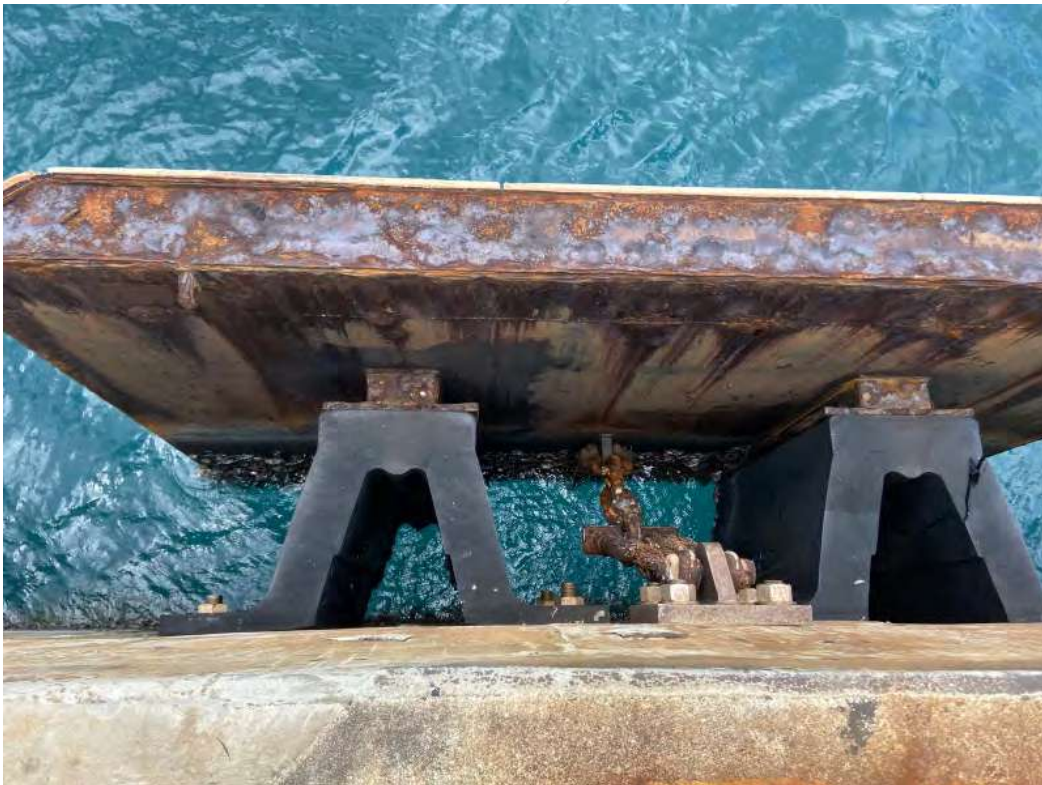
**Photo 22 – Typical Fender Panel**

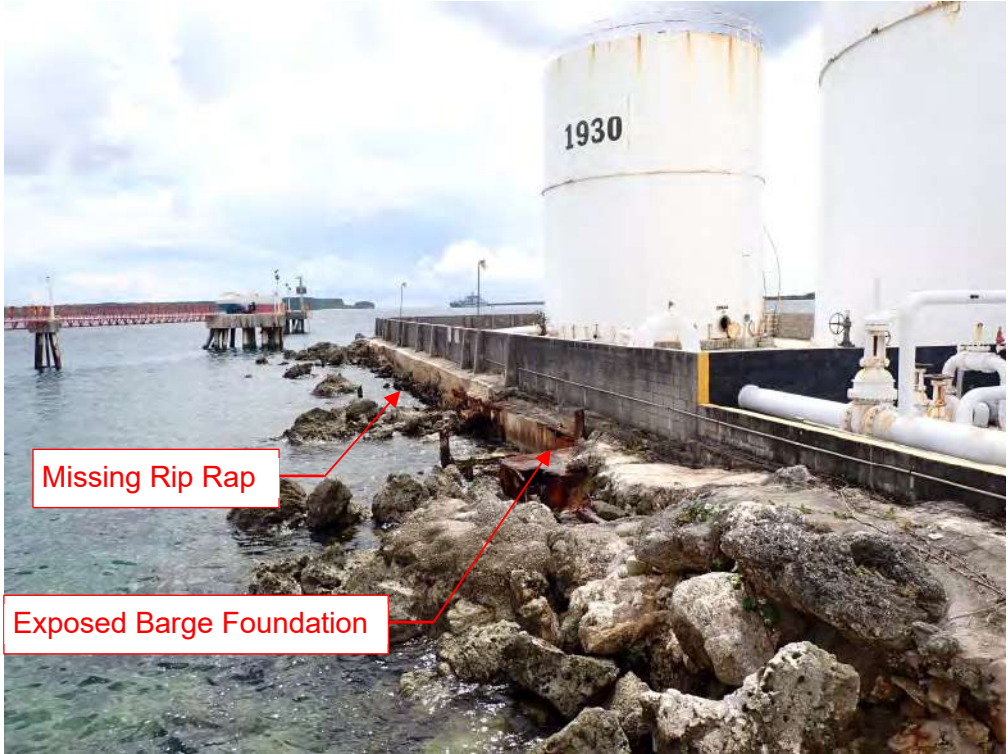
**Photo 5 – Peninsula West of Trestle**

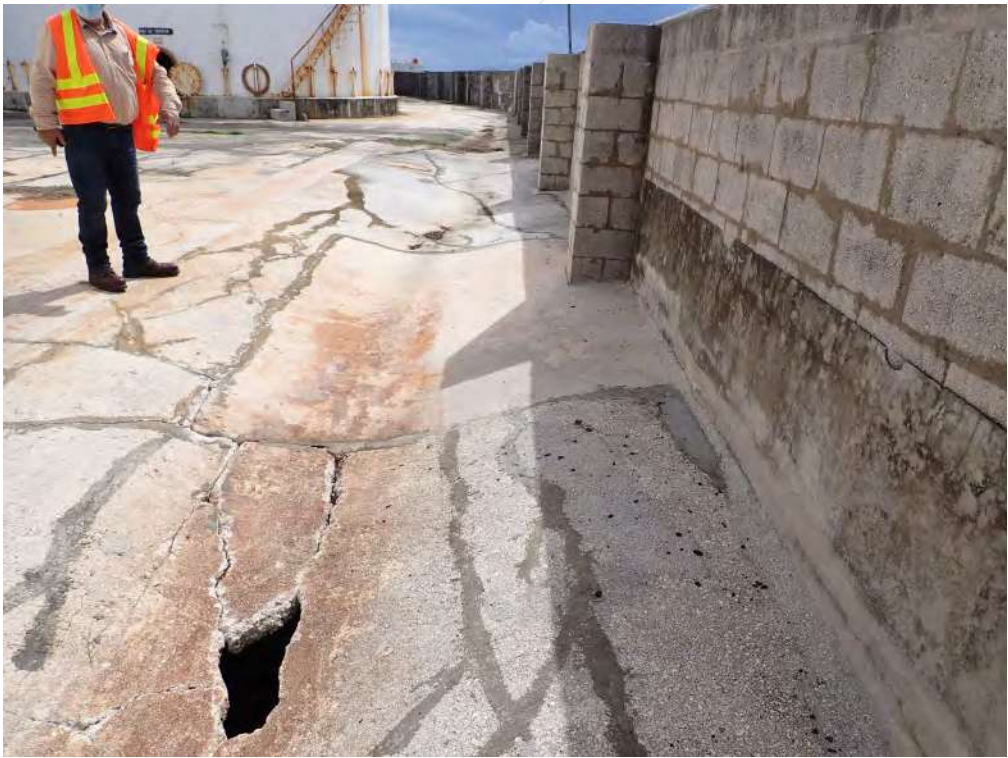
**Photo 6 – Void and Settlement at North Side of Peninsula**
