## 2023 Master Plan

# Jose D. Leon Guerrero Commercial Port of Guam 2023 Master Plan

Prepared by:  
WSP  
Guam International Trade Center  
South Marine Corps Drive, Suite 808  
Tamuning, Guam 96913  
Telephone: 671-646-6872

# Port Authority of Guam Facility Condition Assessment Report Berths F2, F3, F4, F5, and F6

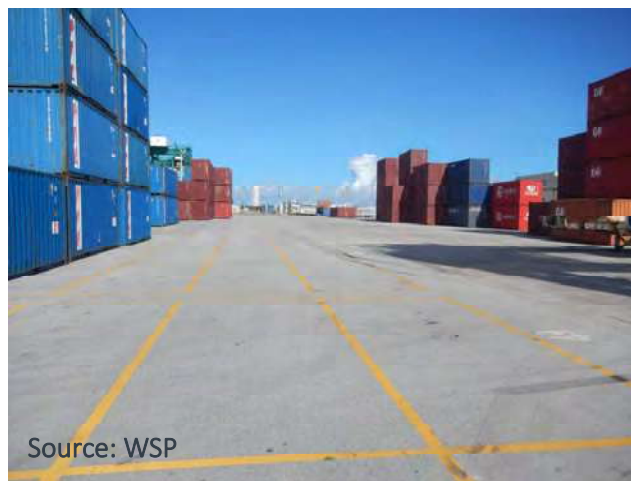
**Photo 2: Grounded Storage Area in Yard**

Berths F4 to F6 are located along a 1,950 foot marginal wharf with a depth of 37 feet that accommodate container ships and general cargo vessels. See Photo 2 for a typical photo of the grounded storage area.

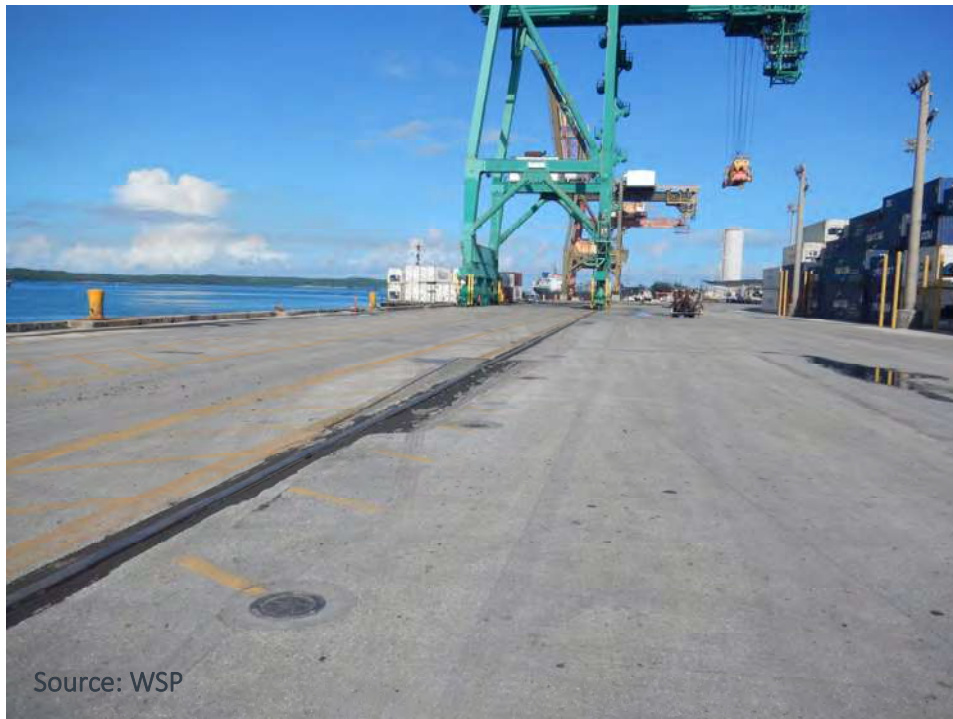
**Photo 7: Crane Rail**

In 1970, a 50-foot-gauge ship-to-shore crane rail was constructed at Berths F4, F5, and F6. The concrete rail girders, measuring 2 feet x 2'-6" in cross section are supported on vertical steel H piles spaced at nine feet on-center. Piles are located between tie rods which prevent outward deflection of the sheet pile wall. The rail is transversely supported by concrete beams spaced at 54 feet on-center for the full length of the crane rail. The crane rail structure is supported independently of the wharf structure. See Photo 7.

During the 1993 earthquake, a portion of the crane rail was damaged. The lateral movement of the wharf structure caused the crane rail to move laterally and sustain permanent (plastic) deformation. New piles were added after the earthquake in order to repair the crane rail. Additional piles were installed and spaced at nine feet on-center, staggered between existing piles. The existing concrete rail beams were widened to correct the alignment of the rails. The extent of the repair to the crane rail matched the length of the pile-supported wharf that was built to replace the damaged portion of the original 560-foot sheet pile wall.

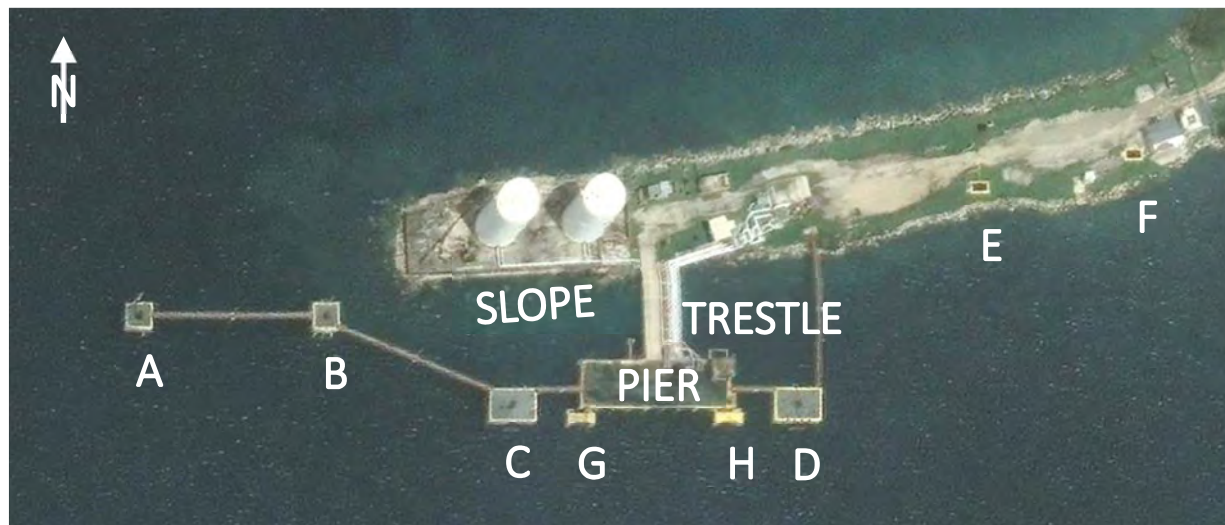
Figure 4-13: Pier F1

The pier is in **serious** condition. Several elements have severe damage consisting of spalled concrete, open corrosion spalls, bent piles, sheared piles, split piles, and non-functional fender systems. At multiple locations, failed pile repairs are present at the pile to pile cap interfaces. Open- and close-corrosion spalls were also observed at the main pier and trestle. Slope protection is in fair condition. The peninsula area west of the trestle was constructed on reclaimed land and is founded on sunken barges. Along the south shoreline west of the trestle, approximately 200 feet of rip rap is missing. At this location, portions of corroded steel barges are visible. Along the north side of the peninsula, a void is present beneath the concrete slab-on-grade which has settled. See Photo 25, Photo 26, and Photo 27. A detailed condition assessment report for Berth F1 is provided in Appendix C.

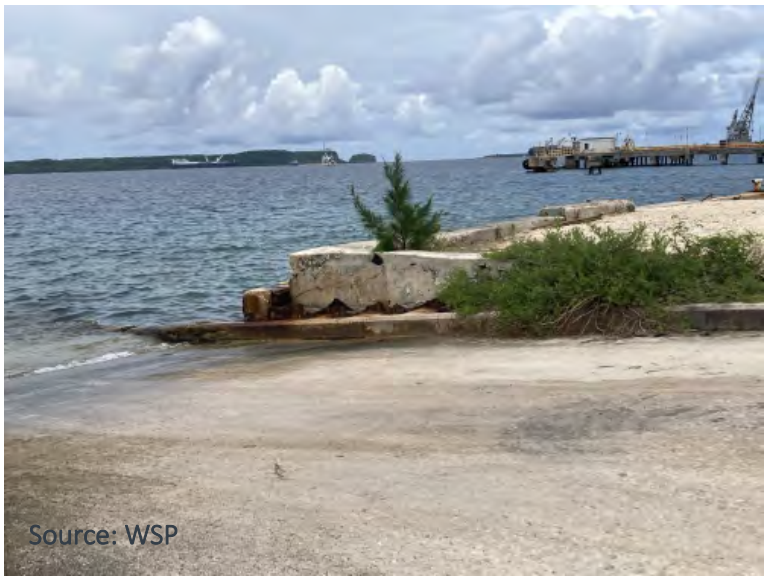
**Photo 30: Seaplane Ramp**

In general, the ramp is in **poor** condition. Major cracking and delamination of the concrete is present at multiple locations. Similarly, mechanical spalling and closed corrosion spalling were also observed at the top of the bulkhead and adjacent to mooring hardware. See Photo 29 and Photo 30.

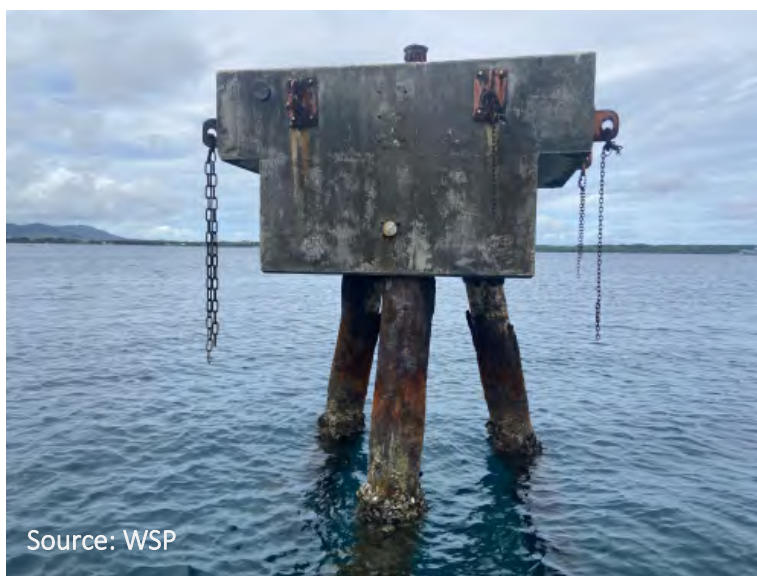
Overall, Golf Pier is in **serious** condition. See Photo 31 and Photo 32. Major and severe corrosion of steel piles is present at multiple locations. Open- and close-corrosion spalls are present at multiple concrete pile cap locations. Moderate to major corrosion is present at multiple mooring bollards. At the walkways east and west of the pier leading to the breasting dolphins, severe corrosion of the steel walkway was observed. Walkways leading to the mooring dolphins northwest and northeast of the pier are missing. For this reason and because ladders are not present, crews are unable to use the mooring dolphins to tie off vessels. For these reasons, managers at Mobil Oil Guam have expressed concern related to fire escape paths for crews. If a fire were to occur on the main pier, the distance between the east and west breasting dolphins and the main pier does not provide a sufficient distance for crews to muster.

**Photo 32: Golf Pier (Non-Functional Mooring Dolphin)**

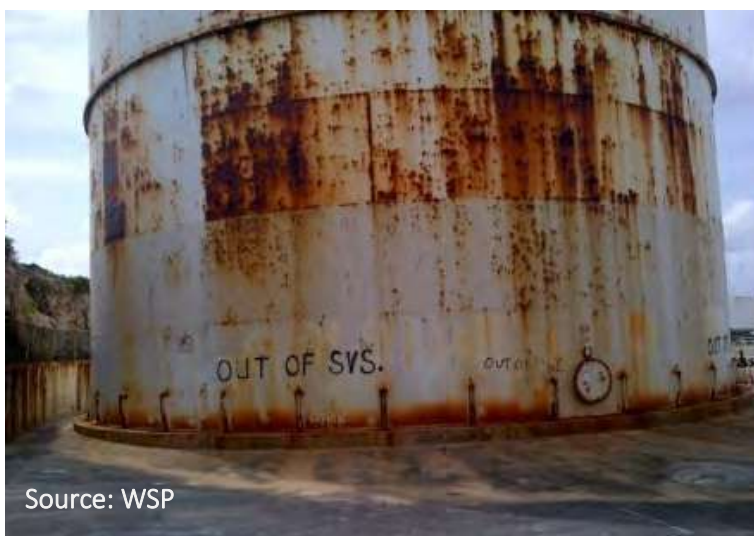
**Photo 35: Tank Farm A**

Tank Farm A is Port-owned and was previously managed by Mobil through a use agreement. It is located on the north side of Route 11, west of Industrial Avenue and within the Marine Industrial Complex. The area is comprised of seven tanks within containment walls. A majority of the tanks date to the 1960s and 1970s and have not had preventative maintenance performed since 2003. The newest tank was installed after Typhoon Paka in 1998 and received its final painting in 2002. The salt spray and the debris that has blown off the adjacent embankment has pitted the paint and accelerated corrosion. See **Error! Reference source not found.**

A cursory visual assessment of Area A was performed in August of 2021 and found the facility to be in **poor** condition. The pipes that supply the tank farm are disconnected at the wye that originates from Golf Pier. Most of the piping internal to the facility has been removed and what remains is not salvageable for use with the exception of the fire water supply lines for the facility. These lines may be salvaged for use in a new and upgraded fire protection system.

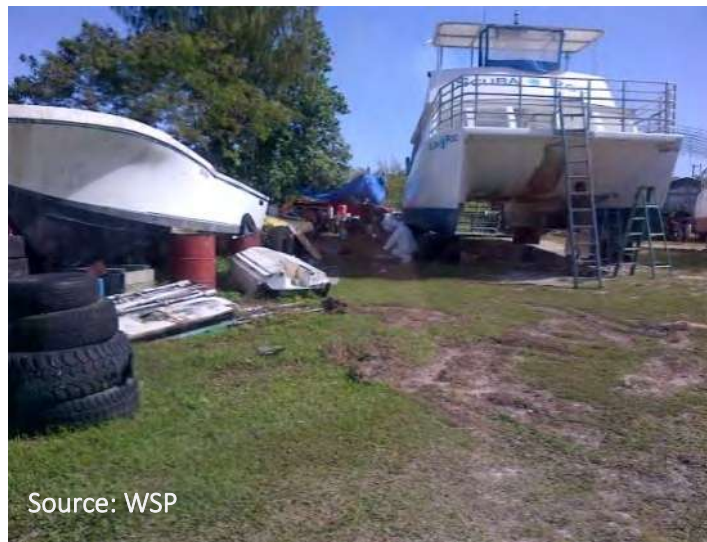
**Photo 43: Harbor of Refuge (Dry Dock Storage)**

As observed during the 2021 inspection effort, several boats are being stored in dry dock on the north side of the L-shaped finger. See Photo 42 and Photo 43. At some locations, the ground surface is not properly covered to contain sediment and spills from boats. Improper protection of the ground surface leaves the area vulnerable to sediment runoff or contamination by paint or cleaning chemicals that may be used.

may be prudent to install a boat haul-out and repair facility at the harbor. It is recommended that a user survey is conducted to collect data related to the need of such a facility, the frequency of boat inspections and repairs, and to understand what features are needed. The user survey should consider the potential elimination of the haul-out ramp at the Gregorio D. Perez Marina should that marina be reconfigured in the future for additional slip spaces.

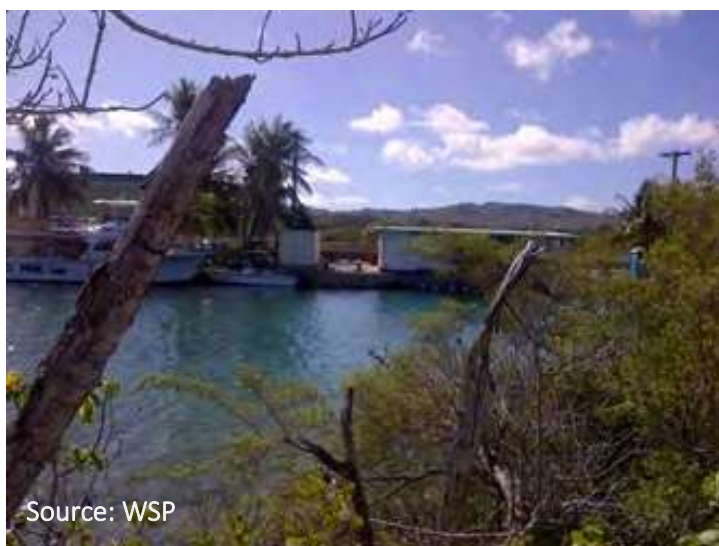
**Photo 44: Aqua World**

Adjacent to the Harbor of Refuge is the Aqua World Marina, an area leased and managed by Aqua World, Inc. Aqua World manages boat slips and landside leases. Sunken vessels are present at this marina resulting from previous typhoons and should be removed to prevent further leaching of chemicals into the water and damage that may occur to passer-by vessels.

Piti Channel is subject to sedimentation from currents and erosion from the shoreline. Depending on the need to maintain small boat passage, consideration should be given to conducting a hydrographic survey and planned dredging and bank protection. See Photo 44.

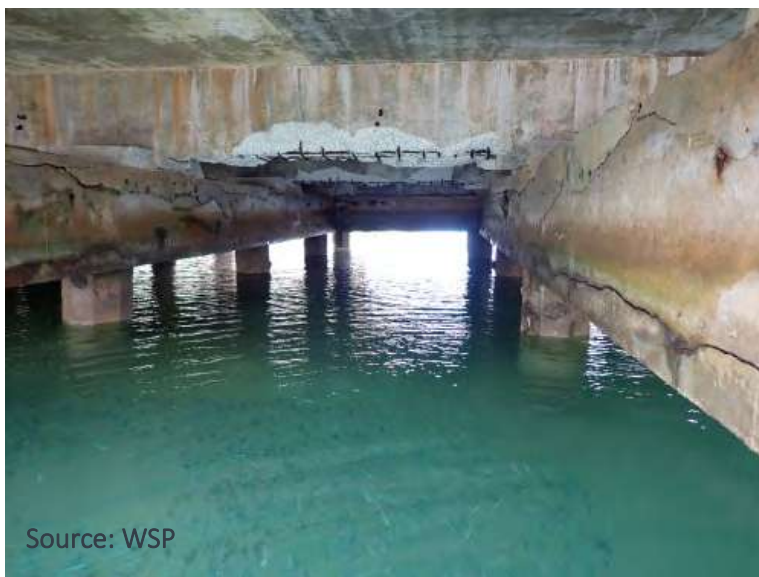
**Photo 49: Agat Small Boat Marina (Loading Pier)**

In general, Agat Marina is in **fair** condition. With exception of minor corrosion of the steel guide piles, damage at docks A, C, and D was not observed. Similarly, the breakwater and slope armoring to the east are in satisfactory to good condition with no noticeable defects. The northern pier at the boat ramp has major to severe damage. At several locations, vertical timber framing is missing and has been replaced with rubber tires suspended from the facing. The boat ramp is in satisfactory condition with only minor cracking observed. At the loading pier, severe damage consisting of cracking, and open- and closed-corrosion spalling are present at multiple locations. Due to the severe nature and extent of damage present, it is understood that this facility closed to pedestrian and vehicular use. A sanitary sewer pump-out is located adjacent to the boat ramp but is non-functional. See Photo 48, Photo 49, and Photo 50.

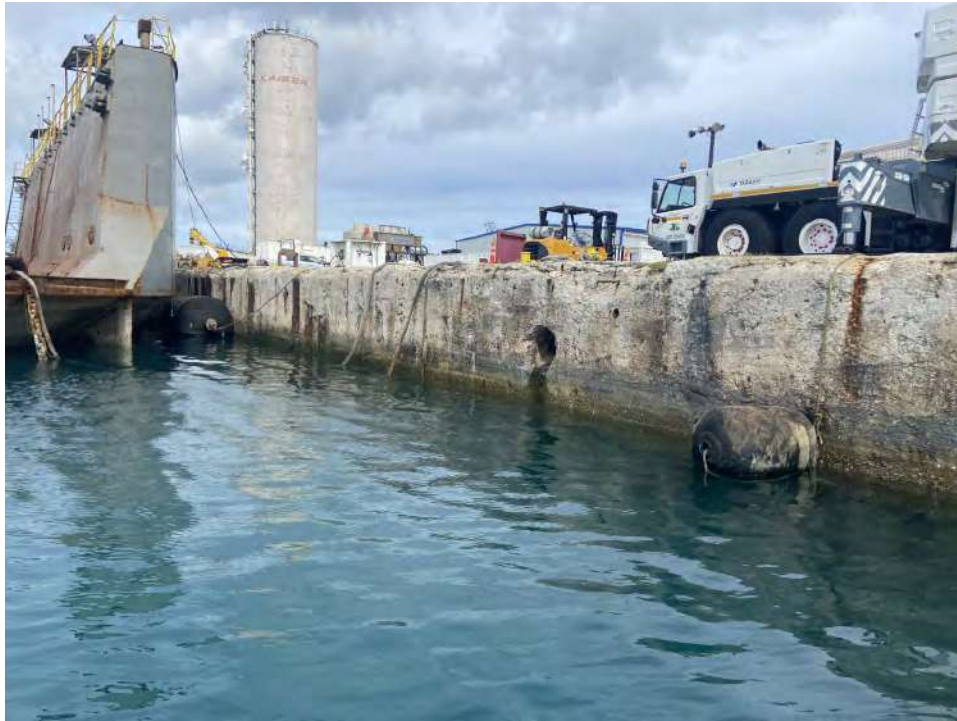
**Photo 1 – Berth F2**

The fender system at F2 consists of irregularly spaced rubber tires and floating pneumatic fenders. See Photo 1. At F3, the fender system is comprised of regularly spaced rubber tires and cylindrical fenders suspended from the bullrail. See Photo 2. At F4, F5, and F6, the fender system consists of regularly spaced fender panels backed by rubber arch fenders. See Photo 3, Photo 4, and Photo 5.

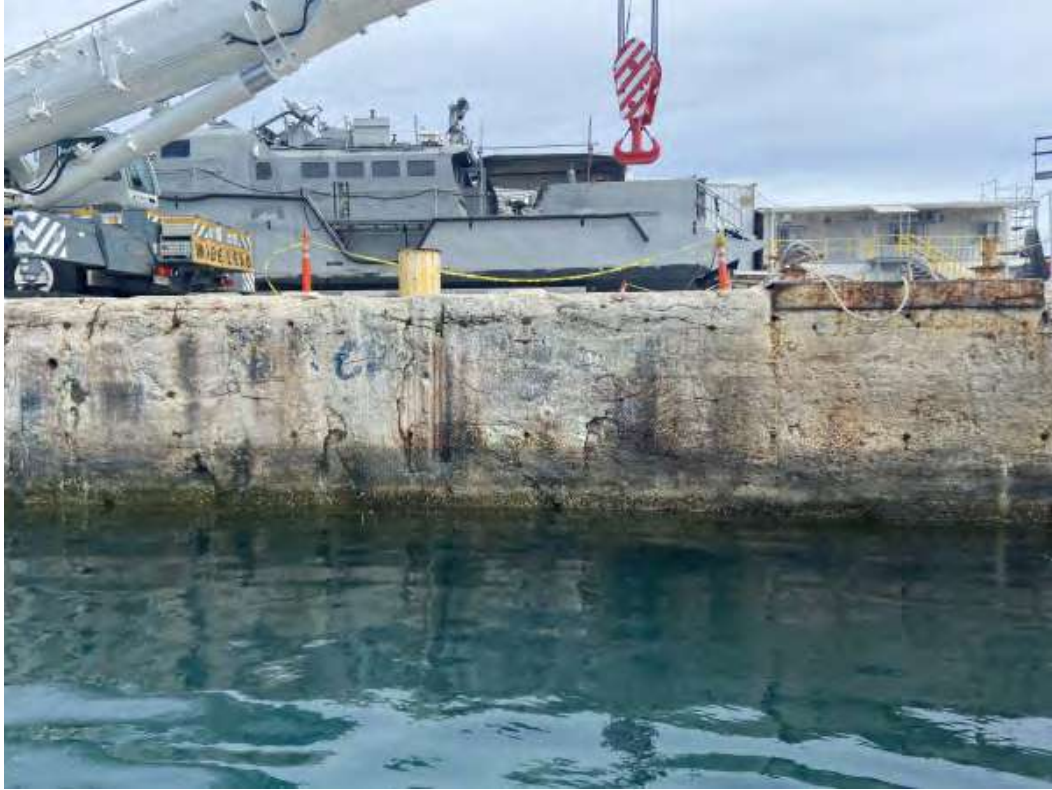
**Photo 1 – Berth F2 Typical Berth Face**

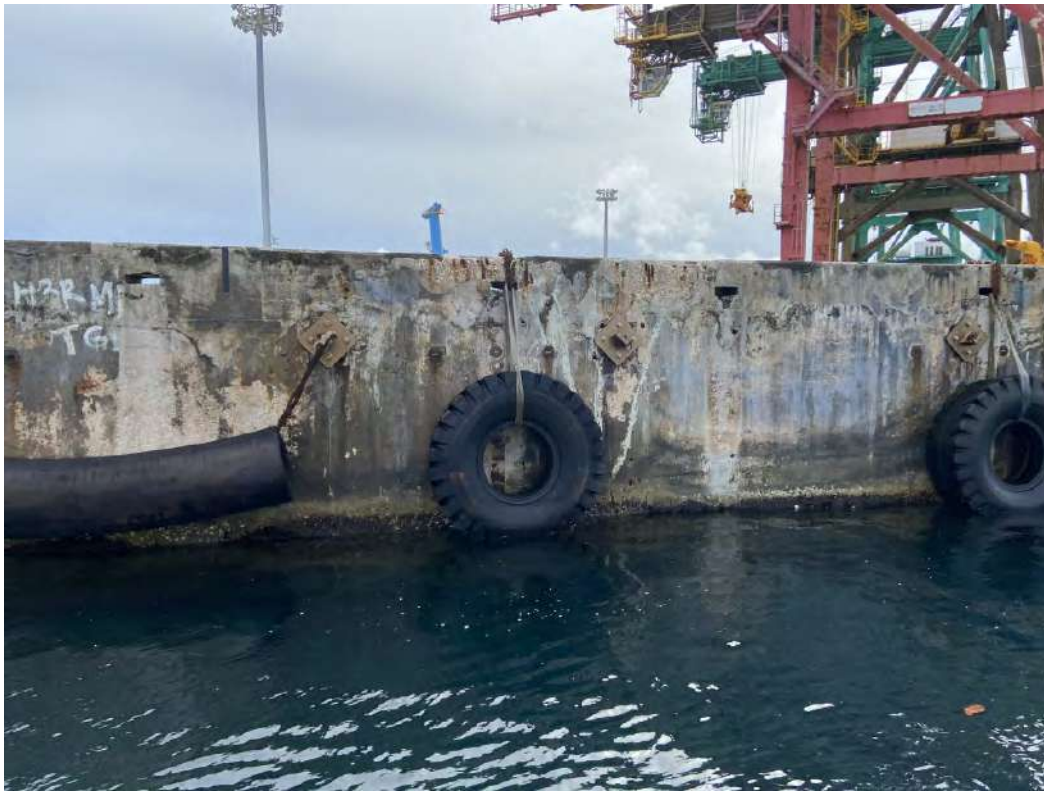
Photo 5 – Berth F3 Typical Berth Face

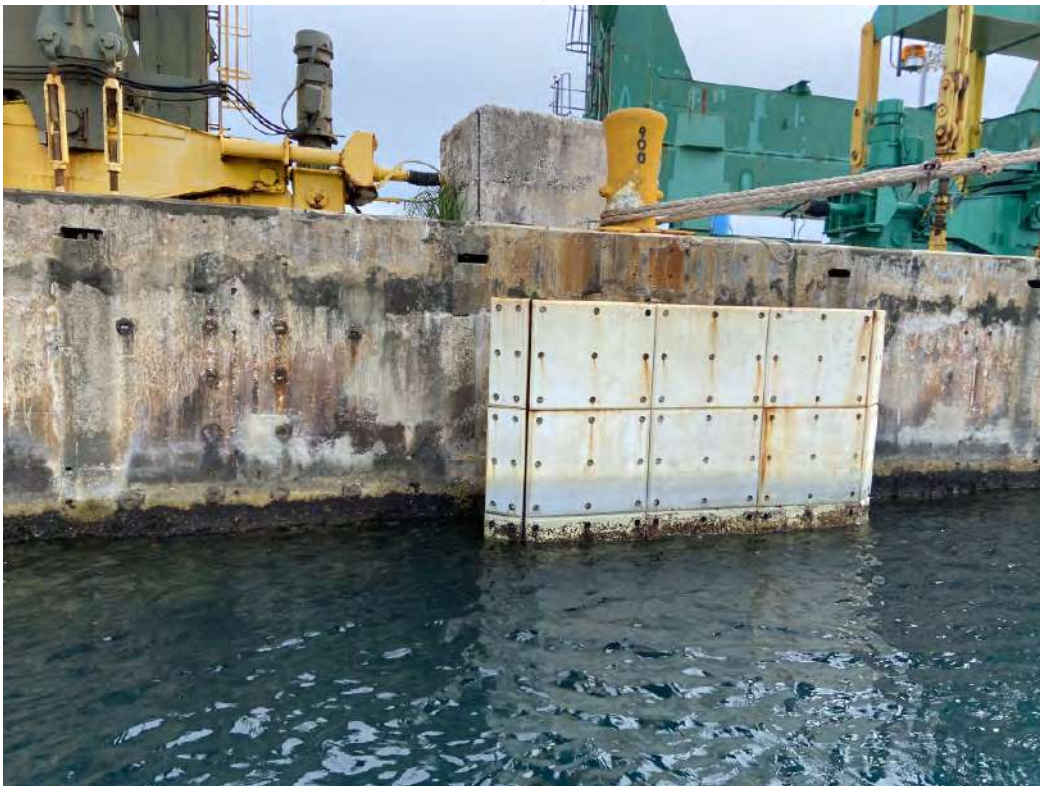
**Photo 8 – Berth F4 Typical Berth Face**

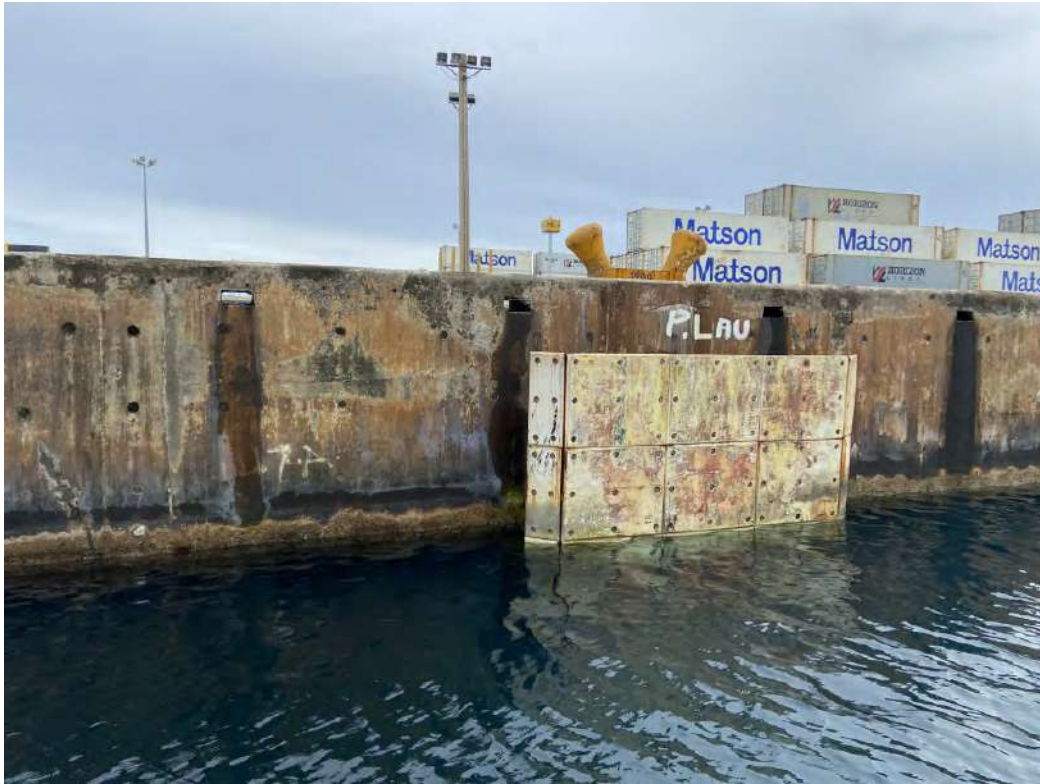
**Photo 13 – Berth F5 Typical Berth Face**

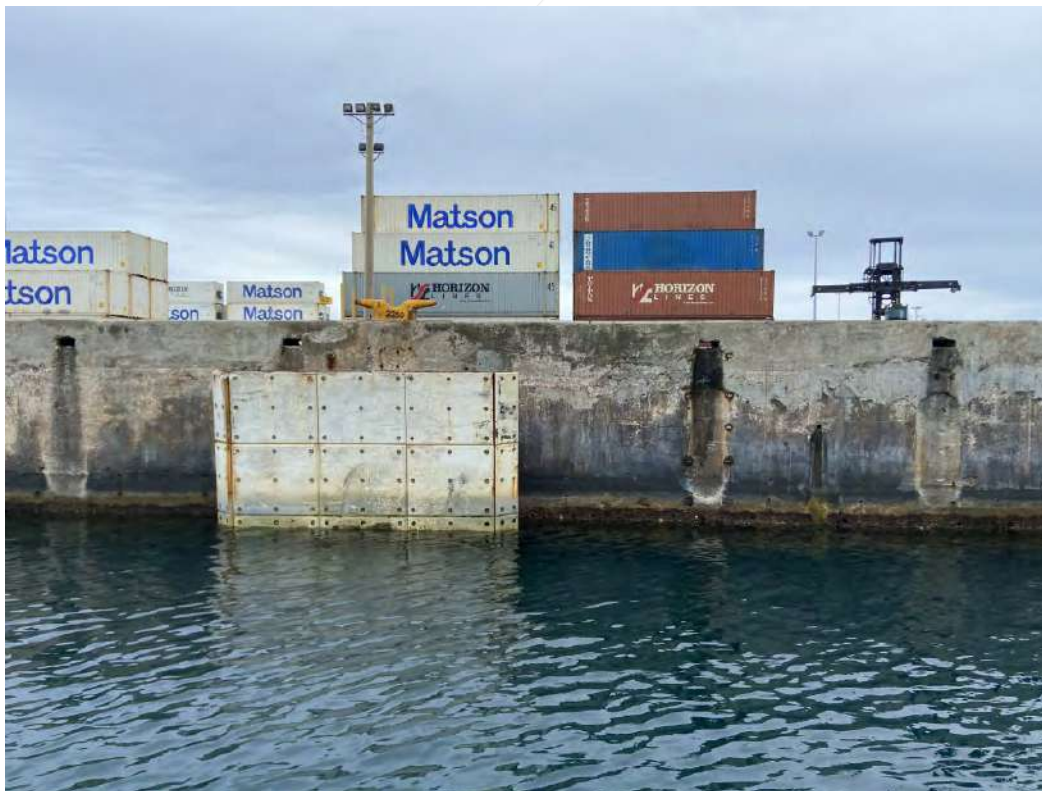
Photo 20 – Berth F6 Typical Berth Face

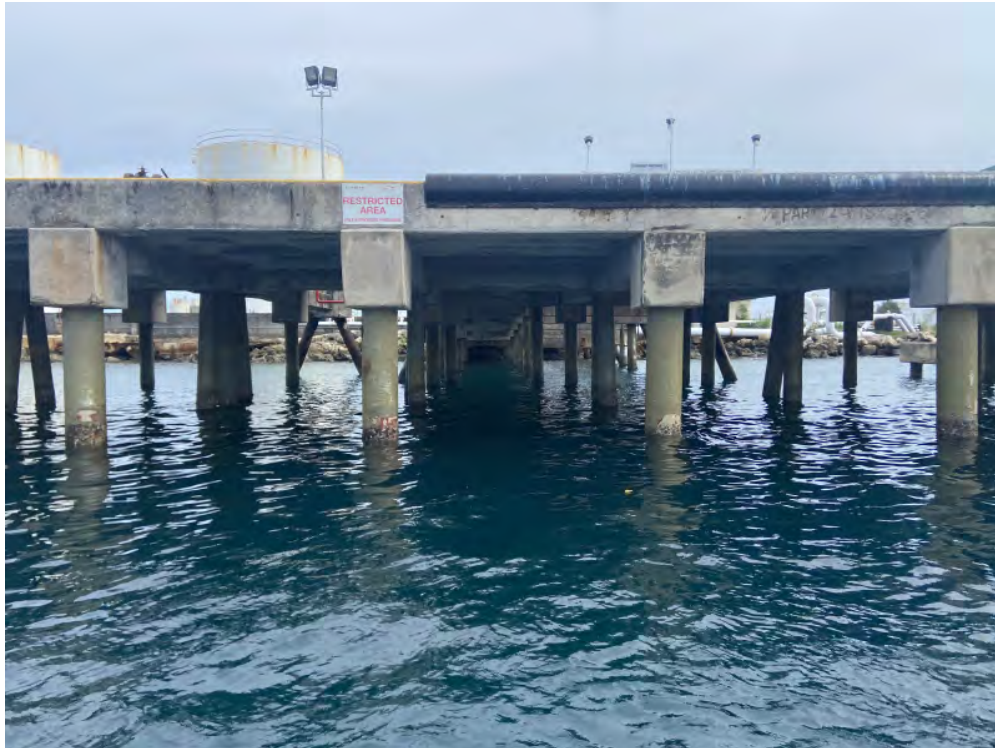
Photo 1 – Main Pier

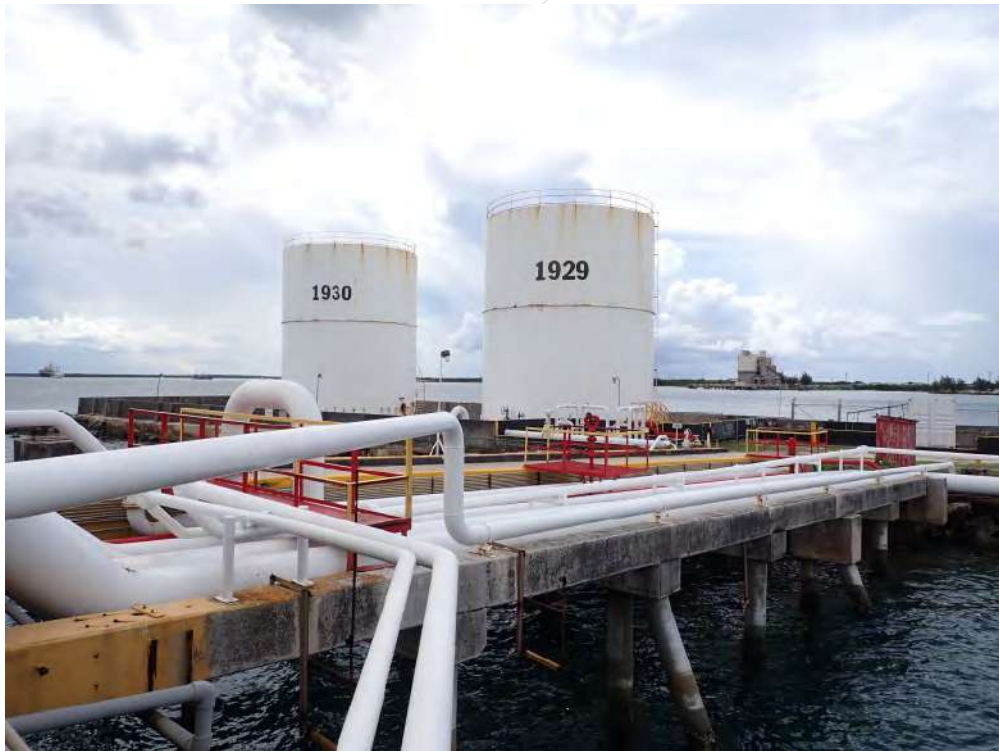
**Photo 4 - Trestle**
